Tahmoor Colliery – Longwall 31

Management Plan for Potential Impacts to Endeavour Energy Infrastructure

Longwall 31

(On Site Audit conducted on Wednesday 5th April, 2017)

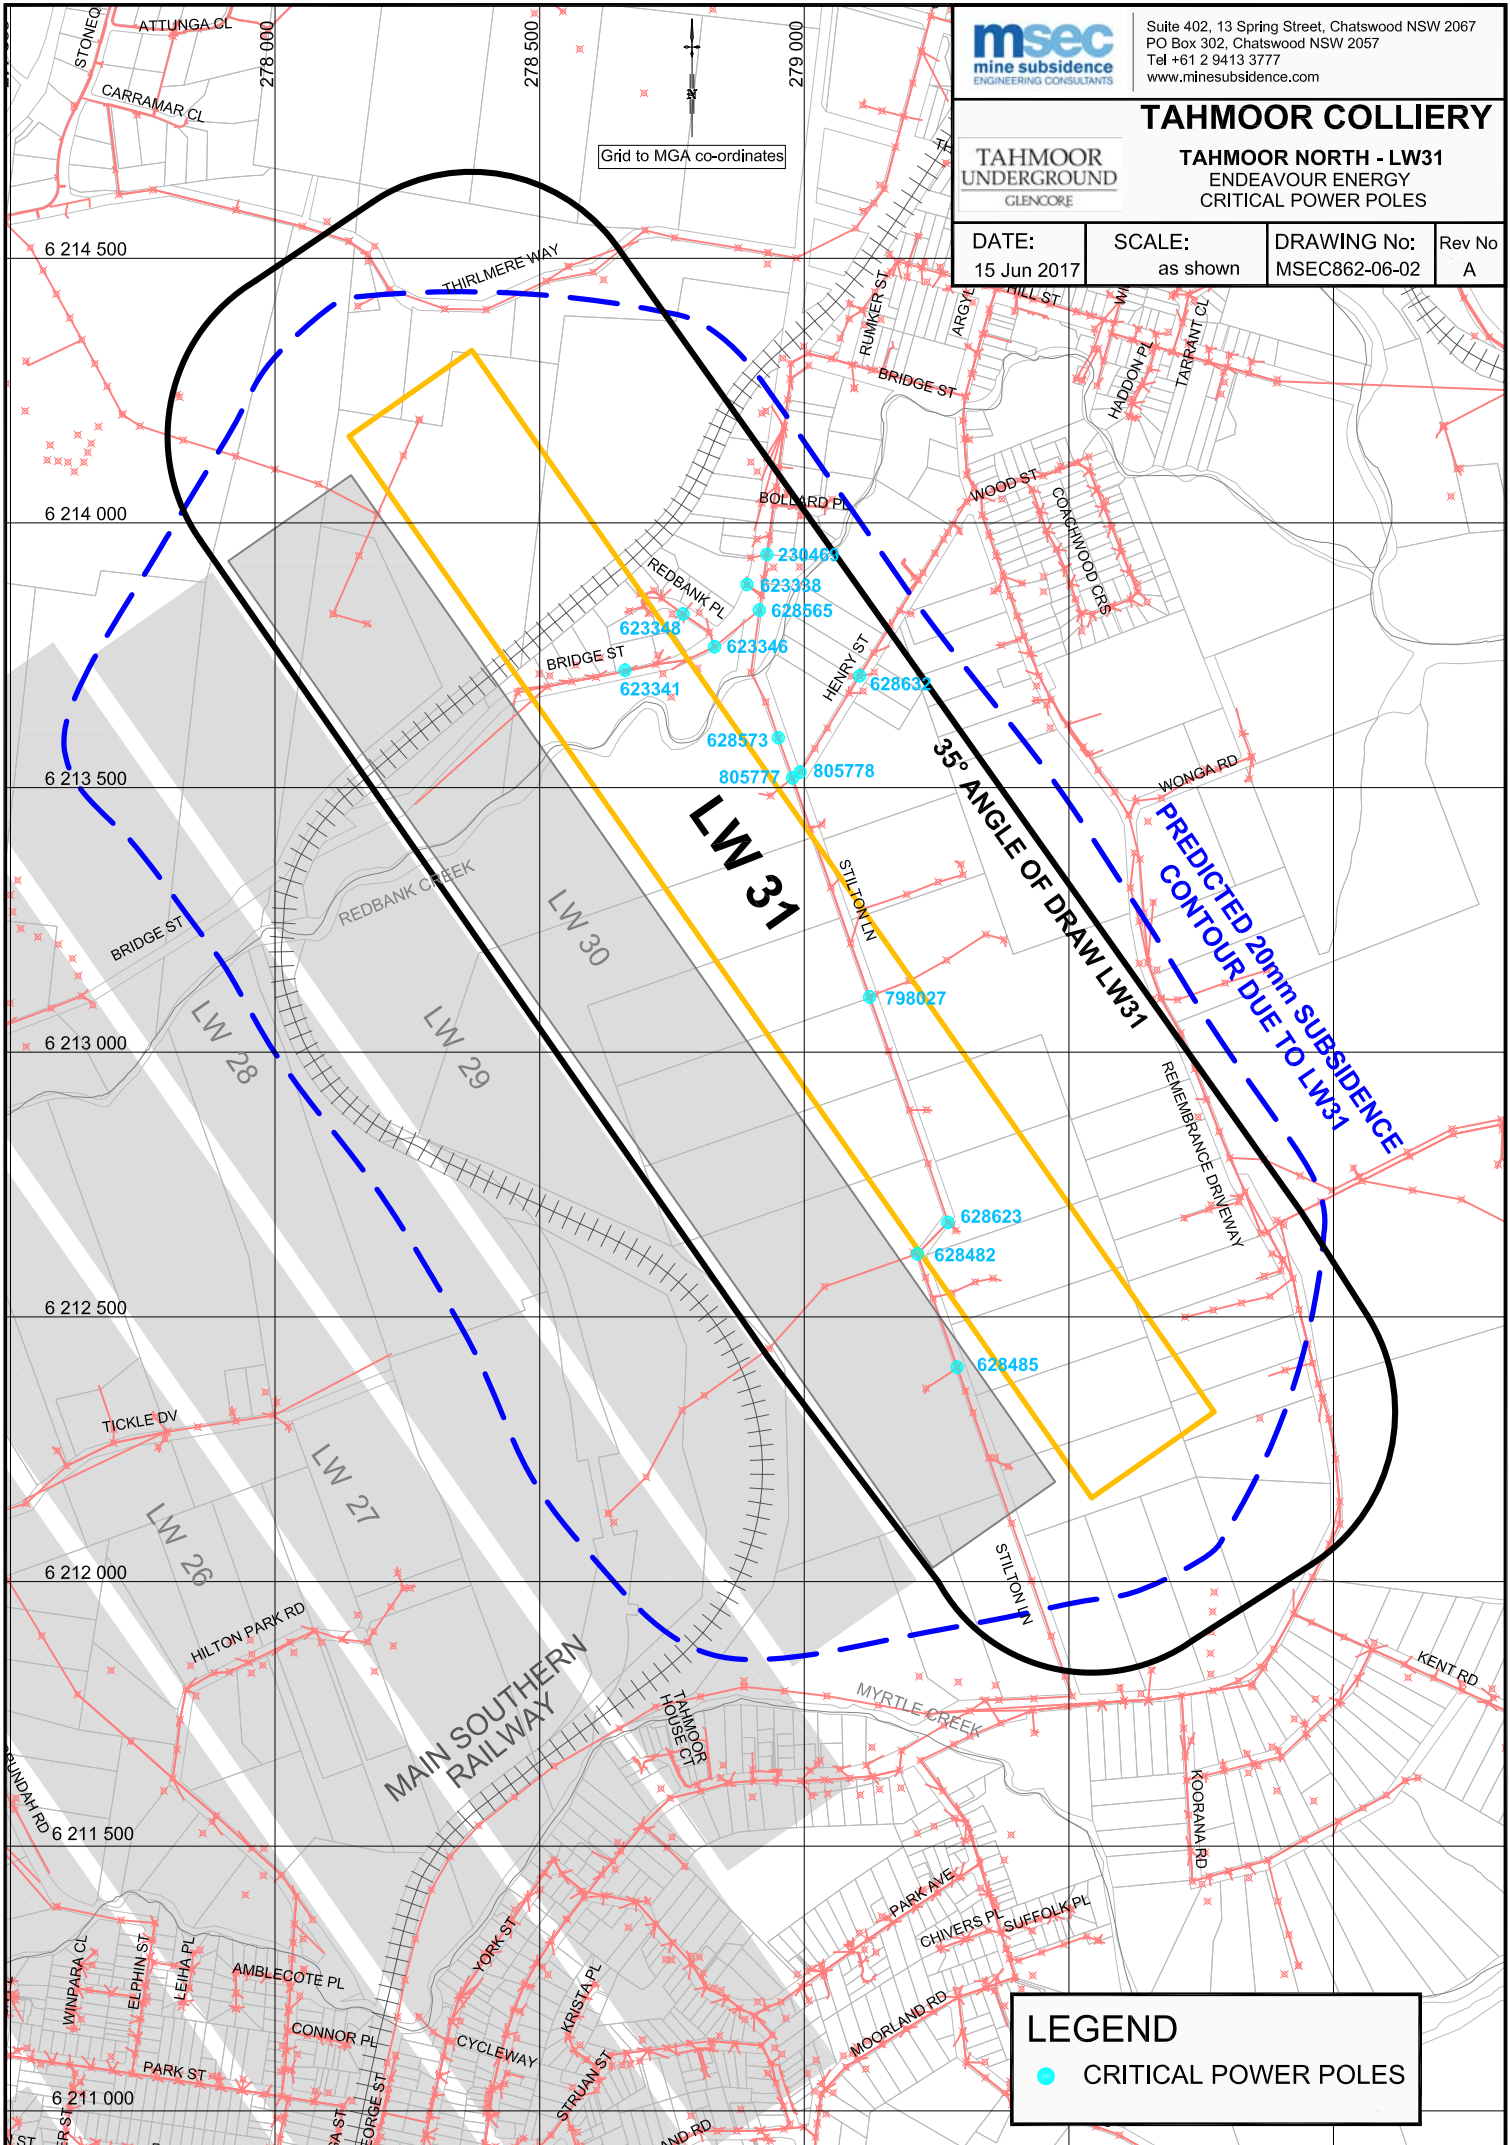
TAHMOOR NORTH - LW31
 ENDEAVOUR ENERGY
 CRITICAL POWER POLES

An inspection of power poles located within the mining area for Longwall 31 was conducted by Endeavour Energy on 5 April 2017. The accompanying report concluded that the electricity infrastructure is generally in a good state of repair and in serviceable order. Experience has shown that power poles have remained safe and serviceable during and after mining.

The poles recommended for monitoring during Longwall 31 are listed in Table 5.2, and are shown in Drawing No. MSEC862-06-02.

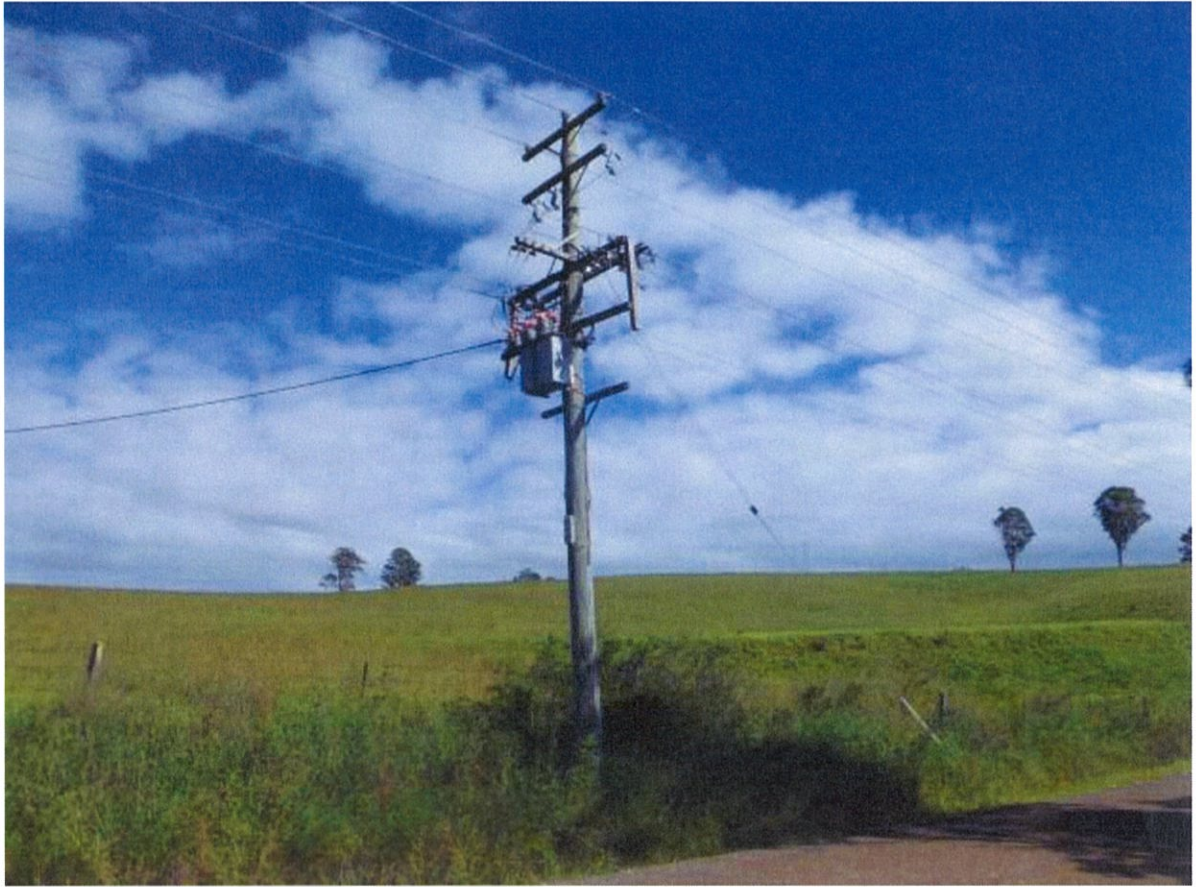
Pole No	Asset	Location	Photo Number	Description
628485	Pole Sub 12016	Stilton Lane (Map 1)	1	12.5/12 Sub Pole - Ground Stayed HV Pin Construction LV Strain Construction Separate Earth Configuration 1 x Service Mains Pole stands vertical and is in good serviceable condition.

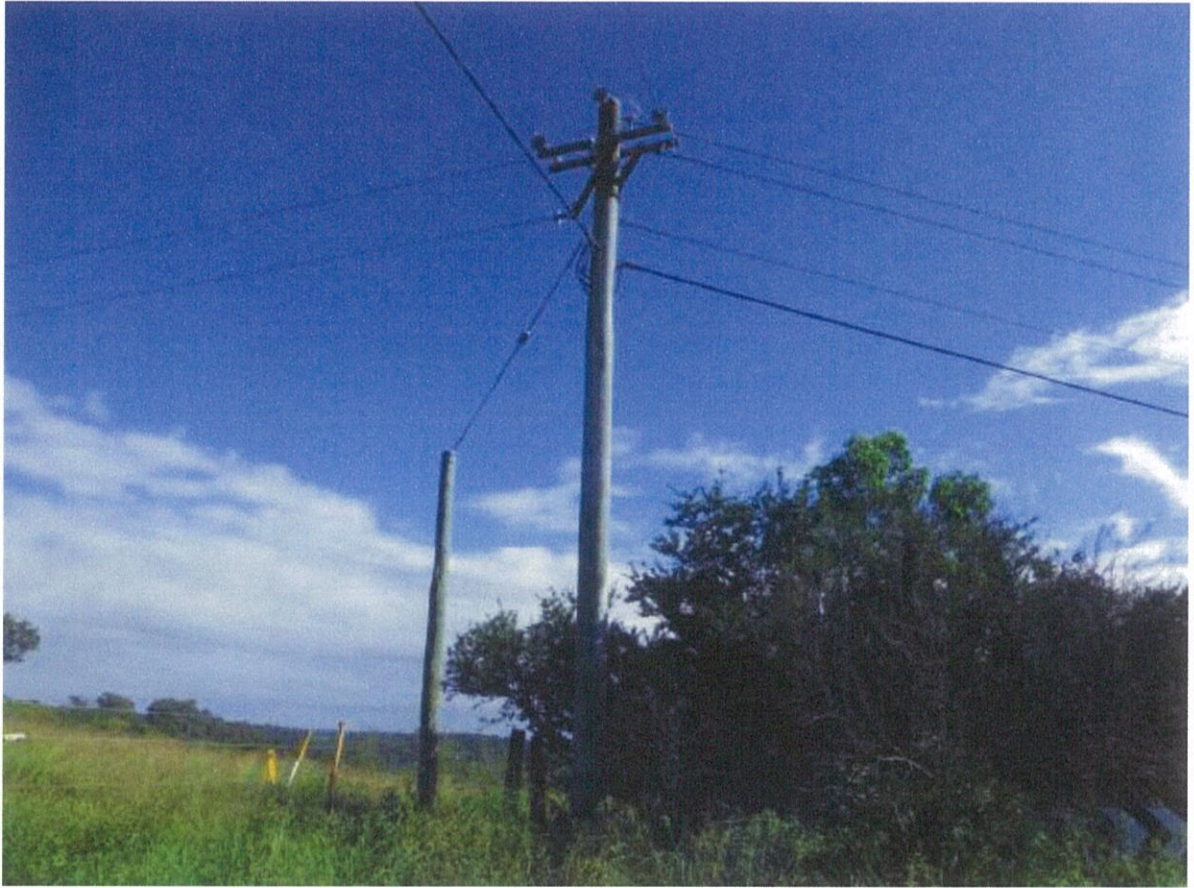
Pole No	Asset	Location	Photo Number	Description
628482	HV Pole	Stilton Lane (Map 1)	2	12.5/12 HV Angle Pole - Stayed to Bollard HV Term Construction HV Strain Construction LV ABC Strain Construction Pole stands vertical and is in good serviceable condition.

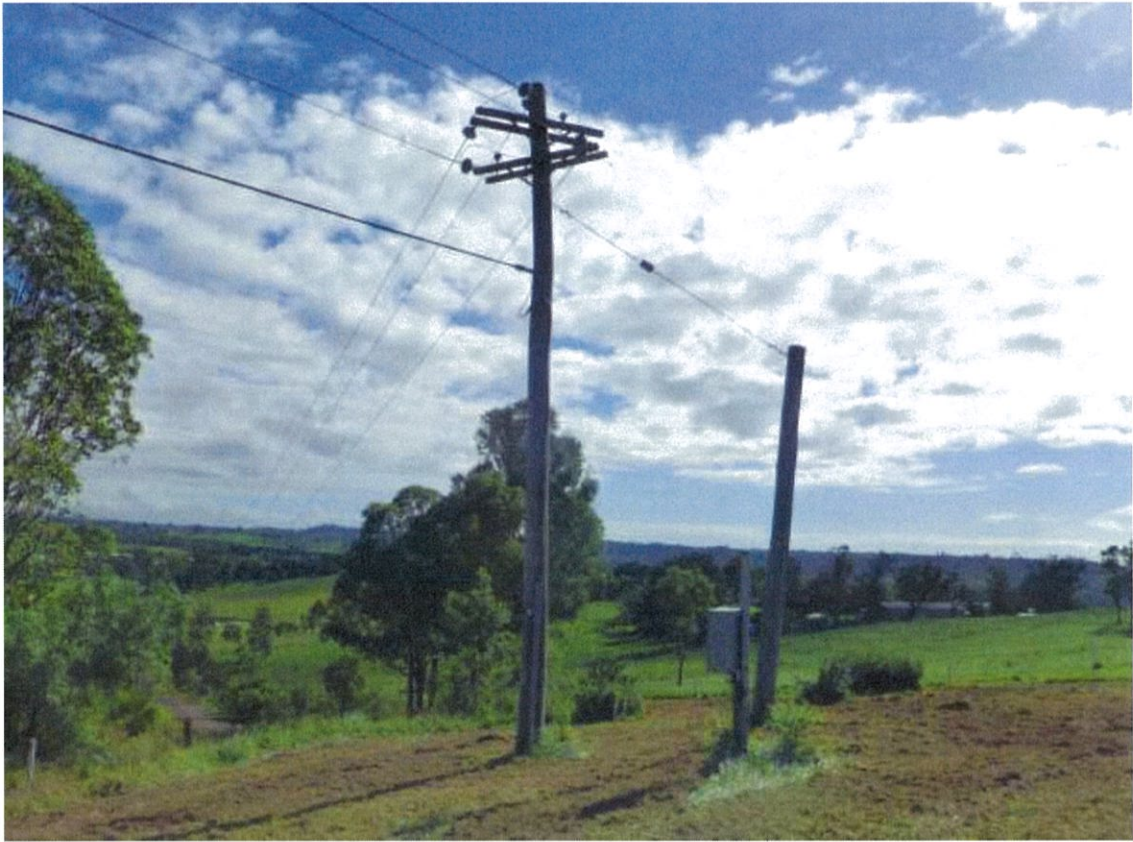
Pole No	Asset	Location	Photo Number	Description
628623	HV Pole	Stilton Lane (Map 1)	3	12.5/12 HV Angle Pole - Stayed to Bollard 2 x HV Term Constructions LV ABC Strain Construction 1 x LV HU Service Mains Pole stands vertical with the top of the pole being slightly bent toward the angle, and is in good serviceable condition.

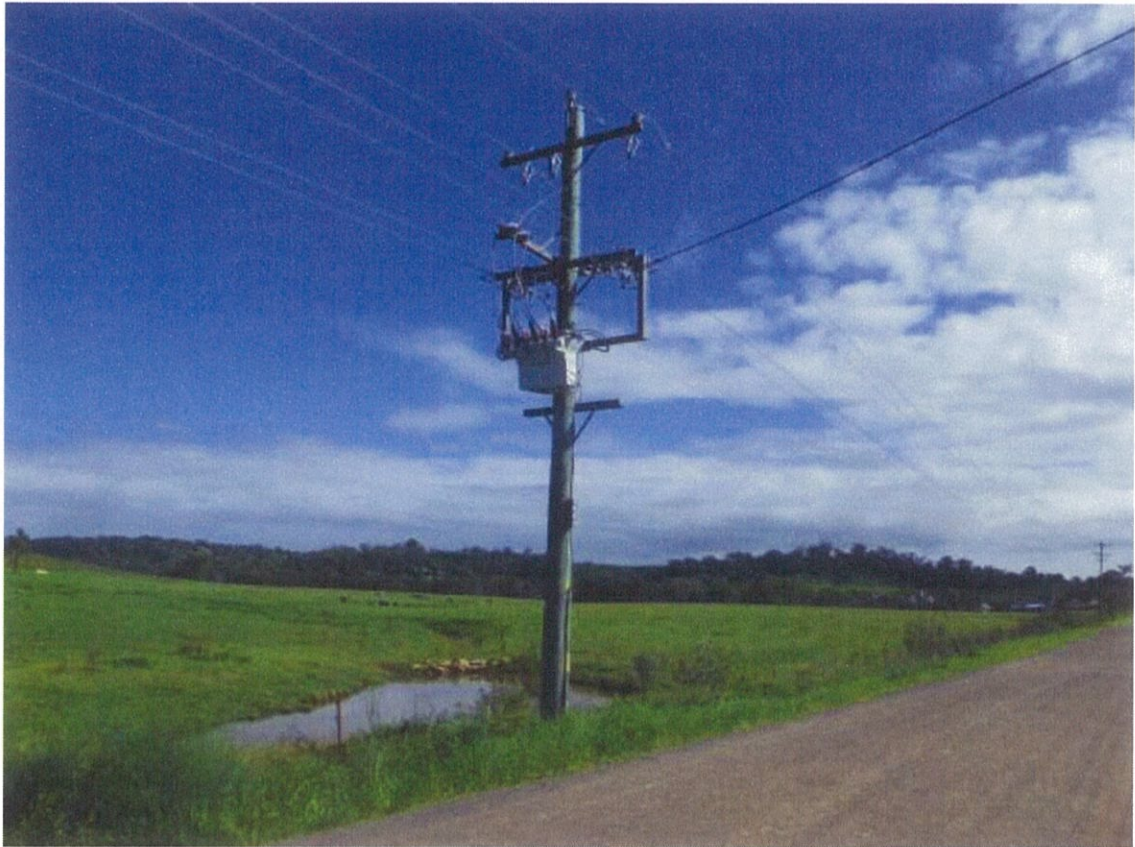
Pole No	Asset	Location	Photo Number	Description
798027	Pole Sub 10209	Stilton Lane (Map 1)	4	12.5/12 Sub Pole - Ground Stayed HV Pin Construction LV Strain Construction Separate Earth Configuration 1 x Service Mains Pole stands vertical and is in good serviceable condition.

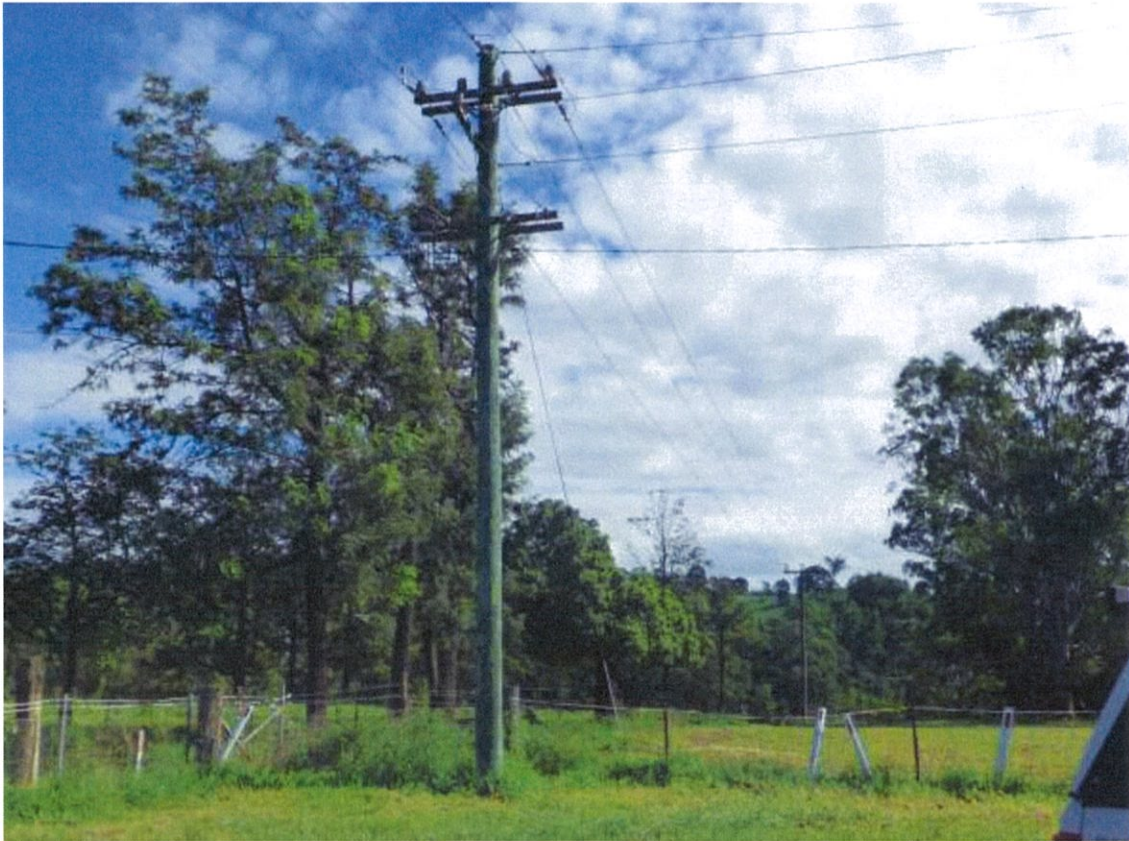
Pole No	Asset	Location	Photo Number	Description
805777	HV POLE	Stilton Lane (Map 2)	5	12.5/8 HV Take-off Pole - Ground Stayed HV Strain Construction HV Term Construction LV Term Construction 1 x LV Service Mains Pole stands vertical and is in good serviceable condition.

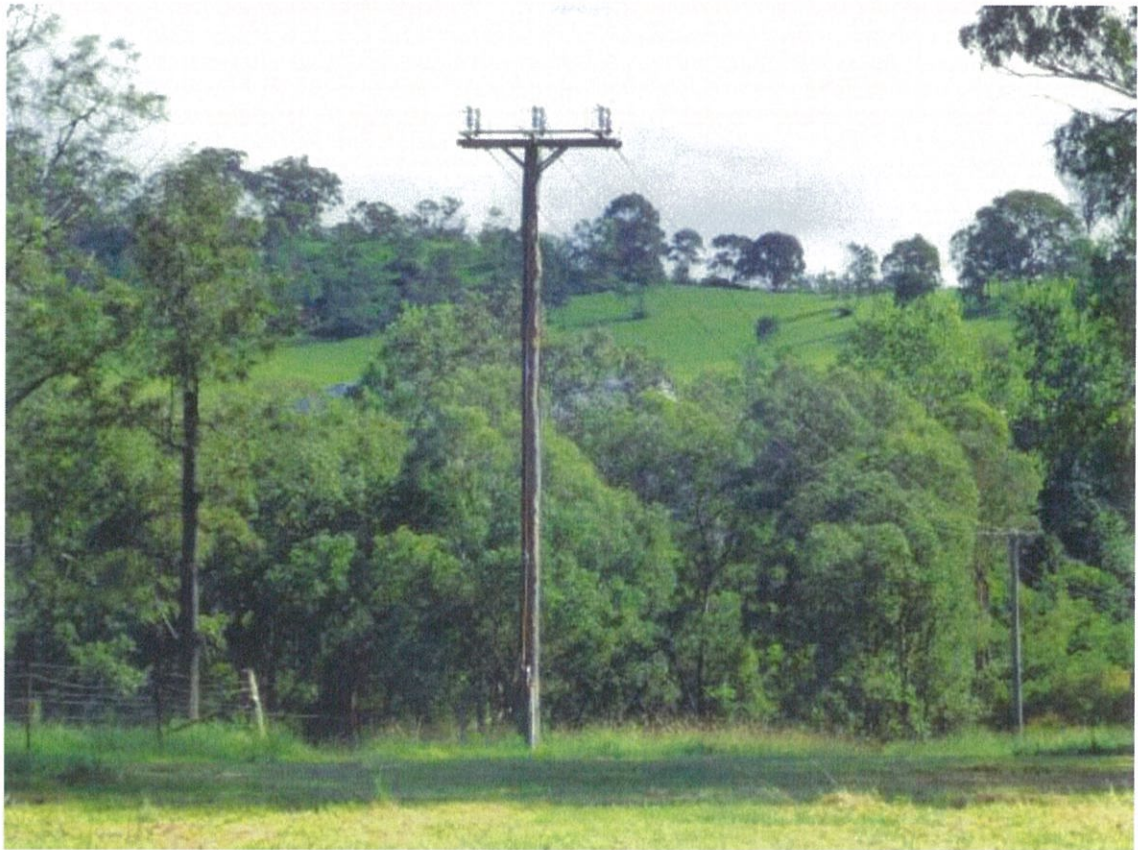
Pole No	Asset	Location	Photo Number	Description
628573	ABS Pole	Stilton Lane (Map 2)	6	12.5/8 ABS Pole ABS No P083 Pole stands vertical but with a slight bend about 2m below the pole top, and is in good serviceable condition.

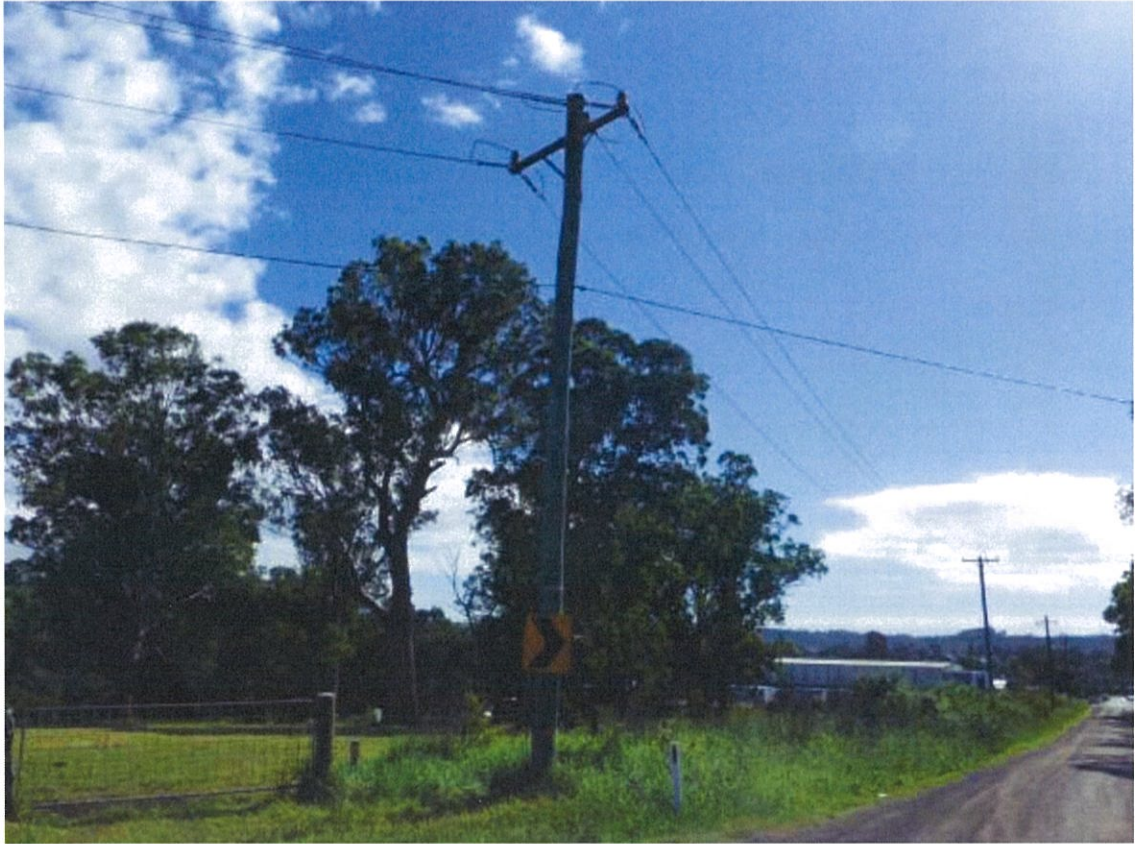
Pole No	Asset	Location	Photo Number	Description
805778	HV Pole	Henry Street (Map 2)	7	12.5/8 HV Angle Pole HV Strain Construction LV ABC Service Mains Pole stands vertical and is in good serviceable condition.

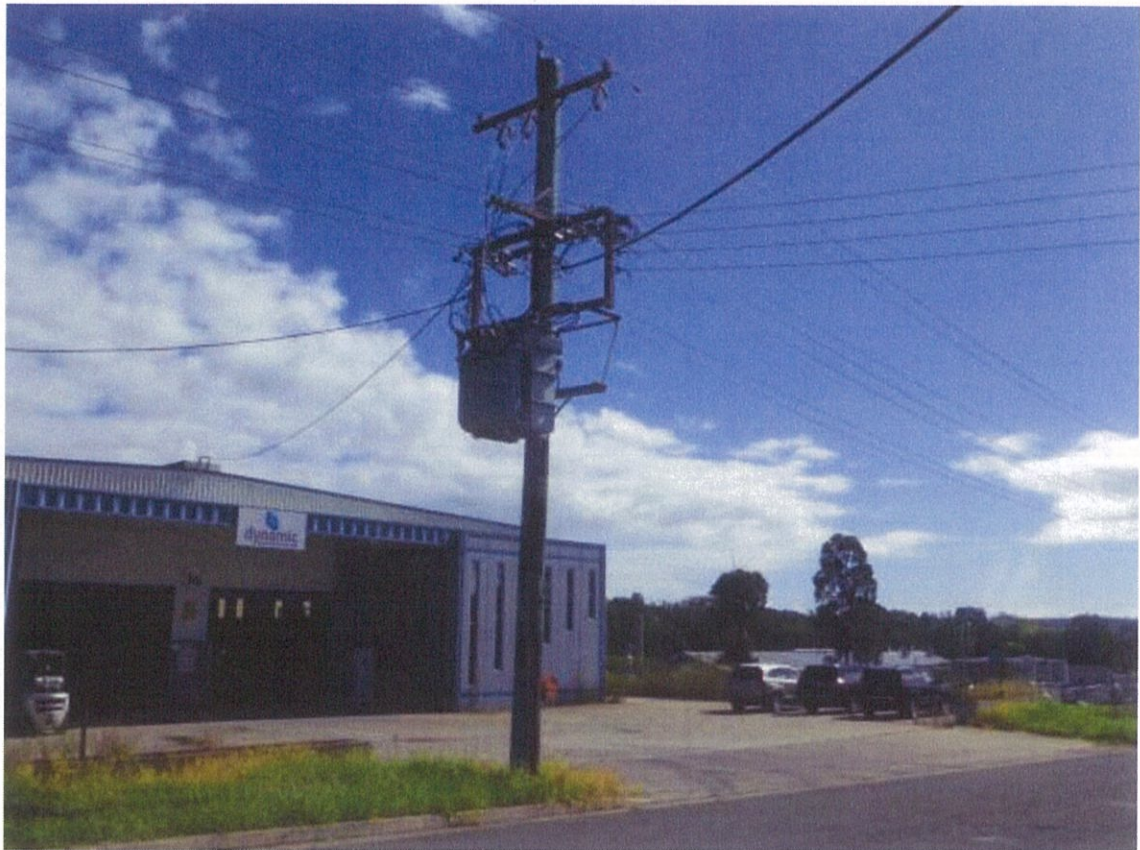
Pole No	Asset	Location	Photo Number	Description
628632	Pole Sub 12089	Henry Street (Map 2)	8	12.5/12 Sub Pole HV Pin Construction LV Strain Construction Separate Earth Configuration 4 x Service Mains Pole stands vertical and is in good serviceable condition.

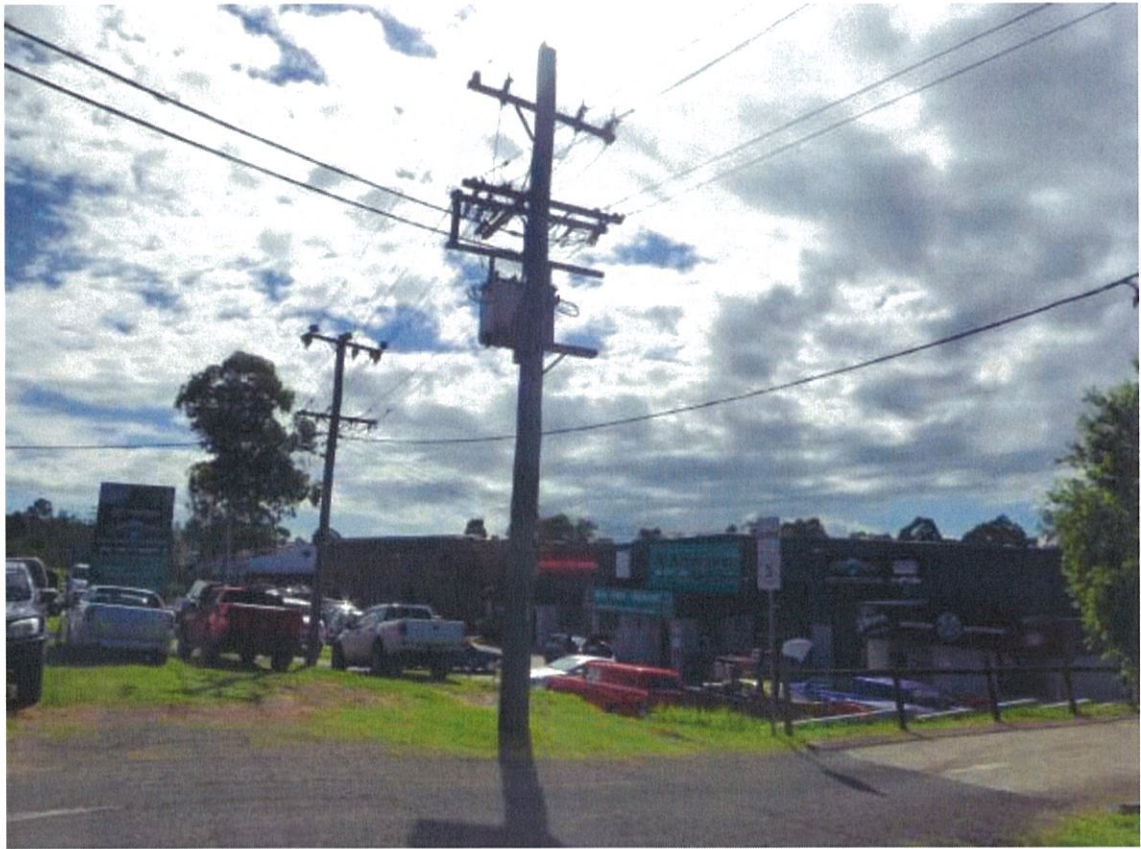
Pole No	Asset	Location	Photo Number	Description
230469	Pole Sub 20823	Bridge Street (Map 2)	9	12.5/12 Sub Pole - Ground Stayed HV Pin Construction LV Strain Construction Separate Earth Configuration 1 x Service Mains Pole stands vertical and is in good serviceable condition.

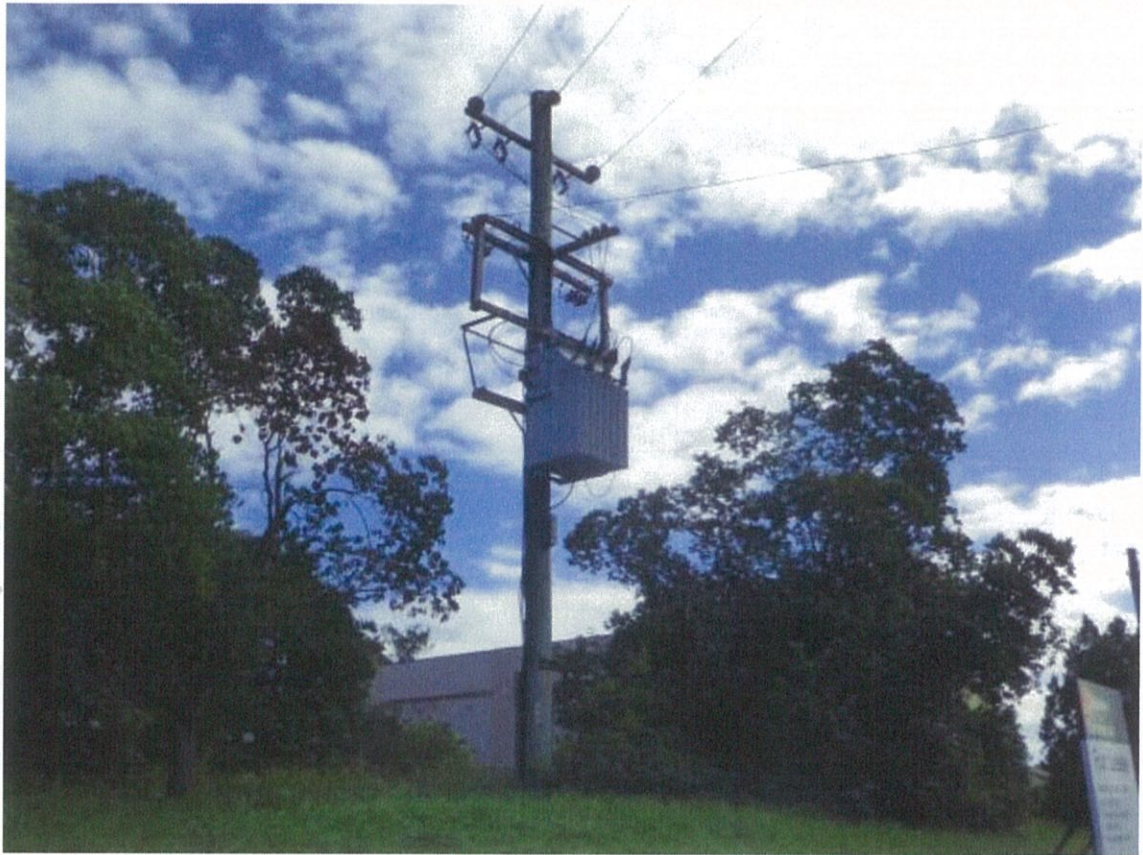
Pole No	Asset	Location	Photo Number	Description
623338	Pole Sub 3915	Bridge Street (Map 2)	10	12.5/12 Sub Pole - Ground Stayed HV Term Construction 1 x SL Conductor crossing road Separate Earth Configuration Pole stands vertical and is in good serviceable condition.

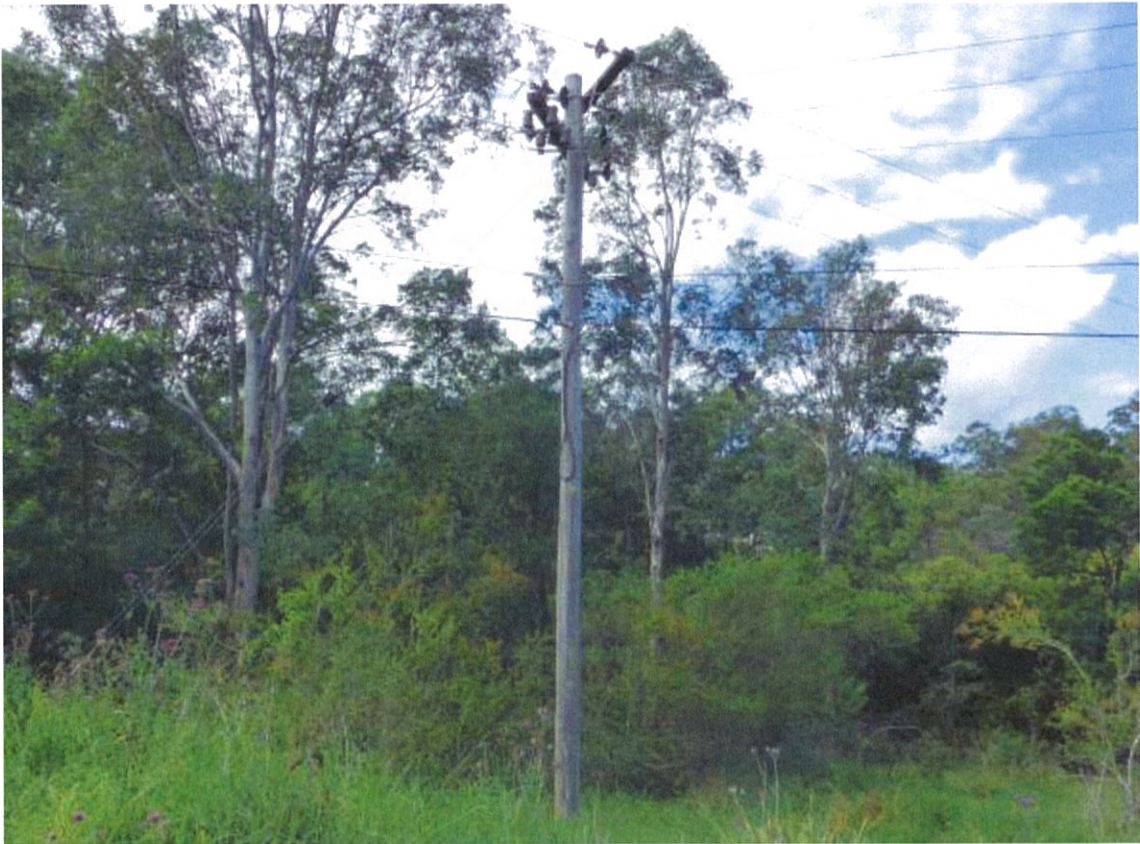
Pole No	Asset	Location	Photo Number	Description
628565	HV Pole	Bridge Street (Map 2)	11	12.5/8 HV Take-off Pole - Ground Stayed HV Strain Construction HV Term Construction – Links 17282 Joint Use Telstra Pole Pole stands vertical and is in good serviceable condition.

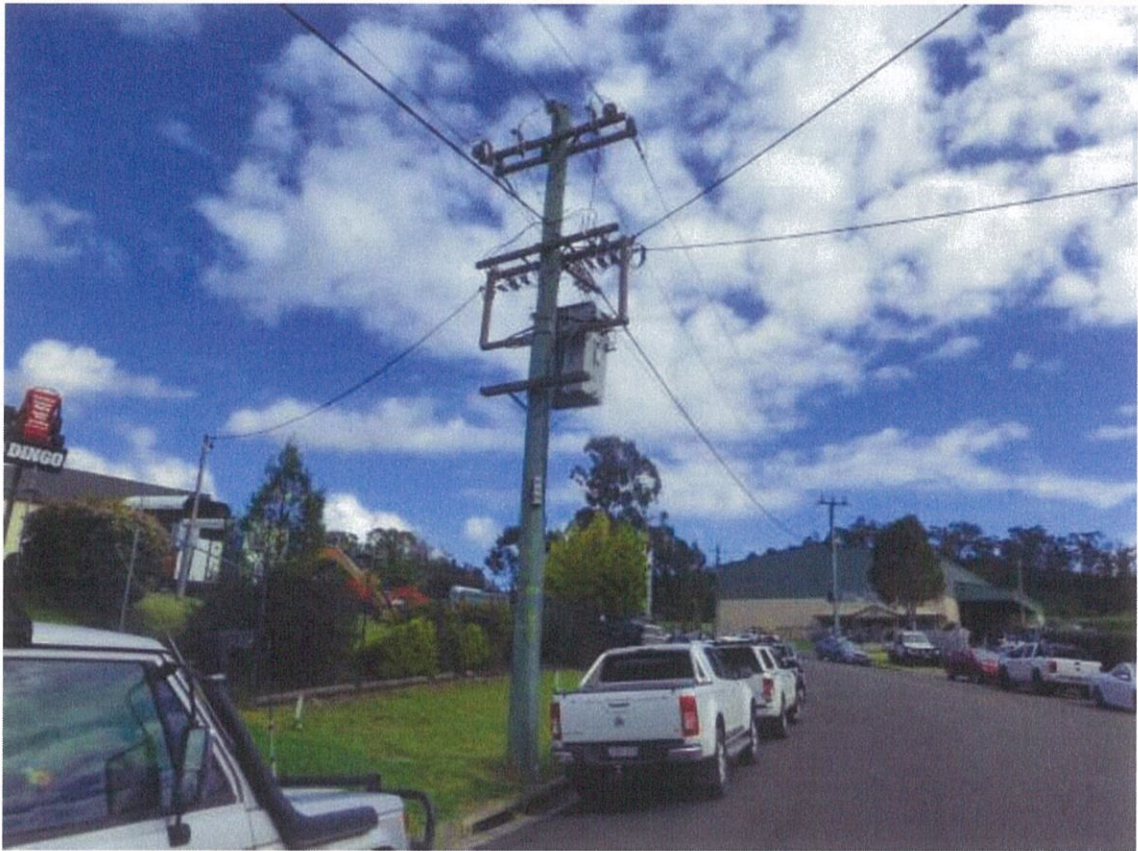
Pole No	Asset	Location	Photo Number	Description
623348	Pole Sub 18638	Bridge Street (Map 2)	12	12.5/12 Sub Pole HV Strain Construction LV ABC Strain Construction Separate Earth Configuration 3 x Service Mains Pole stands vertical and is in good serviceable condition.

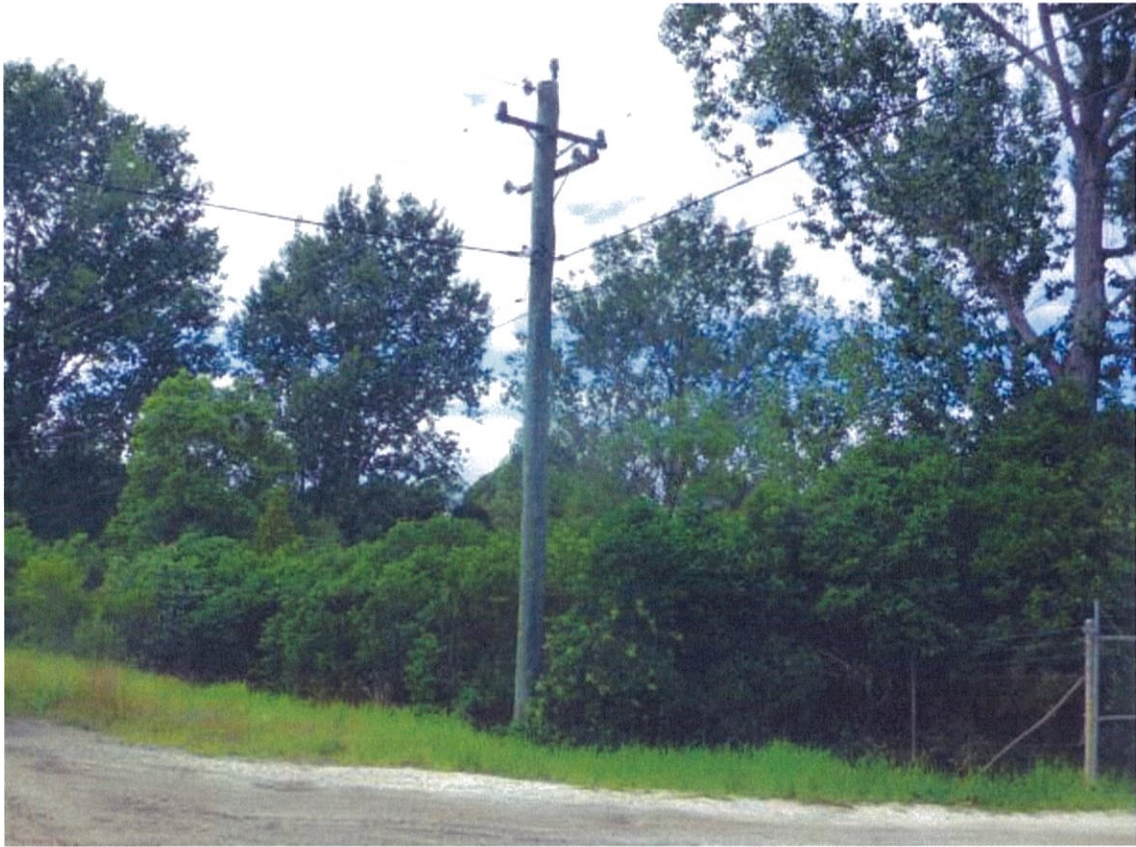
Pole No	Asset	Location	Photo Number	Description
623346	HV Pole	Bridge Street (Map 2)	13	12.5/12 HV Take-off Pole HV Pin Construction HV Term Construction 2 x LV ABC Term Constructions Joint Use Telstra Pole Pole stands vertical and is in good serviceable condition.

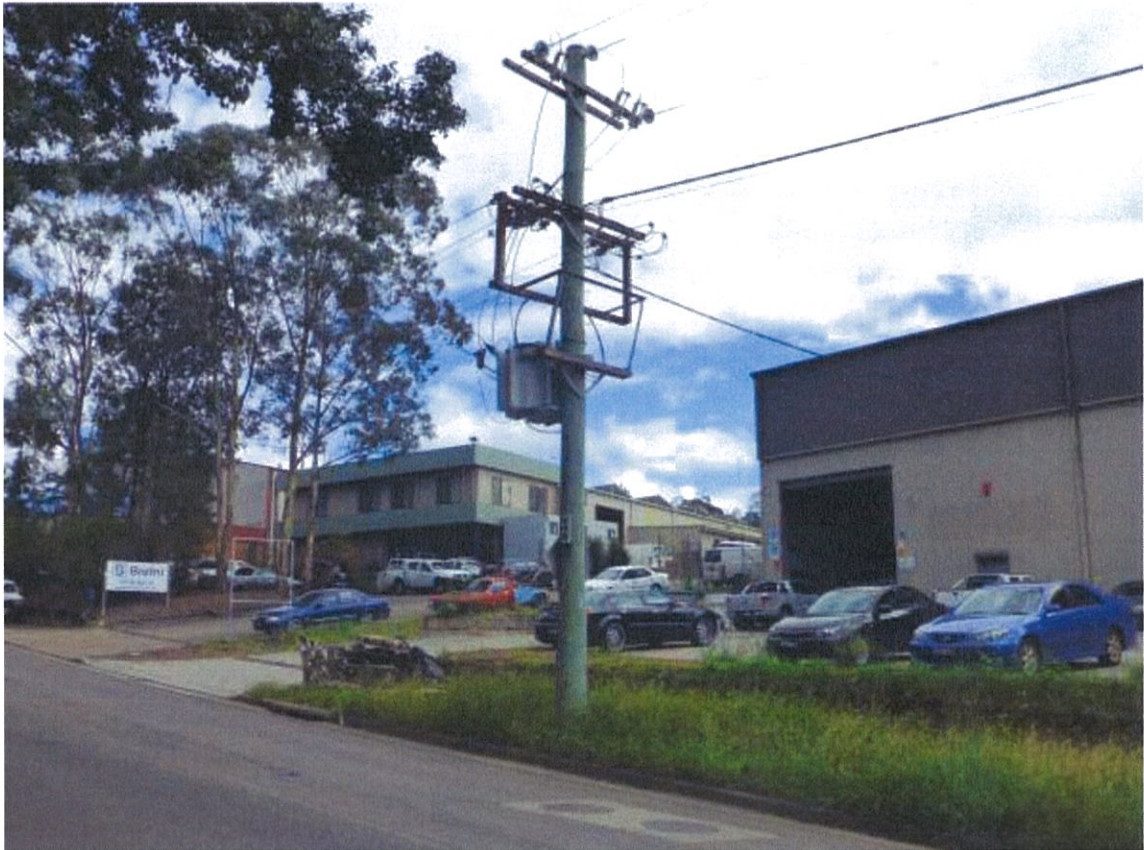
Pole No	Asset	Location	Photo Number	Description
623341	Pole Sub 11338	Bridge Street (Map 2)	14	12.5/12 Sub Pole - Ground Stayed HV Term Construction LV Term Construction LV ABC Term Construction Separate Earth Configuration 1 x Service Mains Pole stands vertical and is in good serviceable condition.
