**TAHMOOR COLLIERY
LONGWALL 23B**

**END OF PANEL MONITORING REPORT
FOR LONGWALL 23B
AT TAHMOOR COLLIERY**

REPORT NO. MSEC235-06

November 2006

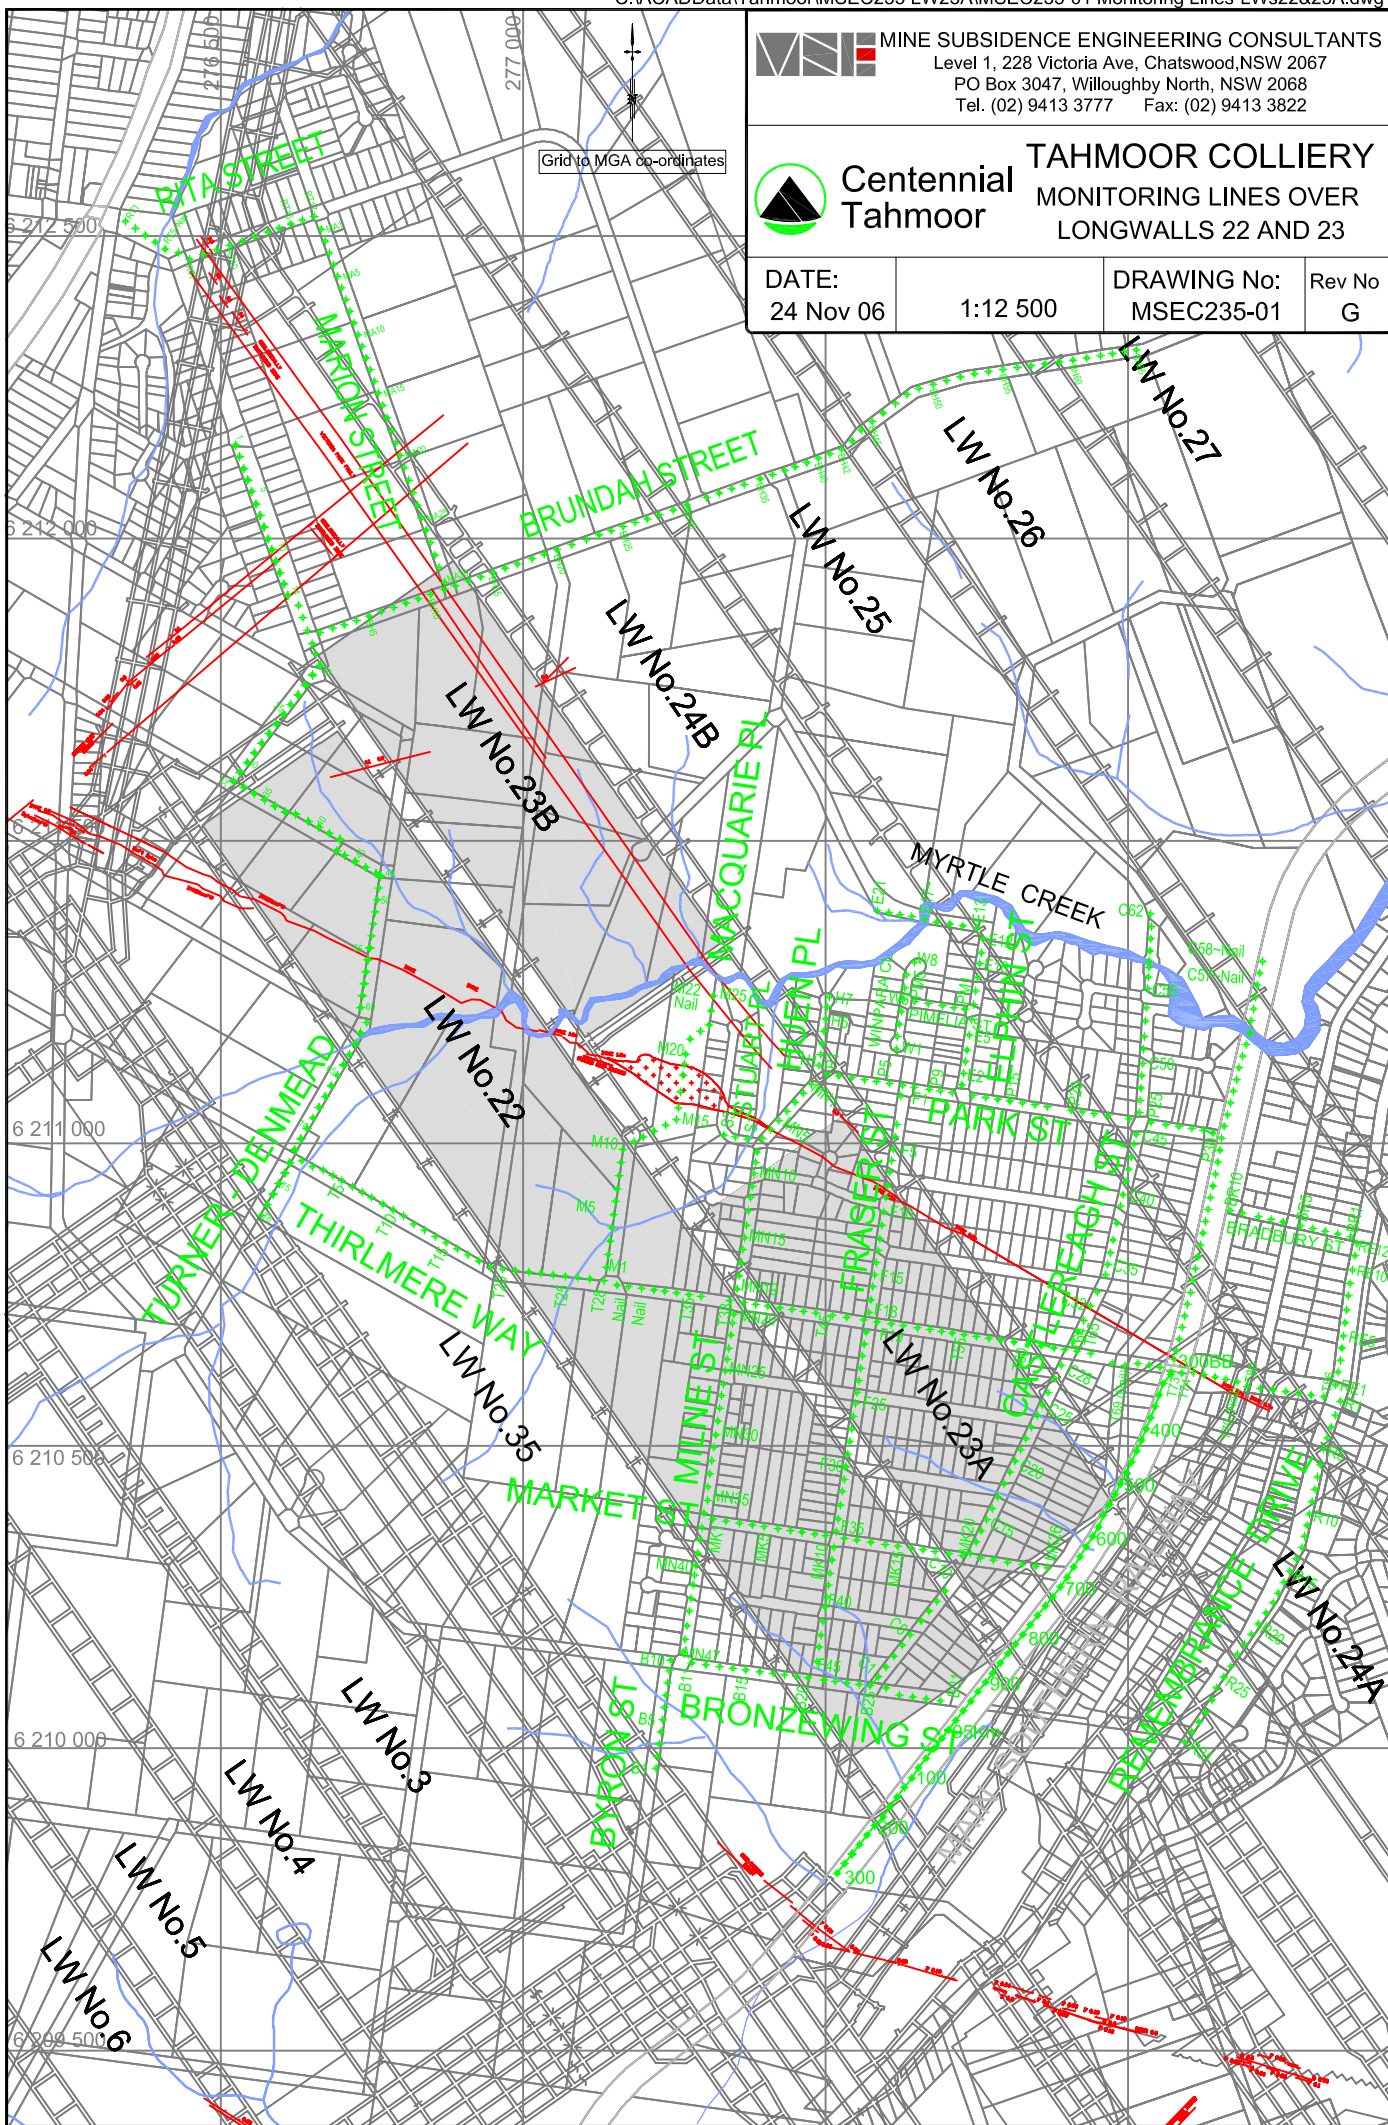
DATE: 24 Nov 06	1:12 500	DRAWING No: MSEC235-01	Rev No G
--------------------	----------	---------------------------	-------------

- There is a reasonable correlation between observed and predicted subsidence and tilt profiles. The main exception to this observation is the Macquarie Place monitoring line, which is influenced by the igneous intrusion in Longwall 23, as shown in Drawing No. MSEC235-01.

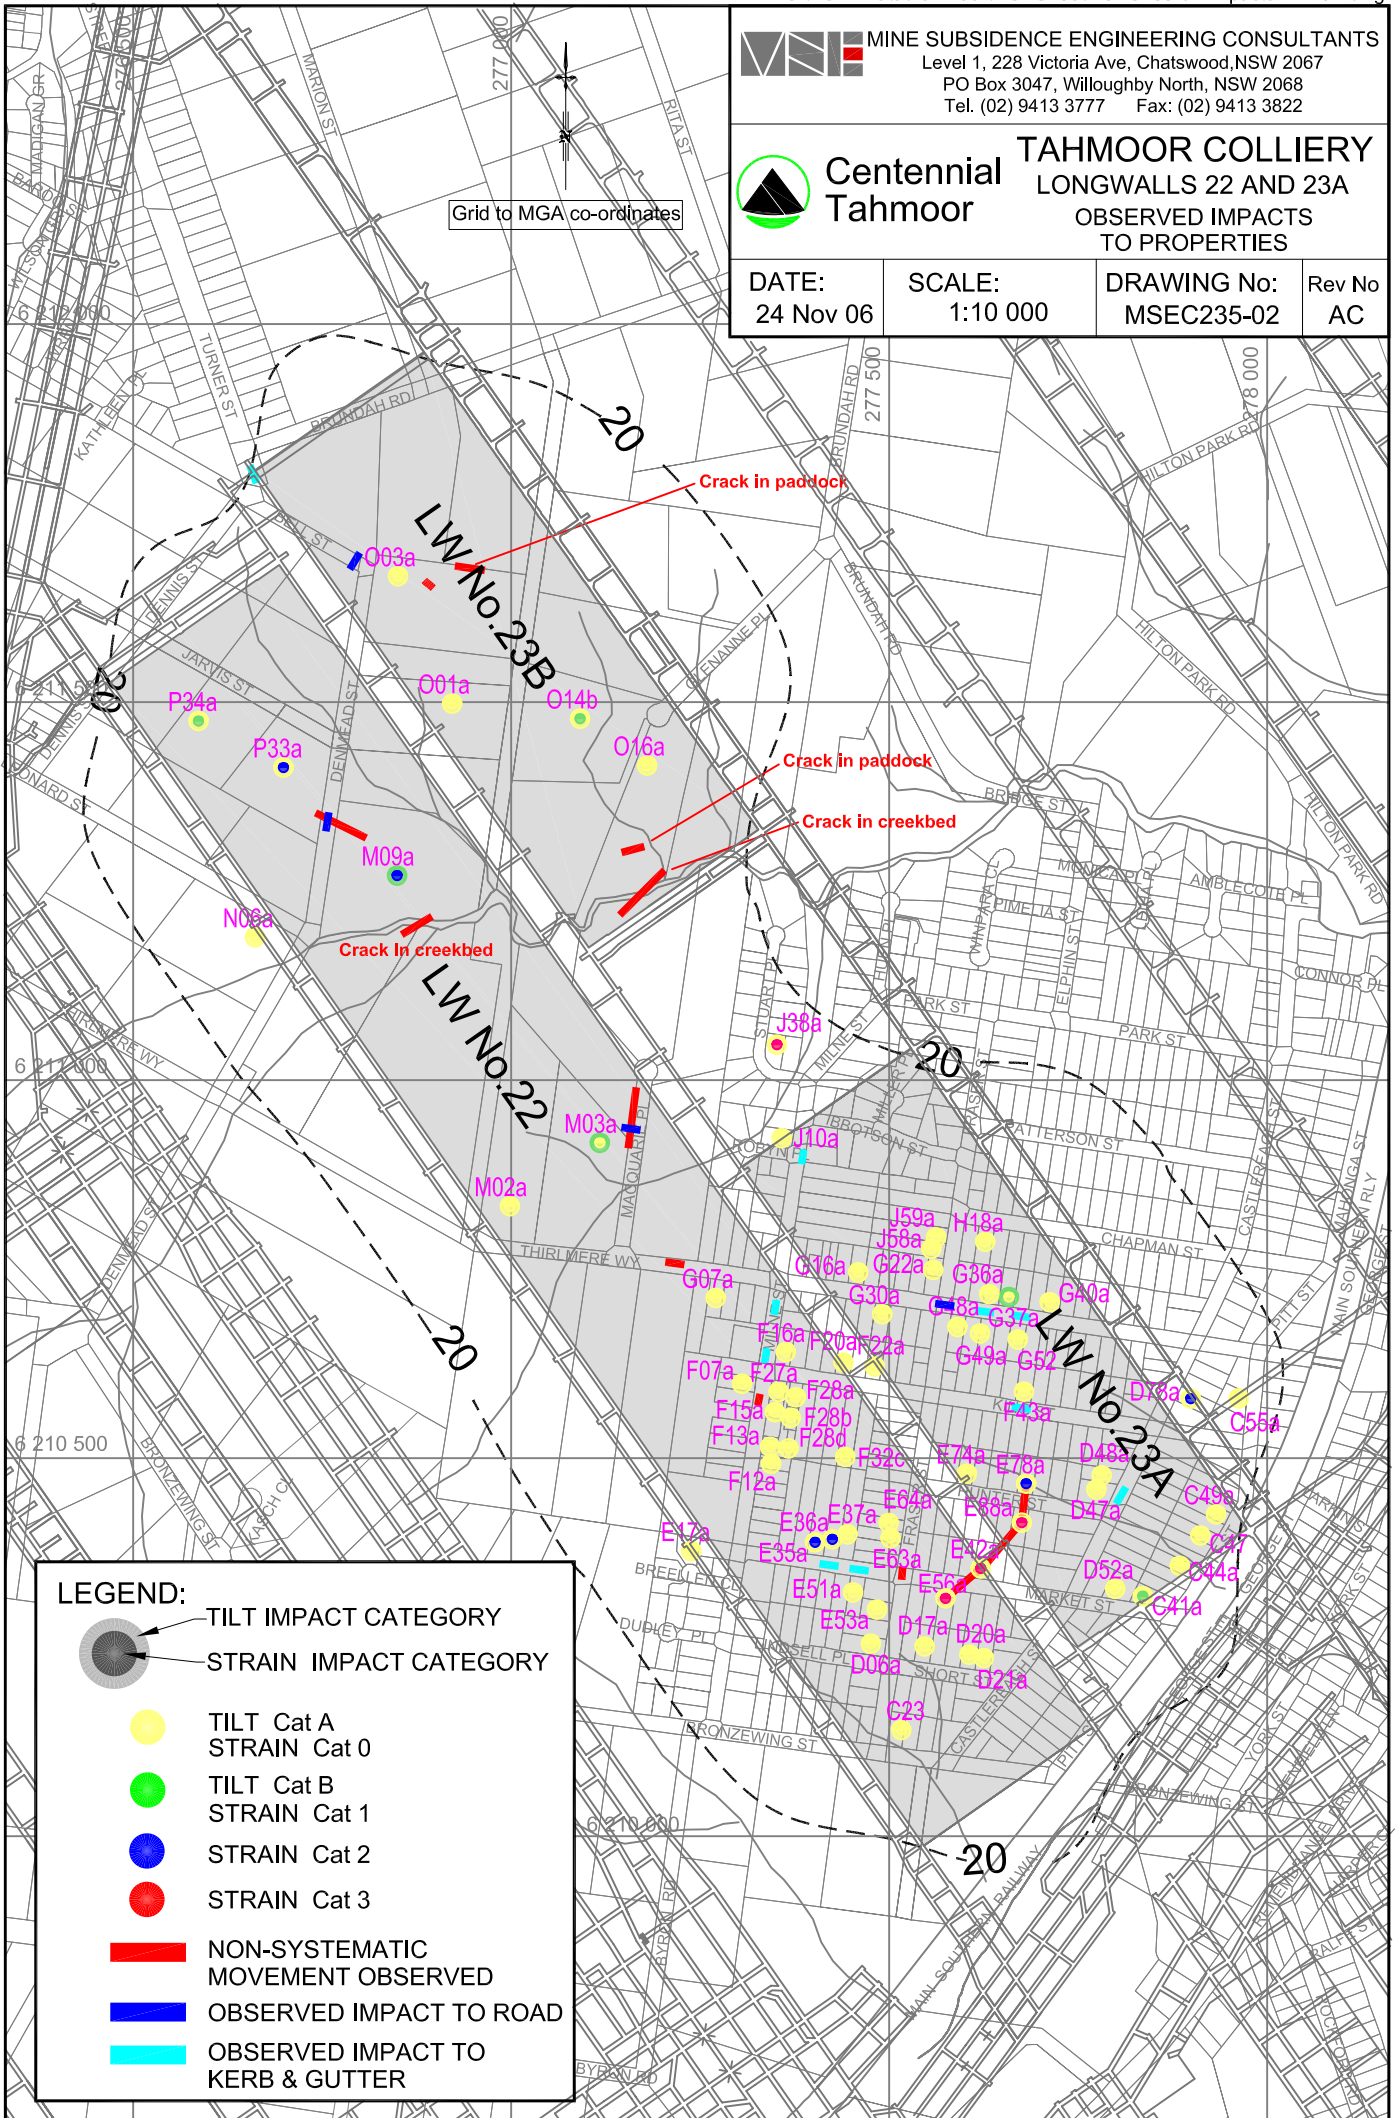
DRAWING No:
MSEC235-02

- The Macquarie Place line was established prior to the commencement of Longwall 22. The pavement first cracked during the extraction of Longwall 22, which is shown in Drawing No. MSEC235-02. There was a slight widening of cracking to the road pavement due to the extraction of Longwall 23B. No further impacts have been observed since the 600 metre street monitoring report.

- A property in Glenanne Place has experienced a differential tensile horizontal movement between two structures (Structure Ref. O14a and b as located in Drawing No. MSEC235-02) that has resulted in substantial impacts to some brick columns. Differential movements have also been observed between the structures and external concrete pavements. There is no evidence of cracking or bulging of the ground around the structures. The house is located adjacent to a small watercourse. The property remains safe and serviceable.

- A tensile crack has formed in a paddock within another property in Glenanne Place (Structure Ref. O16). The crack is approximately 40 metres long and between 10 and 65 mm wide and 200 mm deep. The crack in the ground is shown in Drawing No. MSEC235-02. As shown in this drawing, the orientation of this crack does not align with Structures O14a and O14b. However, the crack is located adjacent to the same watercourse that runs past those structures. A common factor between the two impact sites is the small watercourse. It is possible that the impacts are related to the behaviour of the strata along this drainage line. The movements may be related to upsidence and closure movements, or may be due to the way the strata along this drainage line has failed or responded to subsidence movements.

- Cracking has been observed in the bed of Myrtle Creek near the commencing end of Longwall 23B, as located in Drawing No. MSEC235-02. These may be due to non-systematic upsidence and closure movements. Further details will be provided in a report by Geoterra Pty Ltd.

- Surface cracks have been observed in a property on the corner of Bell and Denmead Streets (Structure Ref. O03a) as shown in Drawing No. MSEC235-02. The crack is approximately 40 metres long and up to 40 mm wide.

The locations of affected houses and public amenities are shown in Drawing No. MSEC235-02. It can be seen from this drawing that the great majority of impacts have occurred directly above the extracted longwall panels. However, in a small number of cases, some minor impacts were reported prior to the longwall directly mining under the properties. The three houses with Category 3 cracks to external walls have experienced non-systematic movements. Two of the houses that have experienced Category B tilt impacts are located near non-systematic movements. It is therefore concluded that whilst some houses have experienced greater impacts when compared to their predicted impact assessments, the impacts are mainly due to non-systematic movements, which cannot be predicted prior to the commencement of Longwalls 22, 23A and 23B.

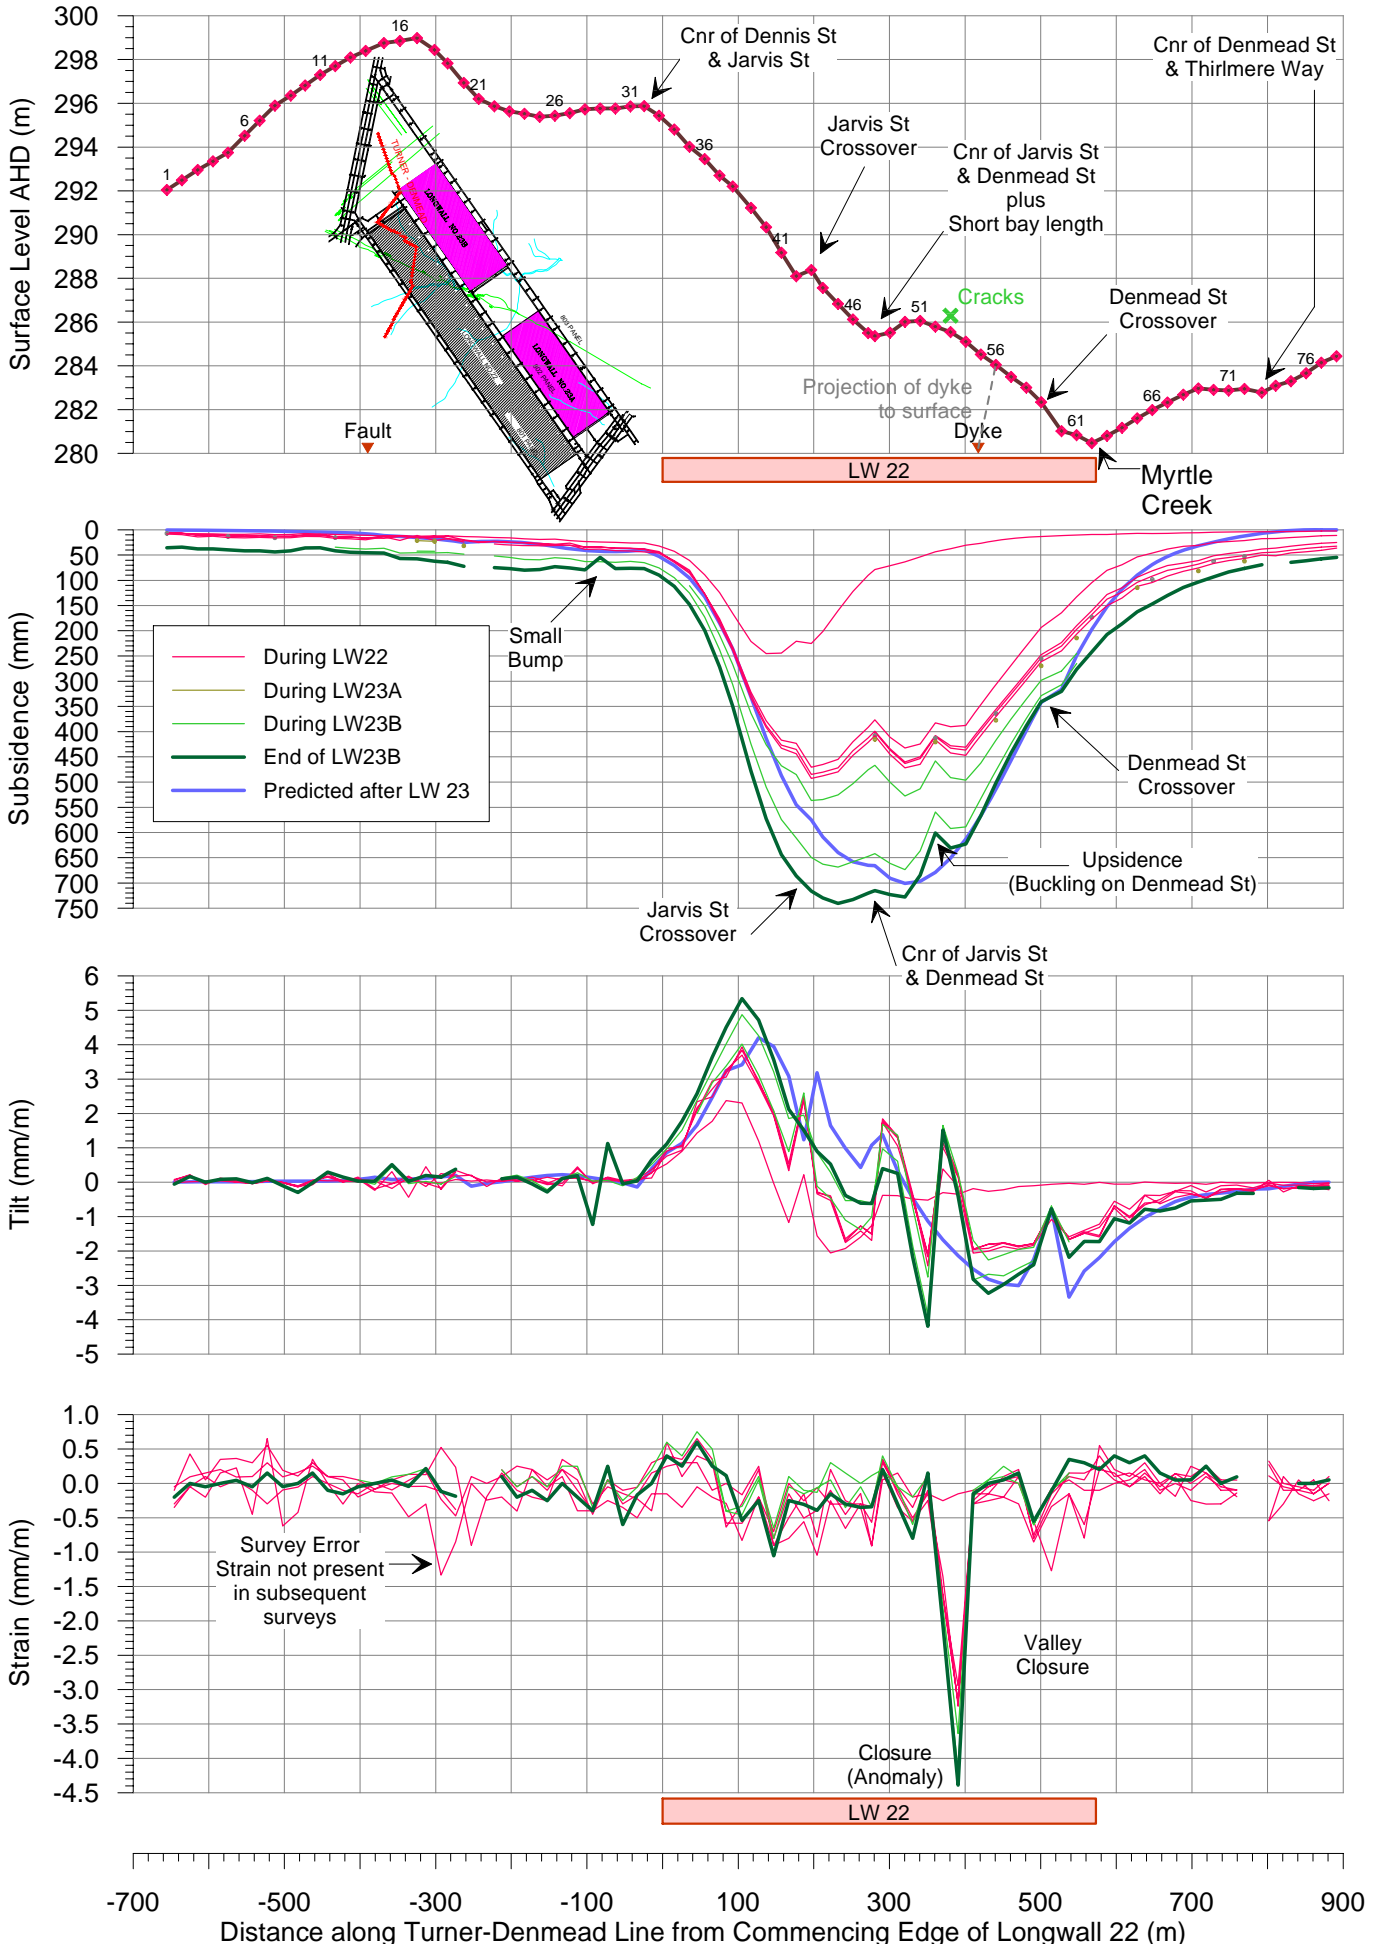
Tahmoor Colliery - Total Subsidence Profiles along Turner-Denmead Monitoring Line

- The Turner-Denmead line was established prior to the commencement of Longwall 22. The compressive strain associated with upsidence along Denmead Street between pegs 54 and 55, has increased to 4.4 mm/m which is an increase of 1.2 mm/m since the completion of Longwall 22. The pavement first cracked during mining of Longwall 22, which is shown in Drawing No. MSEC235-02. Further minor movement was observed on the road pavement and footpath during mining of Longwall 23B.

- It can be seen from Figure No. MSEC235-17 that observed subsidence has exceeded the predicted subsidence over much of the Turner-Denmead monitoring line (pegs 1 to 51 and 61 to 78). The maximum observed subsidence exceeds the predicted maximum subsidence by about 50mm. While there is a good match between the observed and predicted profiles, it appears that the location of the subsidence profile is approximately 20m to 30m further out of the longwall.
