GLENCORE:
Tahmoor Colliery - Longwall 28

End of Panel Subsidence Monitoring Report for Tahmoor Longwall 28

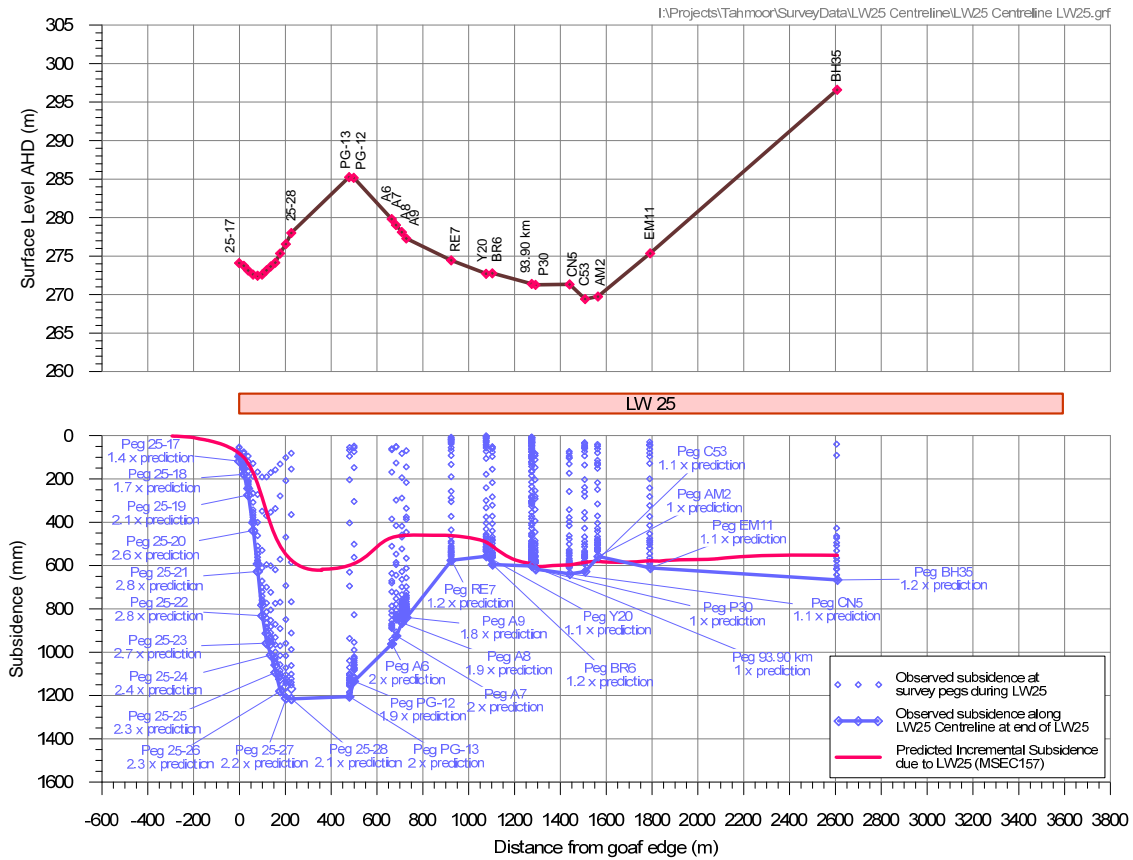
Fig. 2.2 Observed Subsidence along Centreline of Longwall 25

- Fig. 2.2 shows the observed incremental subsidence at survey pegs located along the centreline of Longwall 25. It can be seen that the area of greatest increase in observed subsidence was in an area above the southern half of Longwall 25 that is closer to the Bargo River Gorge and closer to the Nepean Fault Zone.
- The observed incremental subsidence is similar to but only slightly more than was predicted at Peg RE7 and is similar to the prediction at Peg Y20 and at all pegs located further along the panel. Survey pegs A6, A7, A8 and A9 are located within a transition zone where subsidence has gradually reduced from areas of maximum increased subsidence to areas of normal subsidence.

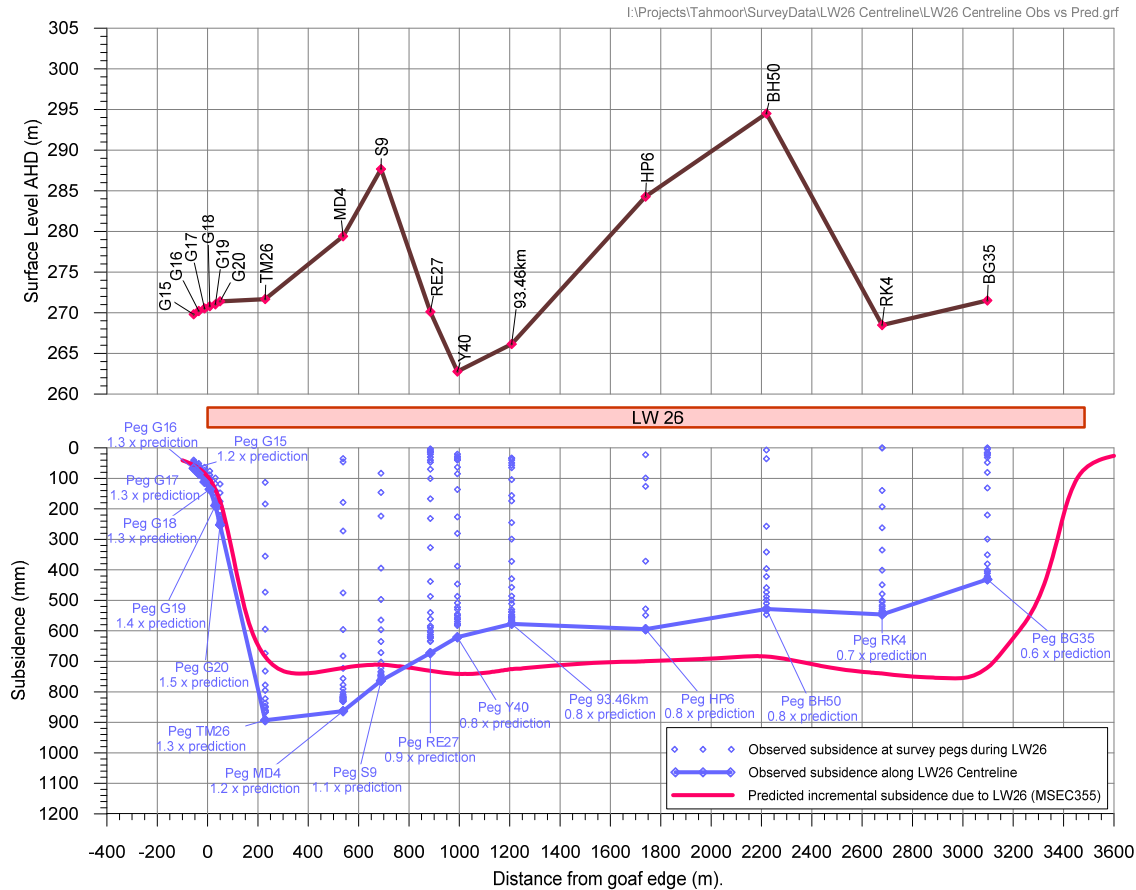
Fig. 2.3 Observed Subsidence along Centreline of Longwall 26

- Fig. 2.3 shows the observed incremental subsidence at survey pegs located along the centreline of Longwall 26. Increased incremental subsidence was observed during the first stages of mining Longwall 26, but at a reduced magnitude compared to the incremental subsidence observed above Longwalls 24A and 25.

- Observed subsidence reduced along the panel until Peg Y40 on York Street, where it was less than prediction. Survey pegs S9 and RE27 are located within a transition zone where subsidence has gradually reduced from areas of maximum increased subsidence between Pegs TM26 and MD4 to areas of normal subsidence at Peg Y40 and beyond.

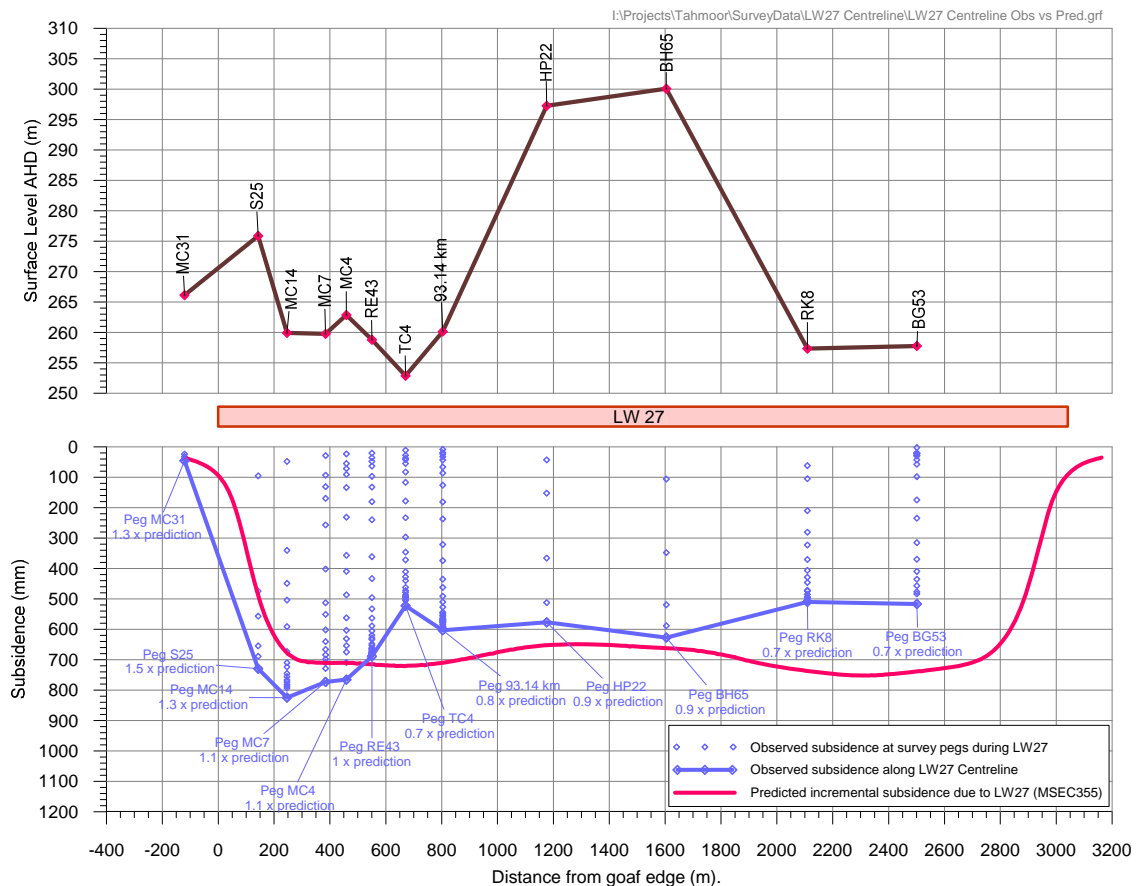
Fig. 2.4 Observed Subsidence along Centreline of Longwall 27

- Fig. 2.4 shows the observed incremental subsidence at survey pegs located along the centreline of Longwall 27. Increased incremental subsidence was observed during the first stages of mining Longwall 27, but at a reduced magnitude compared to the incremental subsidence observed above Longwalls 24A, 25 and 26.
- As shown in Fig. 2.4 the observed subsidence reduced along the panel until Peg 93.140 km on the Main Southern Railway. Survey pegs MC4, MC7, RE43 and TC4 are located within a transition zone where subsidence has gradually reduced from areas of maximum increased subsidence between Pegs MC14 and 93.140 km to areas of normal subsidence along the Railway and beyond.

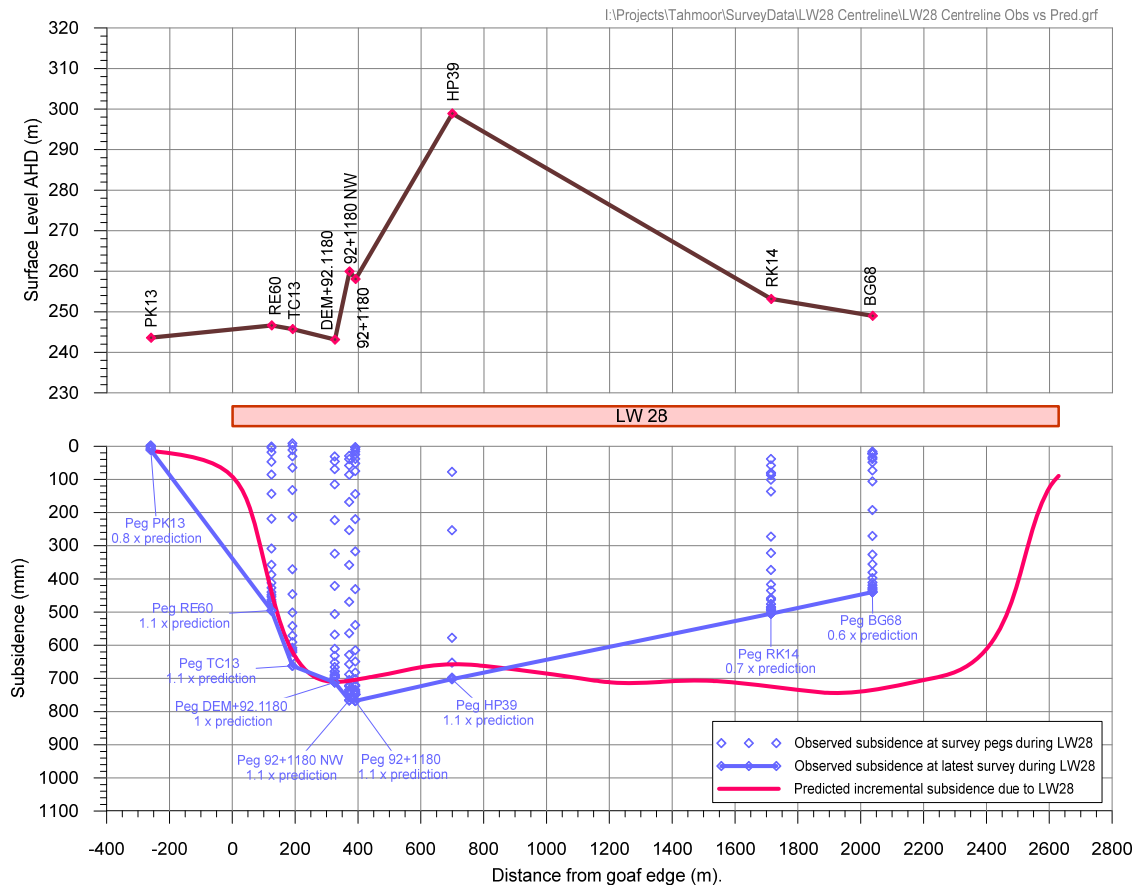
Fig. 2.5 Observed Subsidence along Centreline of Longwall 28

- Fig. 2.5 shows the observed incremental subsidence at survey pegs located along the centreline of Longwall 28. It can be seen that observed subsidence has returned to near normal levels, within 13% of subsidence predictions.
- As shown in Fig. 2.5, there is a reasonable correlation between the observed and predicted subsidence profile along the centreline of Longwall 28.

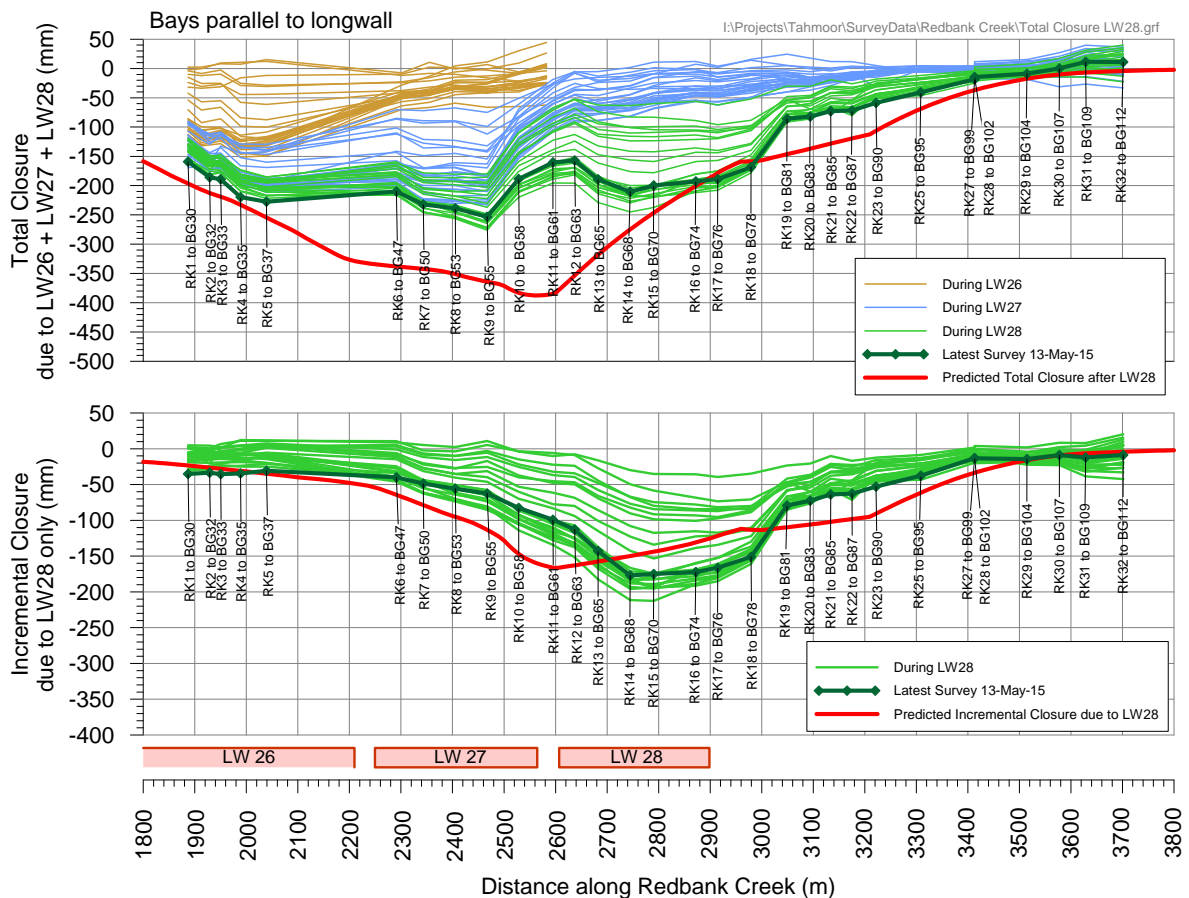
Fig. 2.16 Comparison between observed and predicted valley closure along Redbank Creek

Observed total closure is also less than the predicted total closure of 390 mm due to the mining of Longwalls 22 to 28, as reported in Report No. MSEC355.

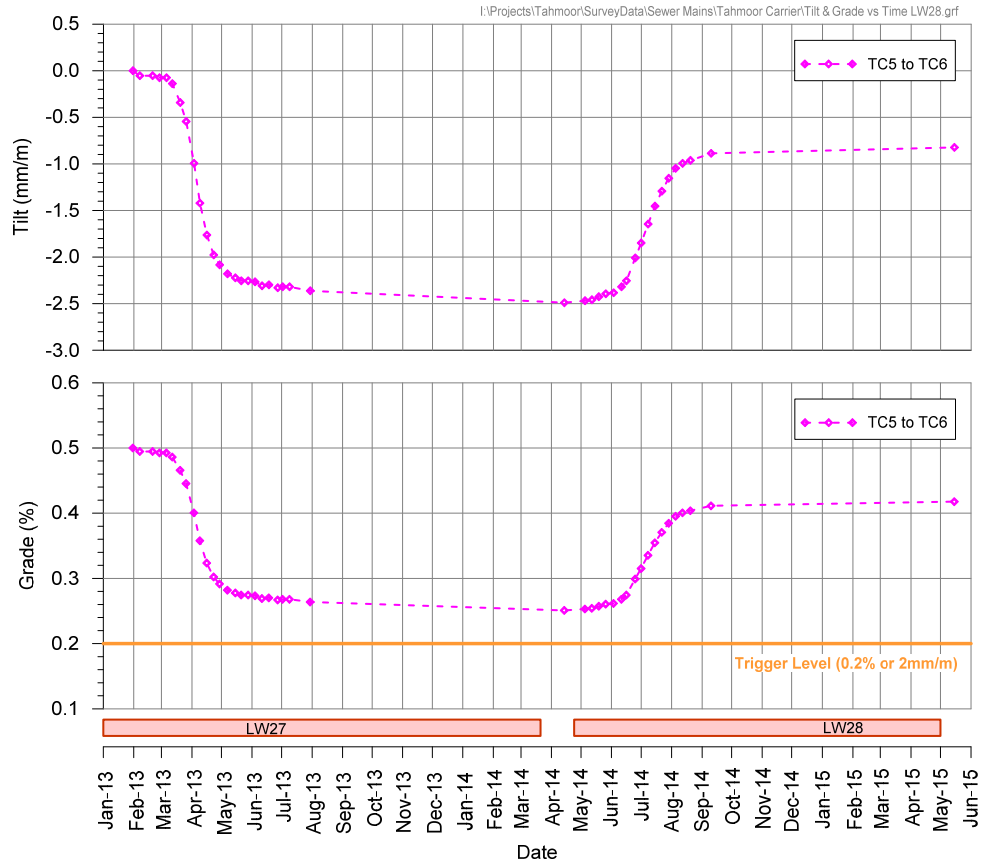
Fig. 2.22 Observed changes in mining-induced tilt and sewer grade at Tahmoor Carrier between Pegs TC5 and TC6

The Tahmoor Carrier is the main branch servicing the majority of Tahmoor township. A total of 17 surveys were undertaken along the Tahmoor Carrier during the mining of Longwall 28. One area of focus was changes in grade between Pegs TC5 and TC6, where pipe grades were predicted and observed to reduce during the mining of Longwall 27. As expected, the mining of Longwall 28 increased the predicted grade in this area almost to the pre-mining grade, as shown in Fig. 2.22.

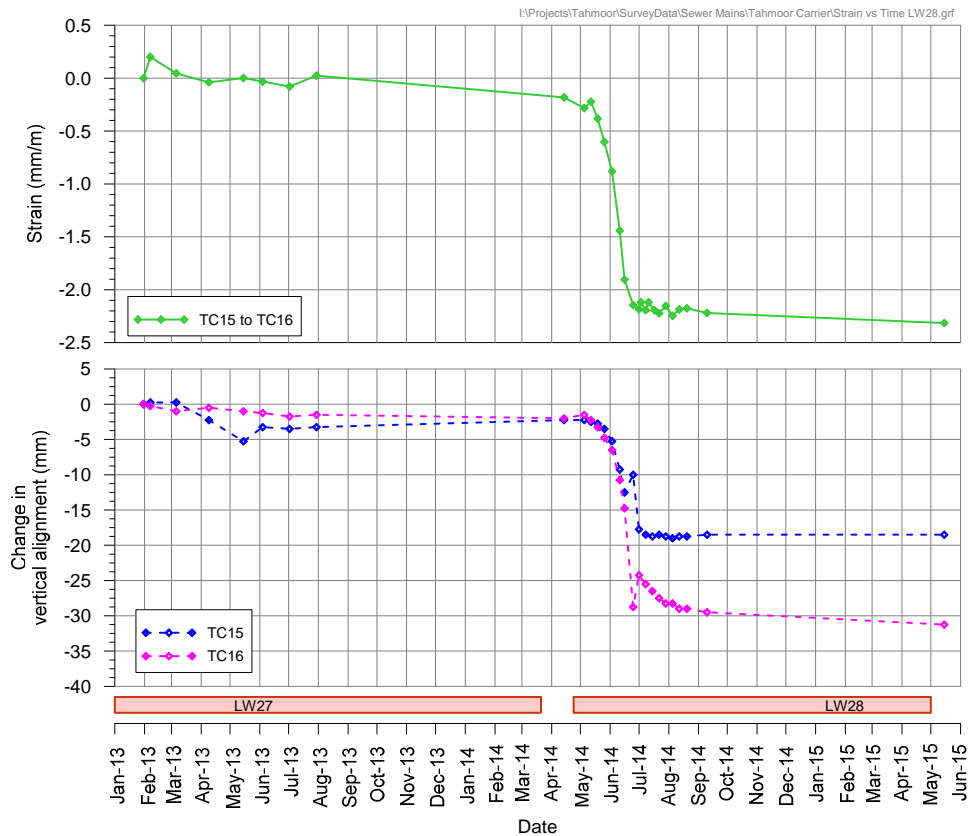
Fig. 2.23 Observed changes in strain and vertical alignment at Tahmoor Carrier between Pegs TC15 and TC16

As shown in Fig. A.39, increased compressive ground strain was observed between Pegs TC15 and TC16, and observed changes are shown in Fig. 2.23.

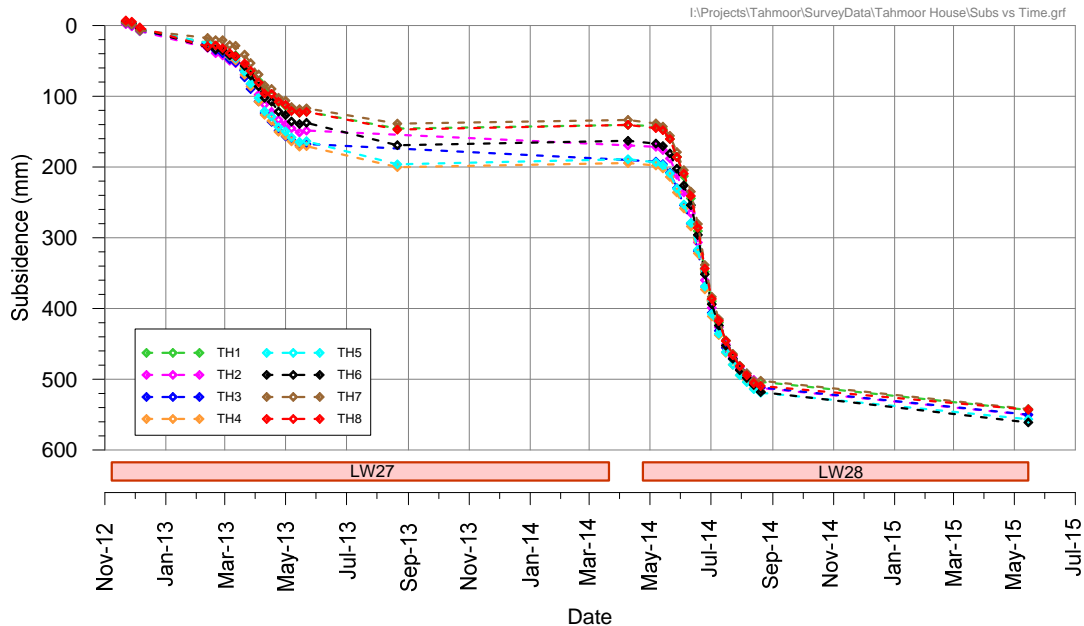
Fig. 2.27 Development of subsidence for ground pegs around Tahmoor House over time

Vertical subsidence around the property has remained relatively uniform. Slightly more subsidence (approximately 10 mm) is observed at the western side of the house compared to the eastern side, as seen in Fig. 2.27.
