INVESTIGATIONS CONDUCTED PRIOR TO SUBMITTING THE SMP APPLICATION FOR LW31-LW37

Structural Investigation Report R0250

John Matheson & Associates Pty Ltd

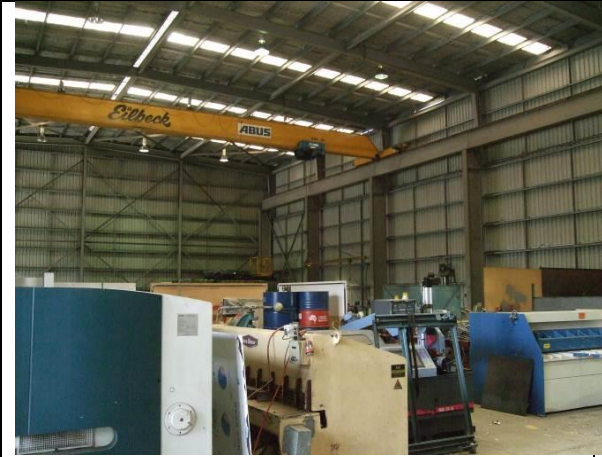
Figure 1 Internal photograph taken at 100 Bridge Street Picton, showing the steel portal frames, bracing panels, gantry crane and sensitive plant located on ground slab

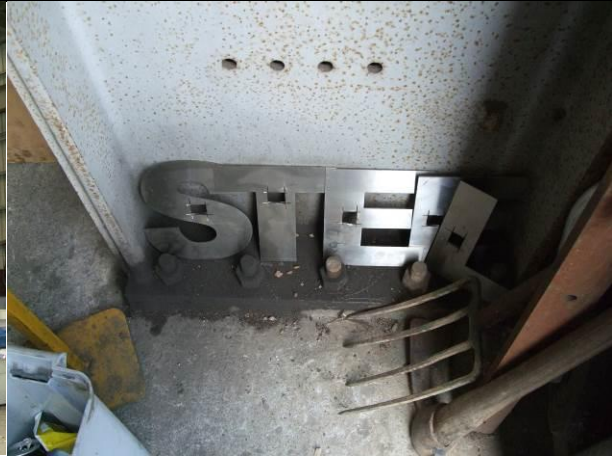
Figure 2 Steel portal frame baseplate hold-down bolts AT 100 Bridge Street

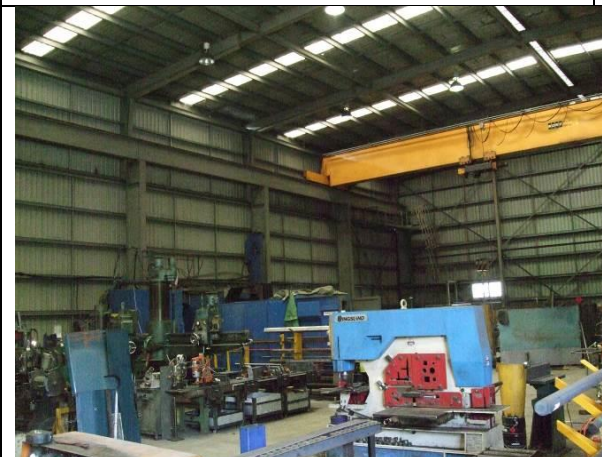
Figure 3 100 Bridge Street equipment. Note that this building has two overhead gantry cranes

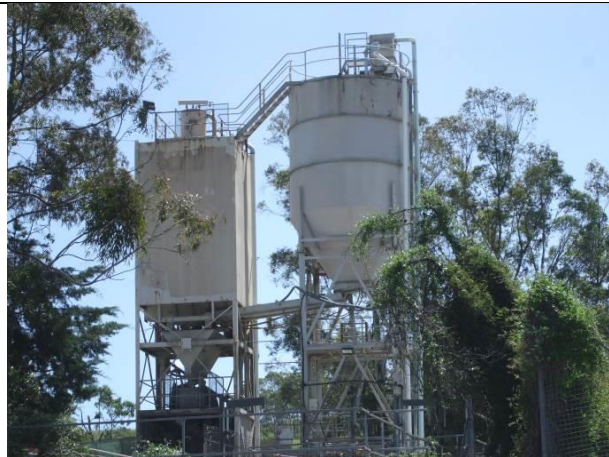
Elevated hopper structures have an elevated lumped mass at the top, supported by a steel framed structure down to ground and footing level. Tilt could increase structure overturning about the base and each elevated hopper structure should be assessed prior to active subsidence. Tilt could also affect feed conveyor and discharge outlet performance.

Figure 10 Hoppers HH07/2d and HH07/2e left and right respectively at 19 Redbank Place

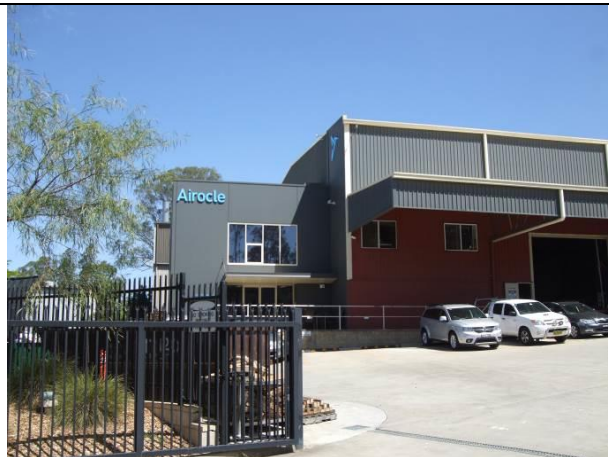
Figure 12 15 Redbank Place large structural steel portal frame with gantry crane and tilt-sensitive equipment. Two-storey tilt panel wall framed office

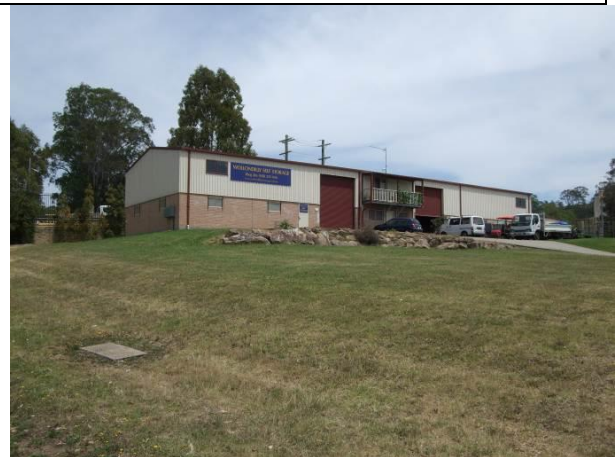
Figure 13 3 Redbank Place storage building with 2.4metre high articulated perimeter cavity brickwork and clad metal framed walls around a ductile steel portal framed structure

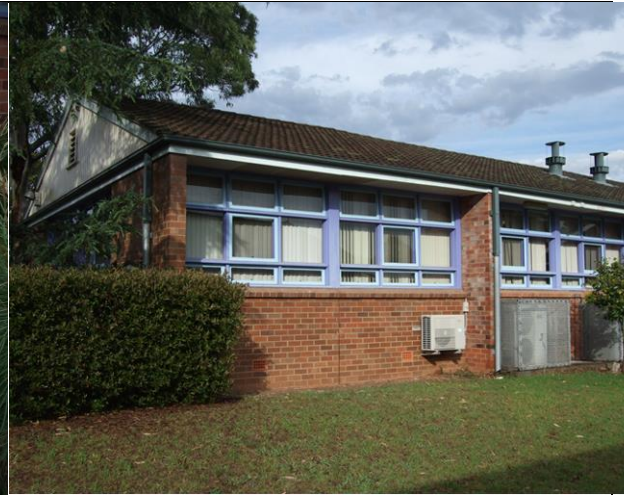
Figure 16 Block A gable wall has windows. Note vertical control joint in brickwork below window sill

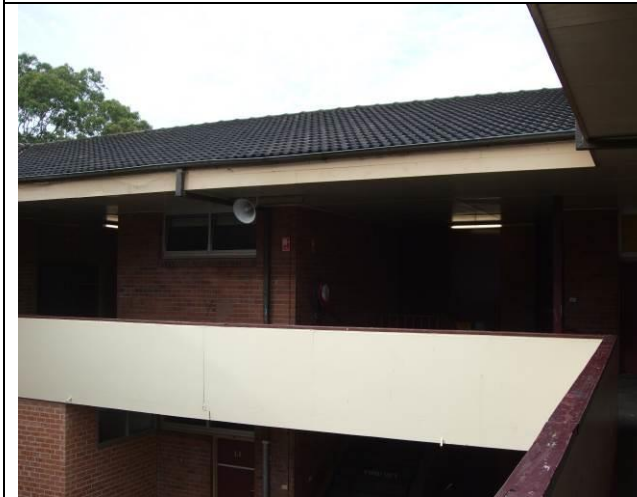
Figure 37 Block I PAR_210_pa09 & 08 at first floor showing slab movement joint reflected in balustrade

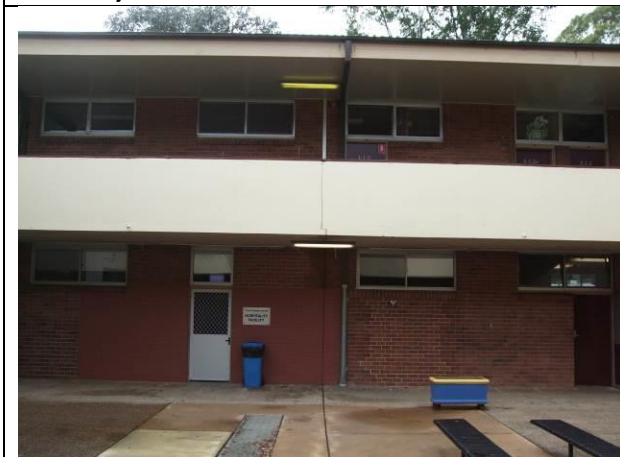
Figure 39 Block I PAR_210_pa10 & 09 showing movement joint, which is reflected in the ground floor brickwork and the ground floor slab

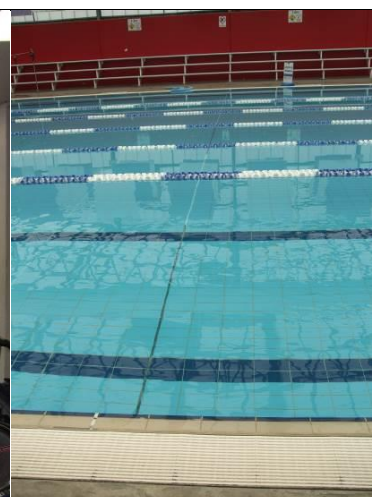
There was no detail information concerning the swimming pools available at the time of drafting. However, significant ground strains are likely to concentrate at expansion/movement joints and some tile cracking or dislocation is possible.

Figure 46 Indoor pool expansion joints

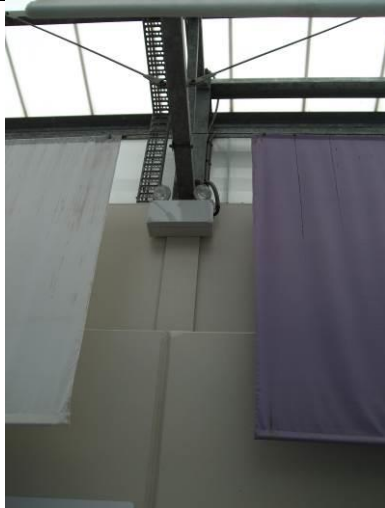
appear to be horizontally spanning and are bolted to the column flanges, are less ductile than the steel portal frames and some damage could develop where differential movement develops between the steel portal frame and precast wall units.

Figure 48 panel junction concealing steel portal frame column

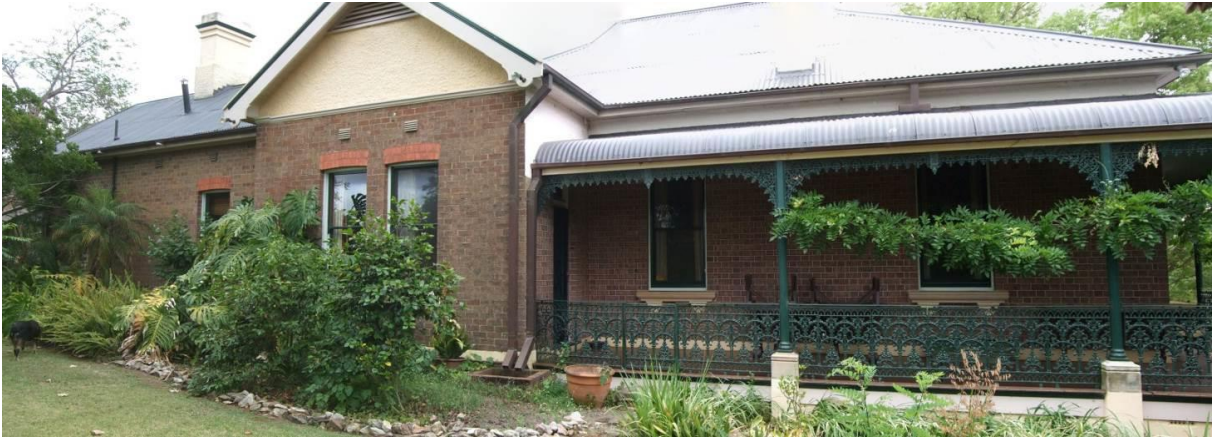
At the time of the inspection, the structure of the main dwelling was in serviceable condition with slight under-sill cracking being detected around the external window openings, which is a common occurrence for masonry structures founded in reactive soil foundations. The caretakers residence was constructed in a similar fashion with a more recent extension on the southern side. The Dairy was constructed as a full masonry structure on brick footings with an internal compacted earth floor. The shed structure adjacent to the dairy was constructed in two stages, firstly with a cross-braced steel frame clad with corrugated metal roof and a more recent extension that was constructed with a structural steel frame with perimeter brick walls and a concrete ground slab.

Figure 51 Southern elevation of the main dwelling

The inspection conducted prior to submitting the SMP application for LW31-LW37 identified that the main dwelling, caretakers cottage and the dairy could be affected by mine subsidence as the perimeter and internal full masonry walls have no articulation (other than doorways and windows). The full masonry walls have been constructed on brick footings on a reactive foundation and there is already evidence of the effects of foundation reactivity in the external brick walls.

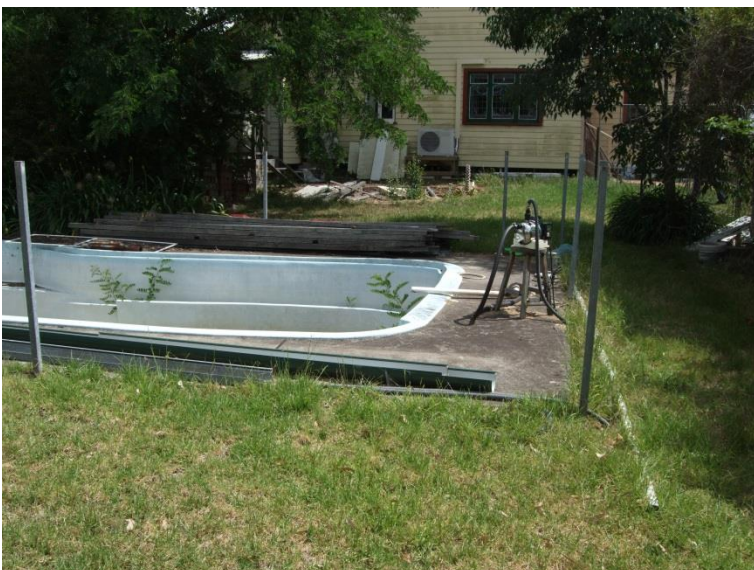
Figure 58 Dilapidated fibreglass in-ground pool
