**Telstra Corporation Ltd**  
Network Integrity.  
N.S.W.

**Tahmoor Coal Pty Ltd.**  
Tahmoor Colliery.

**MANAGEMENT PLAN**  
LONGWALL MINING (LW31)  
BENEATH TELSTRA PLANT  
@ TAHMOOR & PICTON N.S.W.

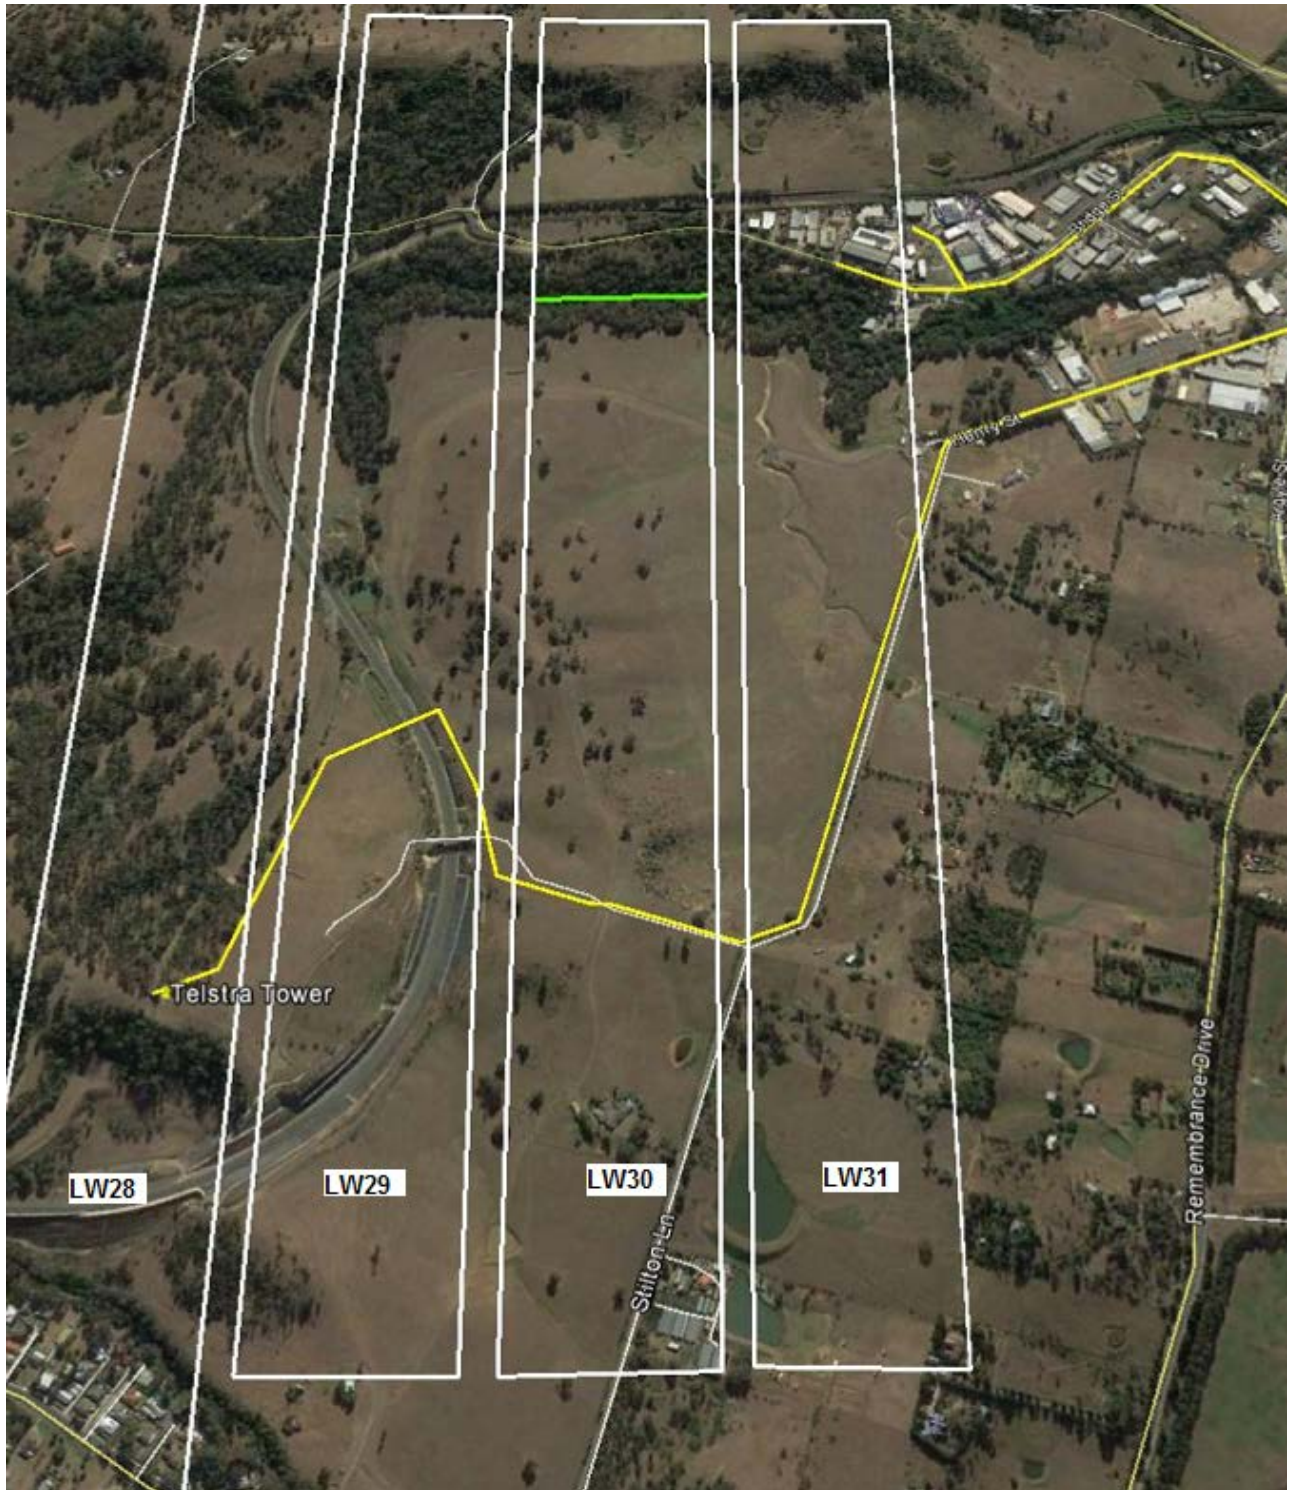
Plate 1:  
 Google Earth aerial view of four longwalls LW28 to LW31 showing current location of extraction in LW30 (Green Line). Longwall LW31 extends north-west from north of Remembrance Drive at Tahmoor, crosses Stilton Lane and then Bridge Street and the Main Southern Railway in the north to the west of Picton. The yellow lines indicate Telstra optical fibre cables, two sections of cable F PCTN 3002 A) and B) feeding along Bridge Street and south section along Stilton Lane to the Telstra Tower

As part of the planning for mining Longwalls LW31, Tahmoor Colliery has identified surface assets which may be affected by the mining operation in Tahmoor north area. Some of these assets belong to Telstra and are part of Telstra's infrastructure in the area. This management plan will consider the impact of the ground surface movements, contributed by longwall LW31 on these assets owned by Telstra. The new longwall LW31 is planned to commence in April 2017 and it is anticipated to take approximately 18 months for full extraction of coal. See layout of LW28-LW31 in Plate 1 on the following page.

Refer to Plate 1 on the following page showing the general layout of the new longwalls.

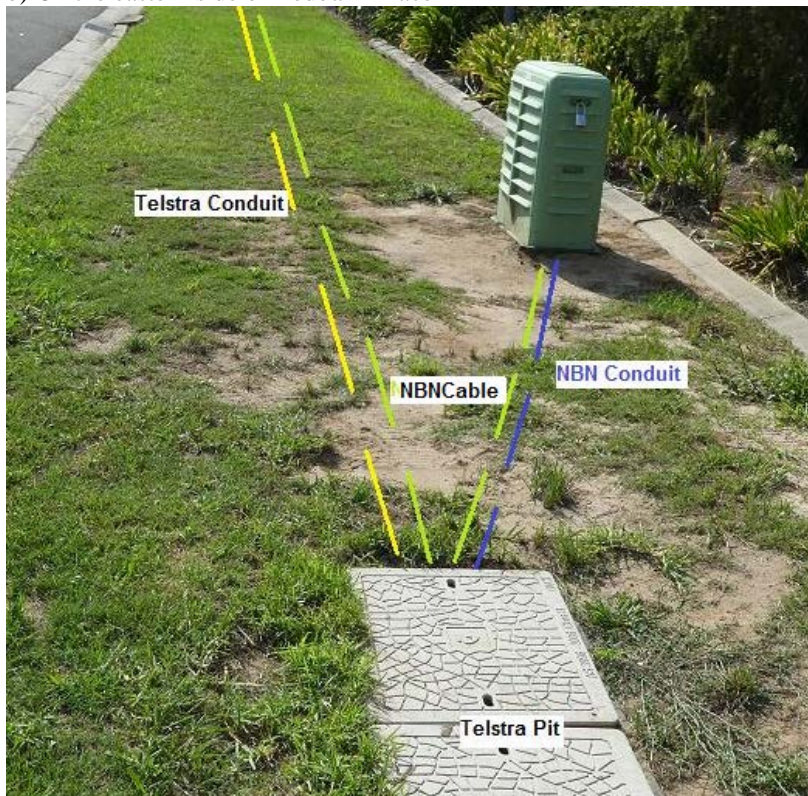
Plate 2:  
NBN above ground Micro Node or VDSL (Very High Bit Rate Subscriber Line) Cabinet in Redbank Place. Shows an example of the arrangement of the ownership of the network between Telstra & NBN.

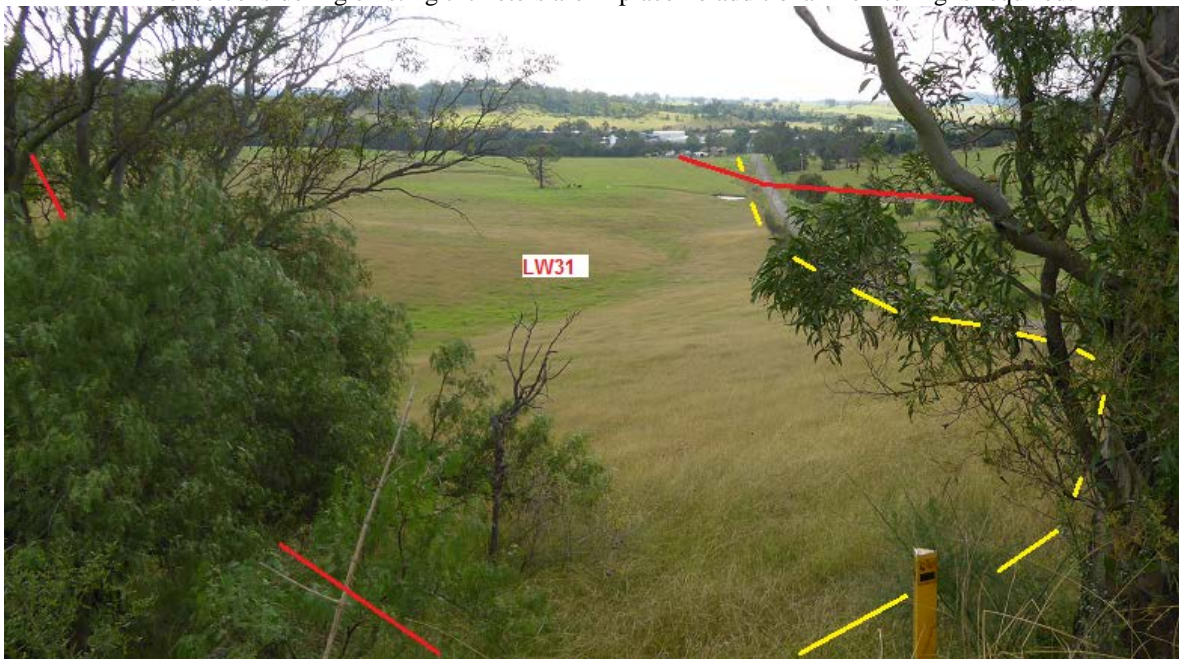
Plate 3:

View north from ridge line on Stilton Lane near western goaf edge of LW31 showing approximate route of to the north of F PCTN 3002 Section A) along the western side of Stilton Lane across LW31 towards Henry Street.

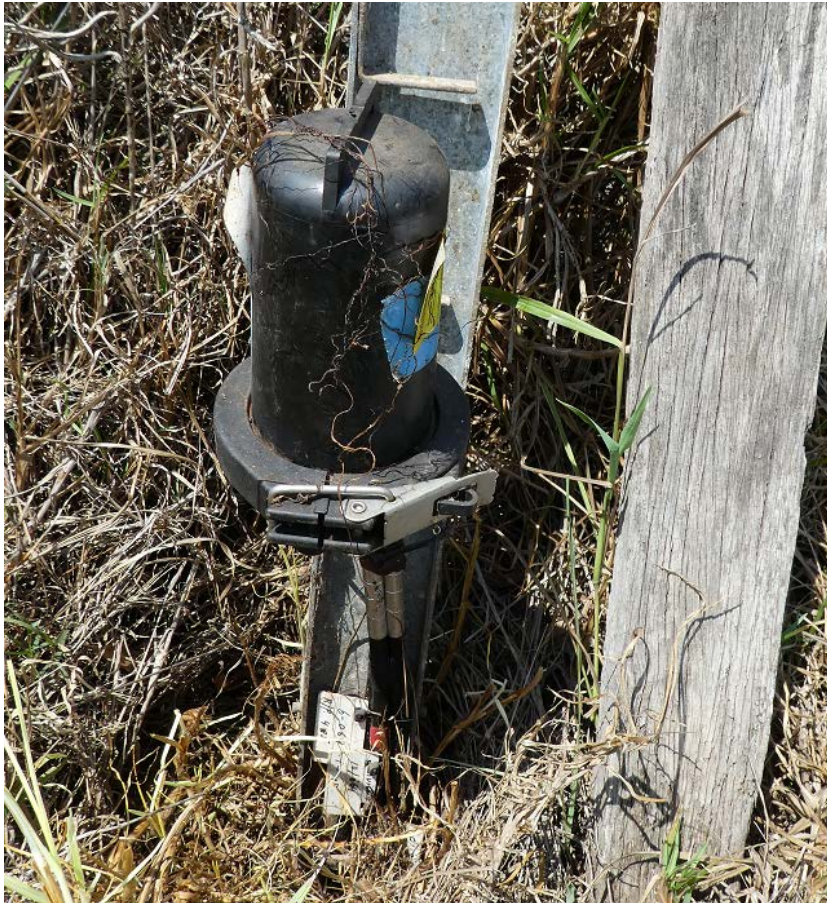
Plate 5:  
View of above ground joint 10Pr/6Pr in Stilton lane over LW31 showing direct buried copper cables entering above ground openable joint.

In past experience with subscriber distribution cable at Appin and Tahmoor/Thirlmere there has been no damage reported or observed with the subscriber distribution network with the exception of an old lead cables used to feed the distribution network at Appin and a main lead sheathed cable in Thirlmere Way. The plastic distribution grease filled cables with either polyethylene or cellular polyethylene insulation over copper conductors are of much smaller size than main cables and are able to tolerate a greater degree of movement due to their smaller size and more flexible nature than the main copper cable. Unlike the main cable they do not generally use rigid lead joints which can fracture when moved, but use openable, in-line or elevated type joints. These joints are able to tolerate significant movement as they are lifted out of pits for jointing and maintenance work. Hence the entire distribution network is generally able to tolerate some reasonable degree of ground movement, see Plate 5.

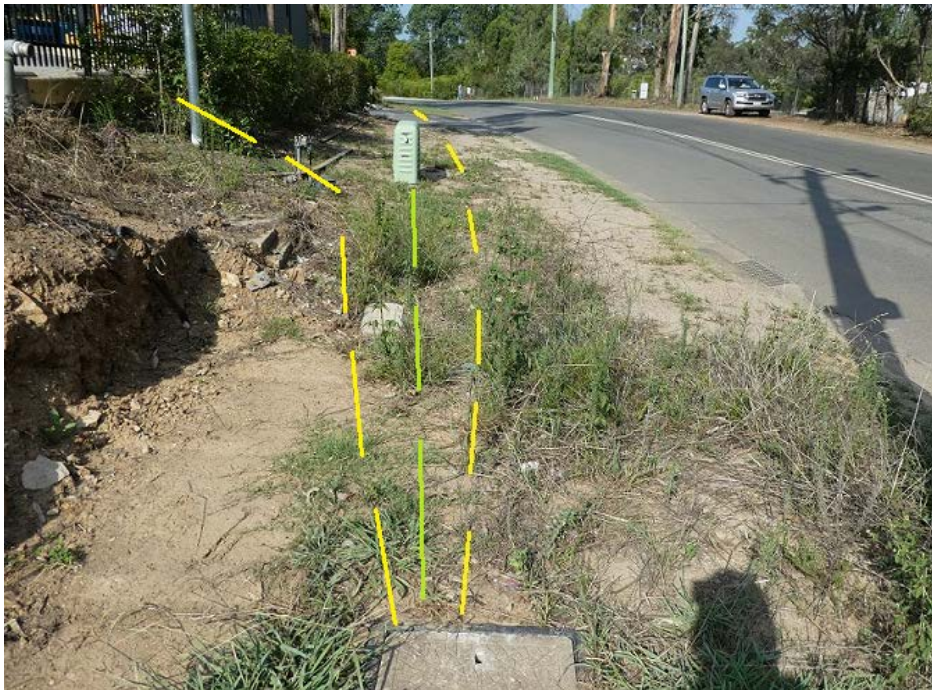
Plate 6;  
View east along Bridge Street showing Telstra optical fibre cable (yellow) to Energy Australia Depot in Bridge Street. Also shows cable feed into Redbank Place and NBN cable (green) to their Node from the Telstra Pit.

The optical fibre cable enters the 20mm subsidence zone around 600m north east of pit shown above and enters the eastern goaf edge of LW31 to the west of Redbank Place. With reference to Appendix A Sheet 3 the predictions for the western end of the cable along Bridge Street are for tensile strain of 0.75mm/m and compression of 1.1mm/m. These levels of ground strain are within the capacity of the cable and providing there is no anomalous ground movement, the Likelihood of impact is Unlikely /Rare but the consequence would be Major resulting in a **Significant** Risk Factor.

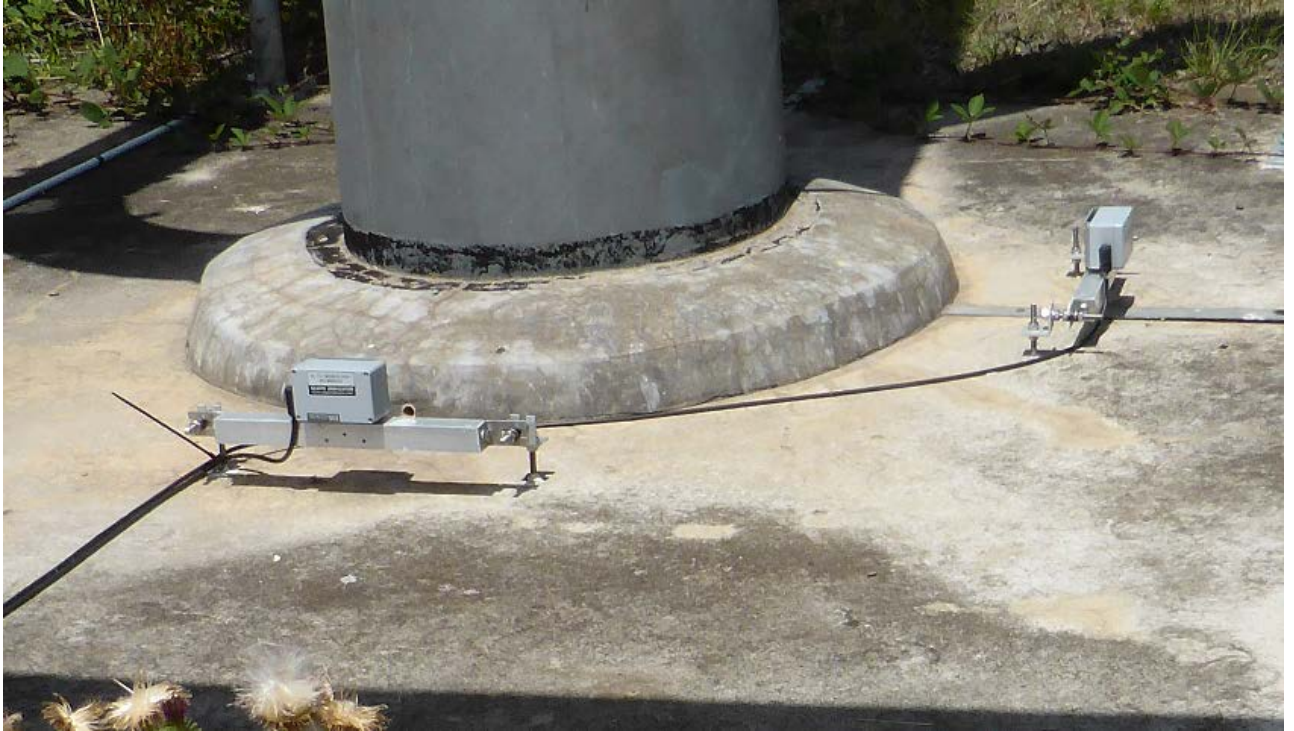
Plate 7:

View of base of tower showing installation of tiltmeters on the base slab of the tower. Live data from the tower for tilt is recorded at 15 minute intervals and graphed on the Lynton Survey website.

As mentioned above due to the low level of predicted ground movement occurring at the Tower the existing tiltmeters only will be used as a check on very minor levels of predicted tower movement.
