GLENCORE:
Tahmoor Colliery - Longwall 28

End of Panel Subsidence Monitoring Report for Tahmoor Longwall 28

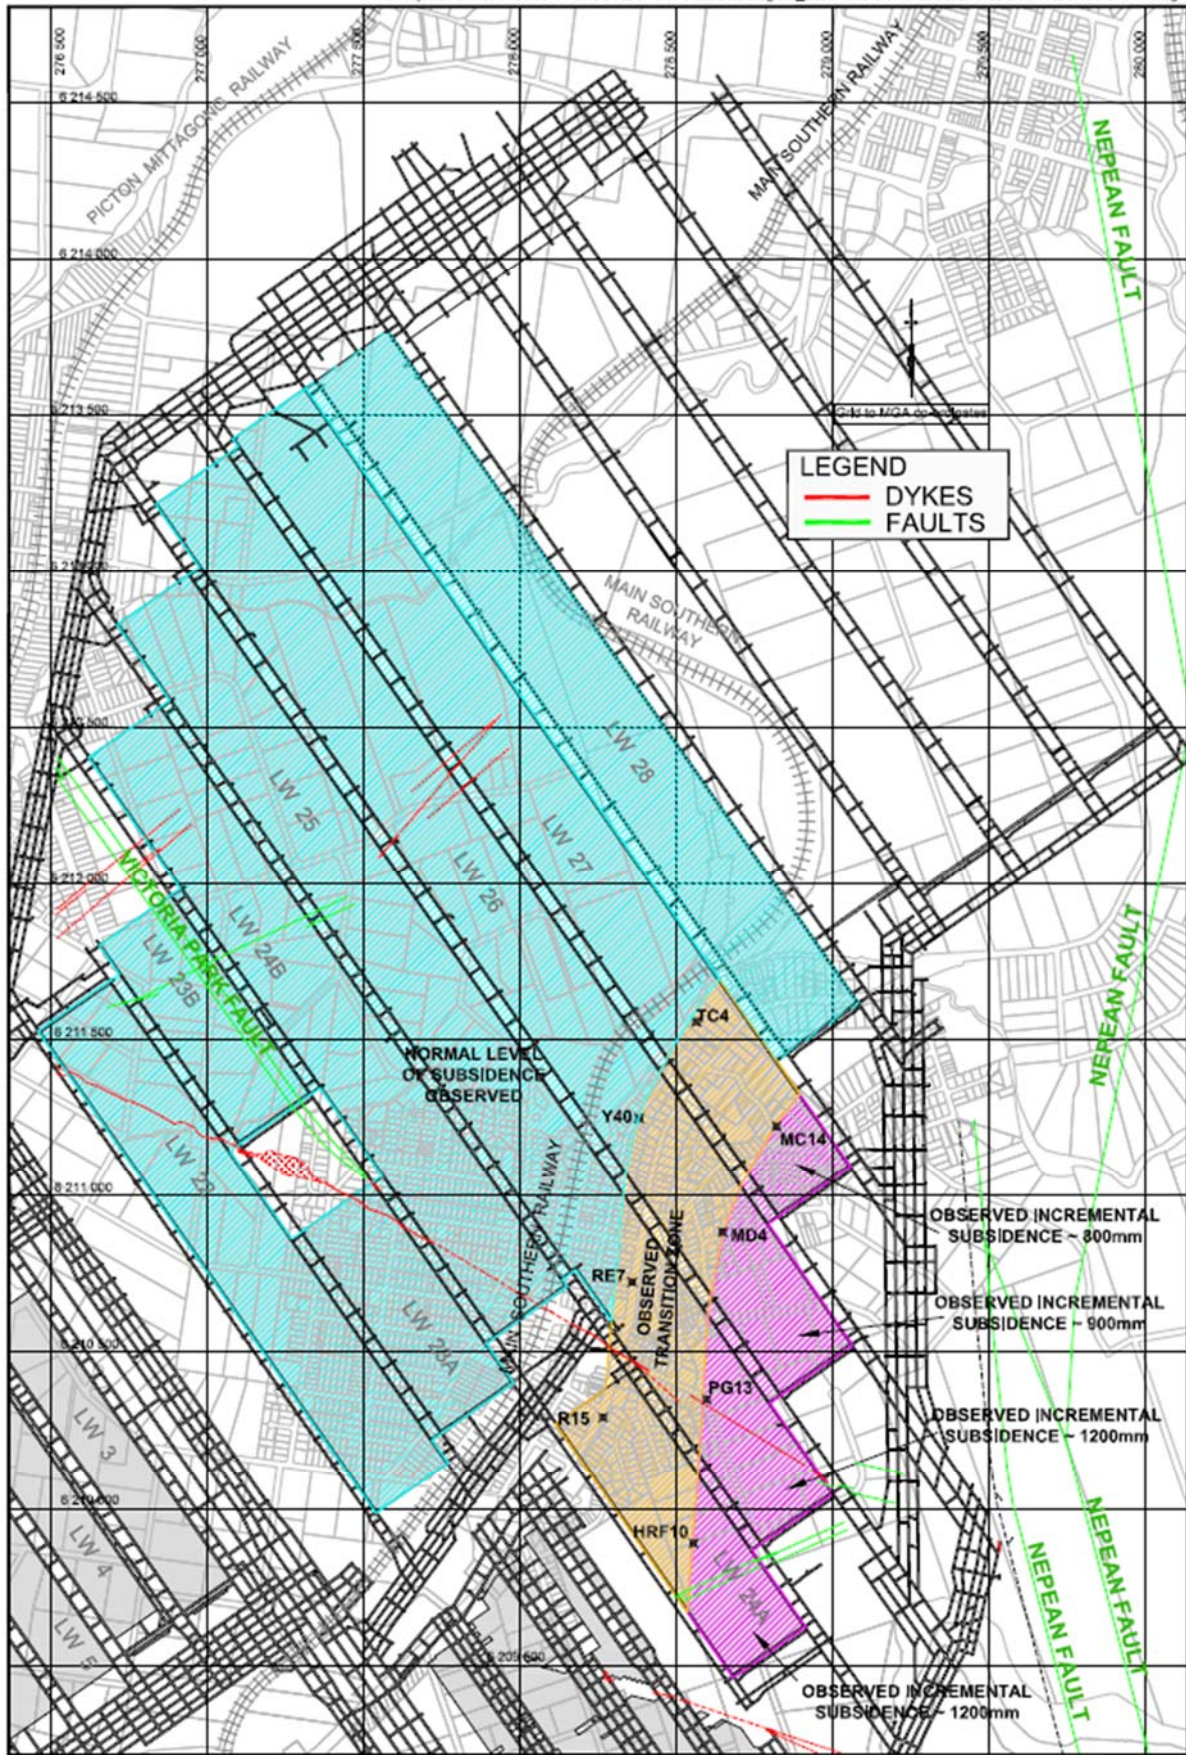
Fig. 2.6 Figure showing zones of increased observed subsidence over Longwalls 22 to 28

The locations of the three zones are plotted on a plan, using the surveyed pegs that were identified along the centrelines above Longwalls 24A to 28 as a guide, as shown in Fig. 2.6, it can be seen that the transition zone is roughly consistent in width above Longwall 24A, Longwall 25 and Longwall 26 and possibly slightly narrower above Longwall 27. The orientation of the transition zone is also roughly parallel to the Nepean Fault and the magnitude of the increased subsidence above Longwalls 26 and 27 is reduced compared to Longwalls 24A and 25. There was little to no increased subsidence identified above Longwall 28.

It can be seen in Fig. 2.6 that the alignment of the surface expression of the Nepean Fault is at a similar distance from the zone of increased subsidence. Two prominent features of the increased subsidence are that its magnitude reduces with increasing distance away from the Bargo River Gorge, and the magnitude reduces as it approaches the termination of the overlapping fault plane. This observation supports the findings of Gale and Sheppard (2011) that the increased subsidence is linked to localised weathering of joint and bedding planes above a depressed water table adjacent to the incised gorge of the Bargo River and the presence of the major fault.

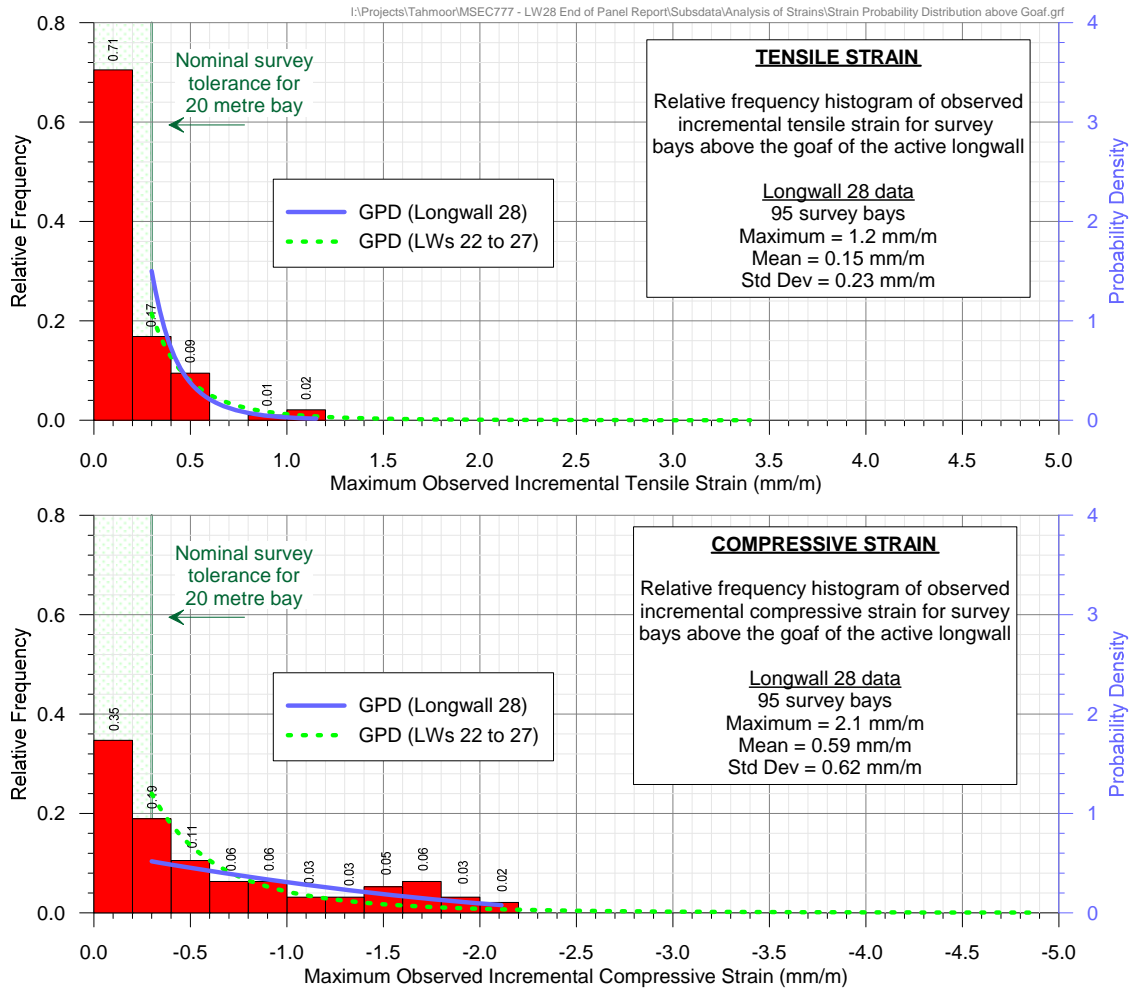
Fig. 2.7 Observed Incremental Strain for Survey Bays above Goaf resulting from the Extraction of Longwall 28

A *Generalised Pareto Distribution (GPD)* has been fitted to the raw strain data for Longwall 28, as shown in the blue lines.

The probability distribution functions for previous monitoring during the mining of Longwalls 22 to 27 are also shown in this figure, as the dashed green lines. It can be seen from these comparisons, that the overall distribution of tensile and compressive strain resulting from the extraction of Longwall 28 was similar to or less than the magnitude of that observed during the mining of Longwalls 22 to 27.

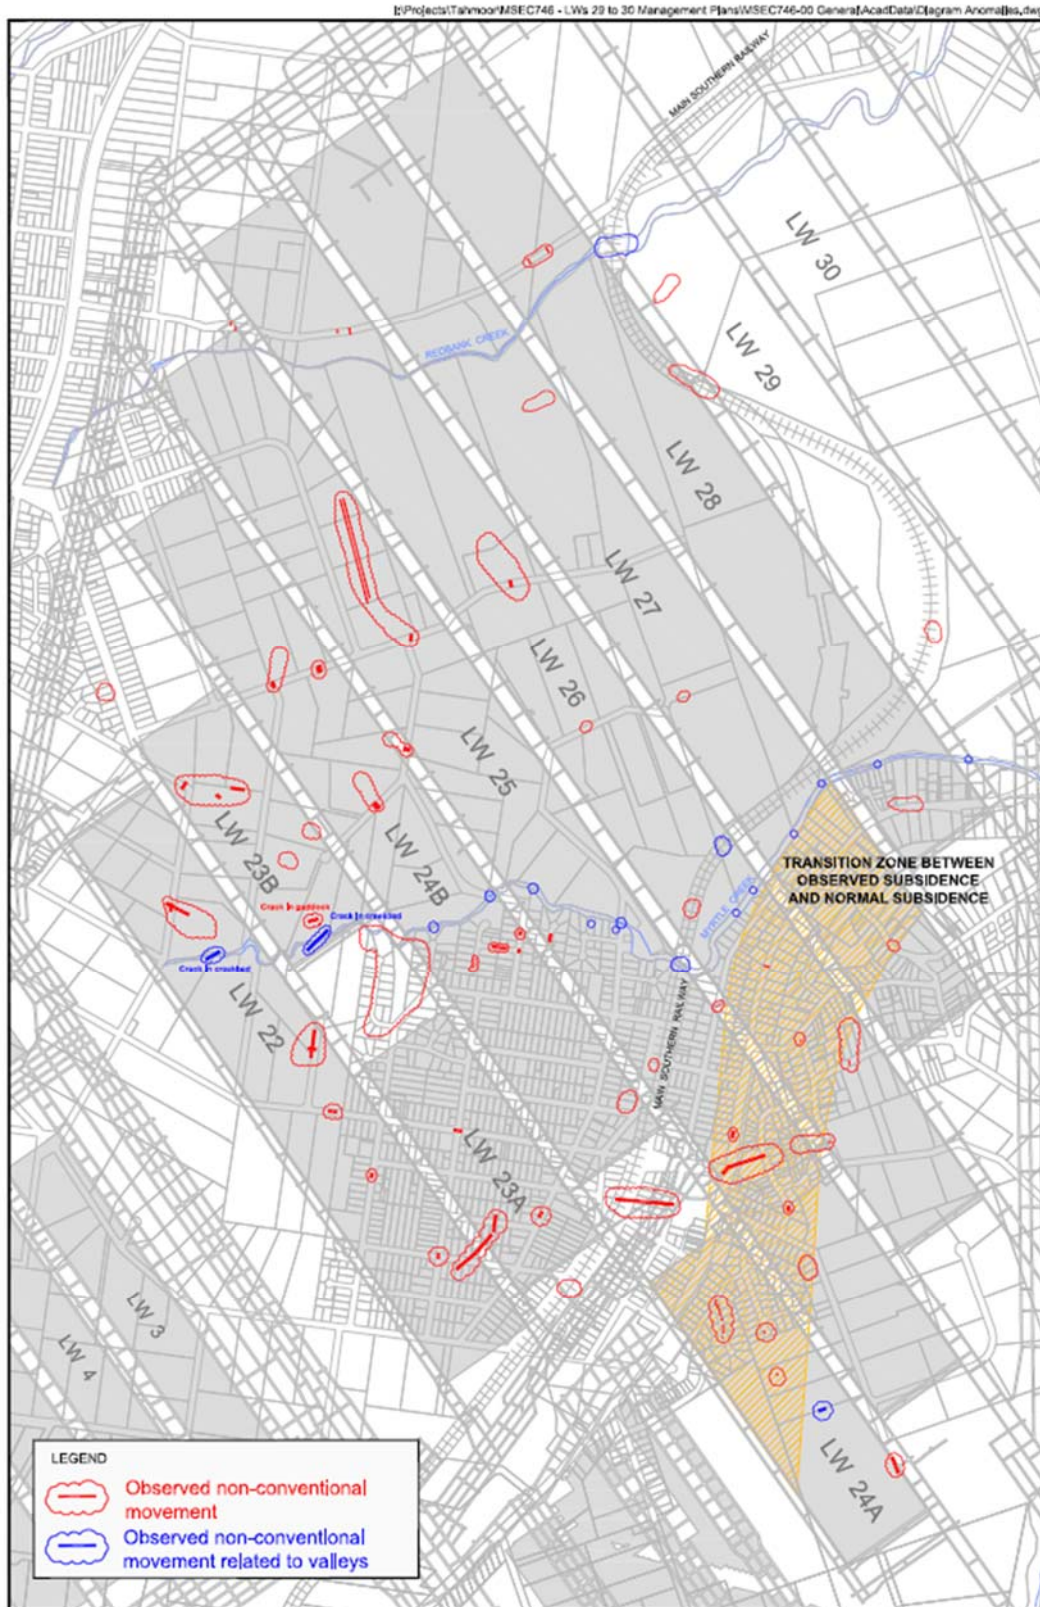
Fig. 2.8 Map of Locations of Potential Non-Systematic Movements

A plan showing the locations of observed non-systematic movements at Tahmoor is shown in Fig. 2.8. The locations were selected based on ground monitoring results or observed impacts that appear to have been caused by non-systematic movement. A total of approximately 50 locations (not including valleys) have been identified over the extracted Longwalls 22 to 28, of which 5 new locations were observed during the mining of Longwall 28.

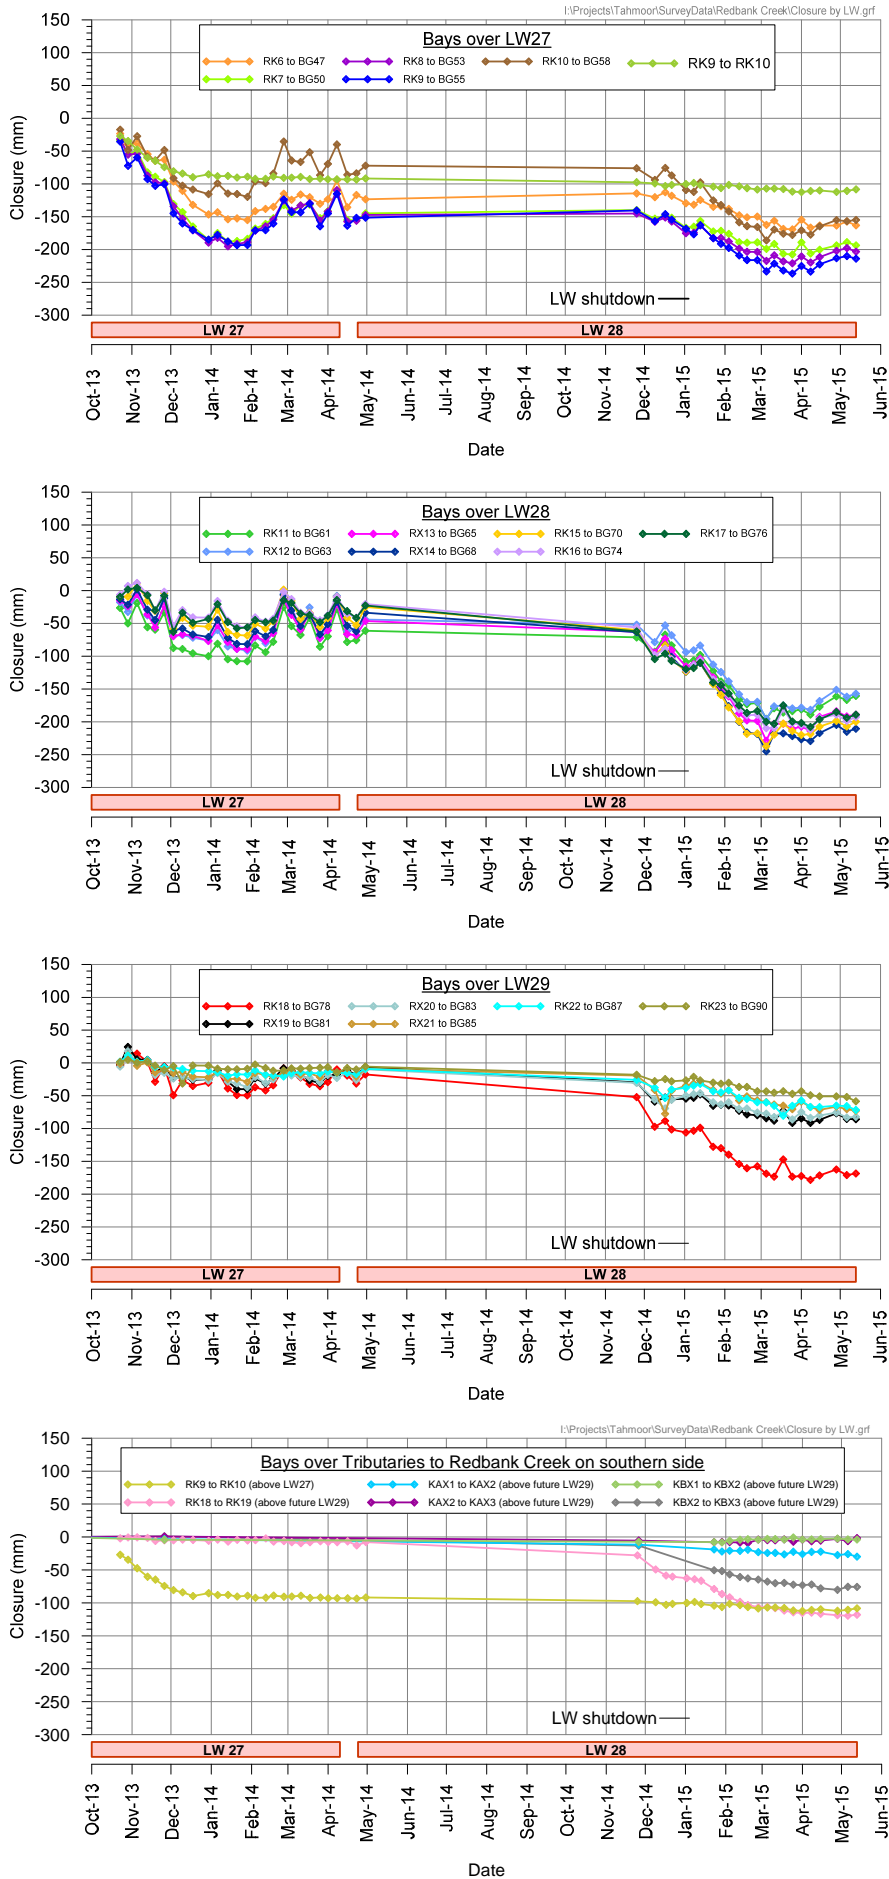
Fig. 2.14 Observed development of closure across Redbank Creek over time

- It can be seen from Fig. 2.14 that valley closure was slightly greater for a temporary period of time, when the transient effects of the subsidence travelling wave passed through the valley.

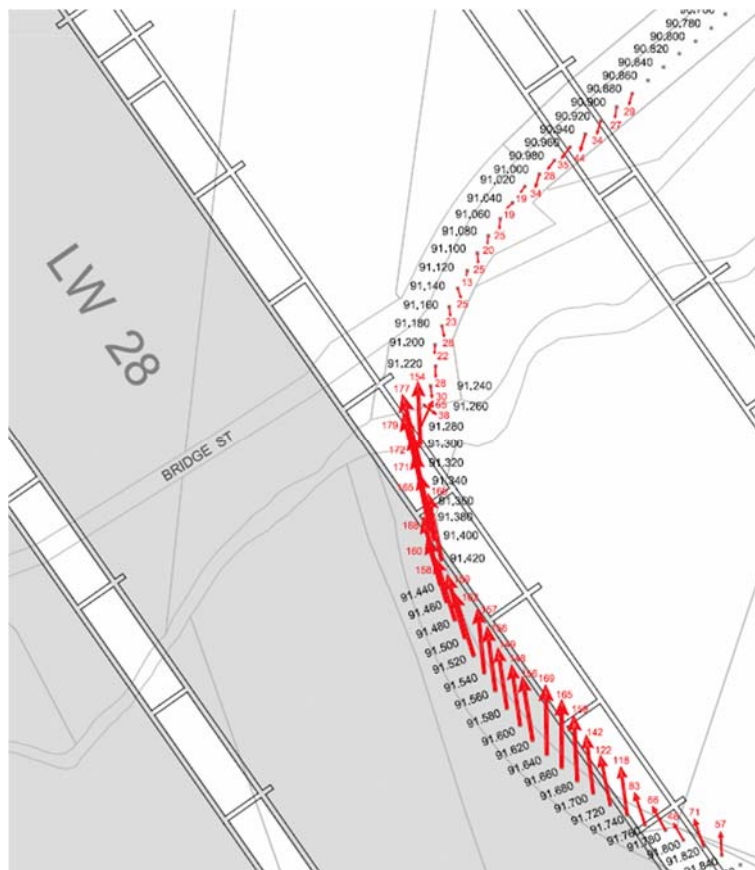
Fig. 2.17 Observed total horizontal movement along Main Southern Railway during the mining of Longwalls 27 and 28 as at 5 May 2015

Observed absolute horizontal movements along the Main Southern Railway are shown in Fig. 2.17. It can be seen that the rockmass on the Sydney side of the Culvert has moved substantially relative to the Country side. When observed in conjunction with the relative 3D surveys, as shown in Drawing No. MSEC777-03, it is clear that the boundaries of the rockmass are approximately Redbank Creek and the tributary, with ground strains relatively small in the plateau areas.

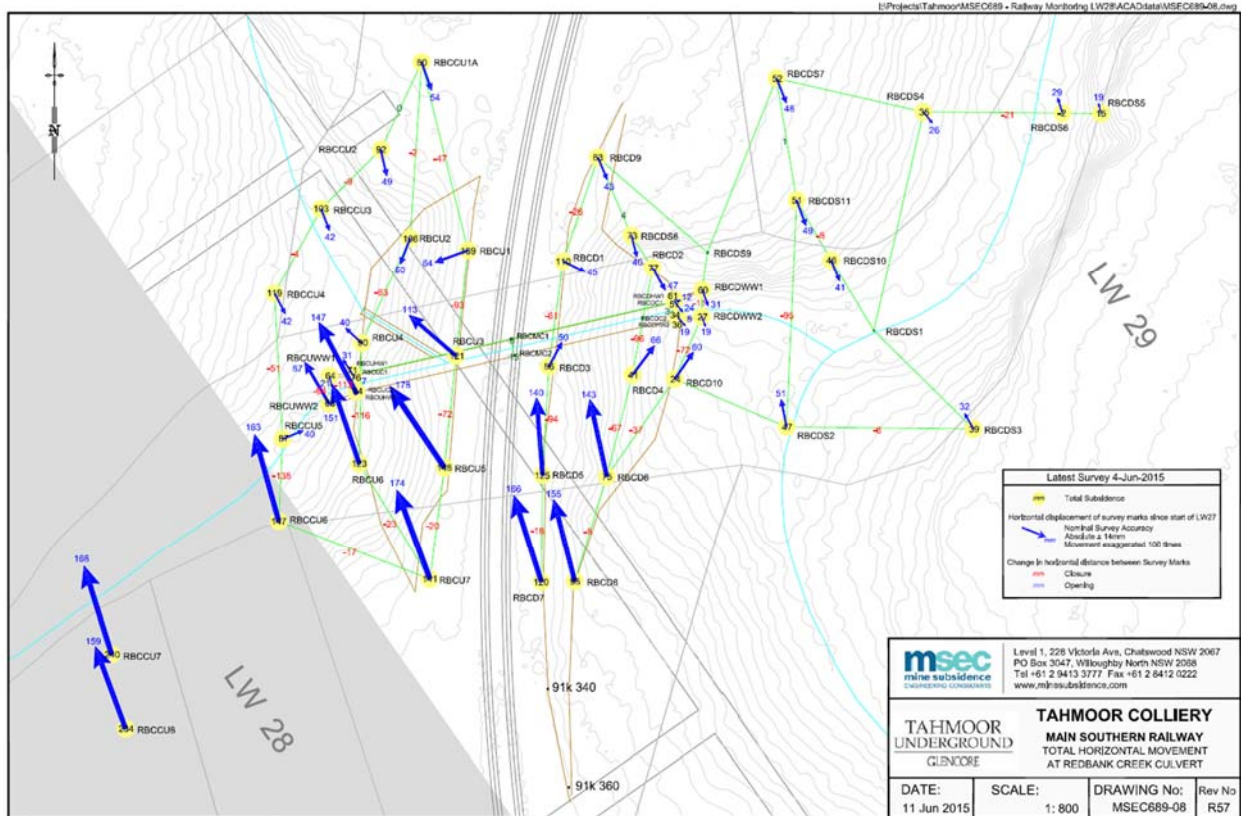
Fig. 2.18 Observed total horizontal movement at Redbank Creek Culvert and embankment during the mining of Longwalls 27 and 28

Observed incremental subsidence and horizontal movement of survey marks in the immediate of the culvert and embankment are shown in Fig. 2.18. The results show that boundaries of the rockmass in the south-western quadrant intersect with the country side of the culvert. The corner of the rockmass is approximately aligned with midpoint of the culvert, which correlates well with observed detailed closure measurements inside the culvert itself.

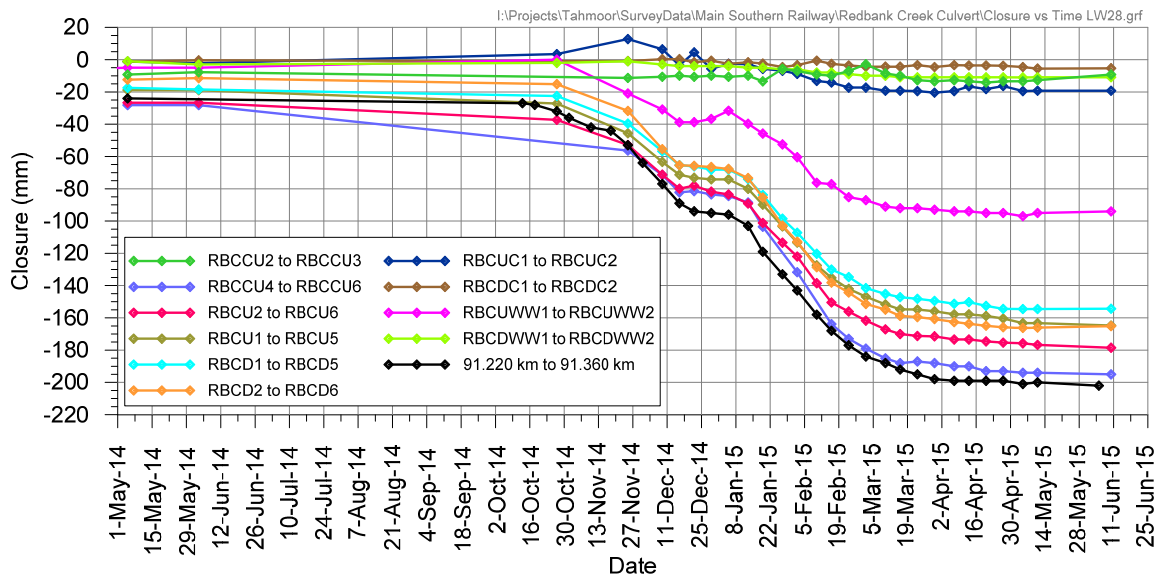
Fig. 2.19 Observed Total Valley Closure over time across Redbank Creek Culvert at Main Southern Railway during the mining of Longwall 28 (includes closure from Longwall 27)

The observed gradual development with time of differential horizontal movements between selected pegs at the culvert and embankment are shown in Fig. 2.19. Maximum observed closure was measured between the long bay survey pegs on the track at 91.220 km and 91.360 km, though a very similar result was observed between Pegs RBCCU4 and RBCCU6, which are located in the base of the embankment across the upstream inlet. This suggests that closure across the valley of Redbank Creek and its tributary, were focussed at the culvert. This was confirmed at greater detail from additional detailed surveys in the culvert, which are discussed later.

Whilst the ends of the wingwall on the upstream end closed almost 100 mm, the culvert barrel at the inlet closed only 20 mm. Very little closure was observed across the culvert barrel or wingwalls at the downstream inlet.

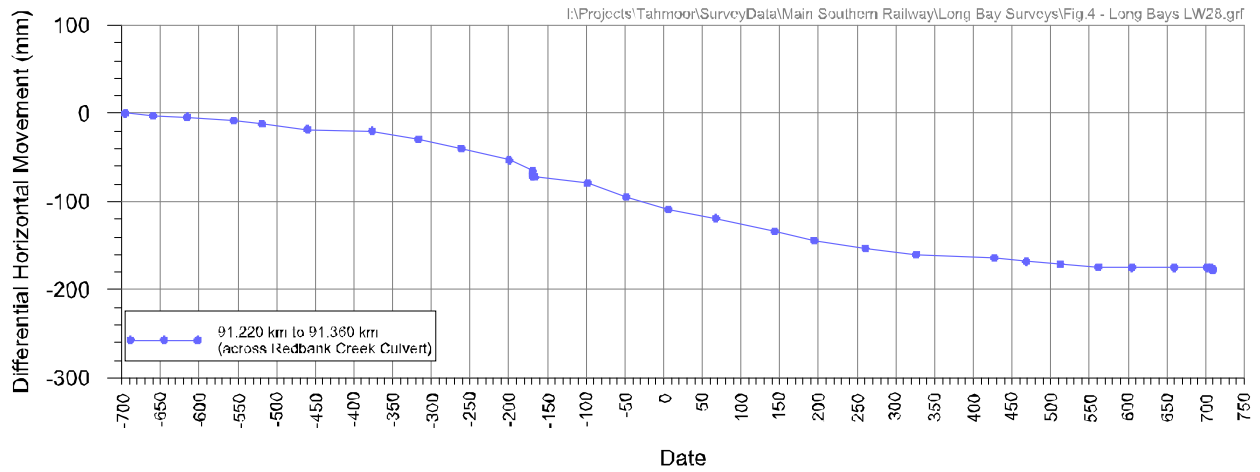
Fig. 2.20 Observed Total Valley Closure as measured by long bay survey, relative to face distance across Redbank Creek Culvert at Main Southern Railway during the mining of Longwall 28 (includes closure from Longwall 27)

It can be seen from Fig. 2.20 that the majority of valley closure movements occurred from when the longwall face had approached within 300 metres of the culvert, until the longwall face had passed the culvert by approximately 300 metres.

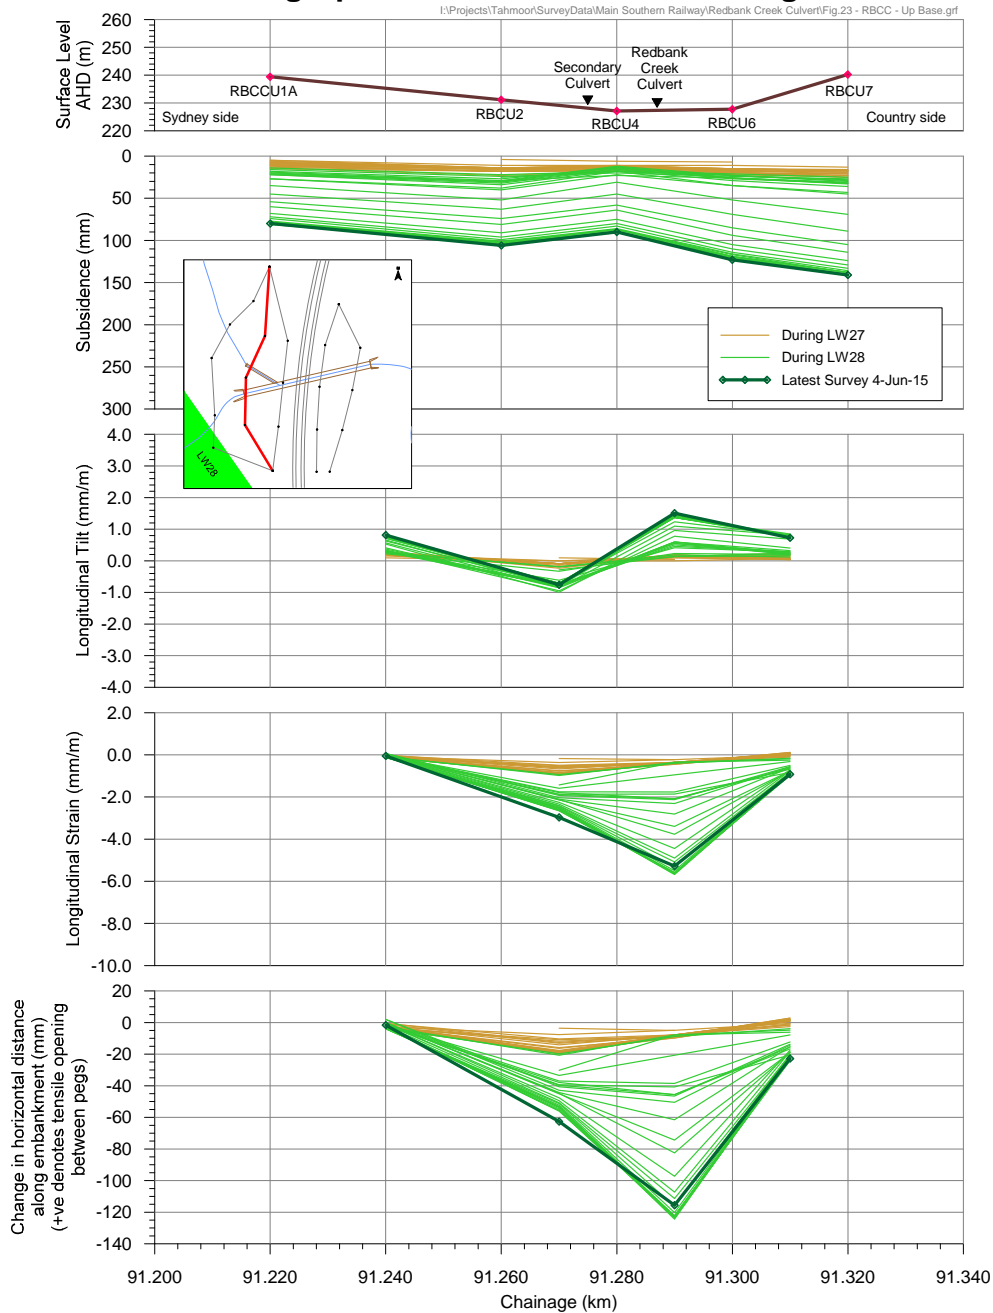
Fig. 2.21 Observed subsidence, tilt and strain across the upstream base of Redbank Creek Culvert during the mining of Longwall 28 as at 4 June 2015

Observed along subsidence the base of the embankment on the upstream side is shown in Fig. 2.21. The results show valley closure focussing between Pegs RBCCU4 and RBCCU6, with upsidence observed at Peg RBCCU4.

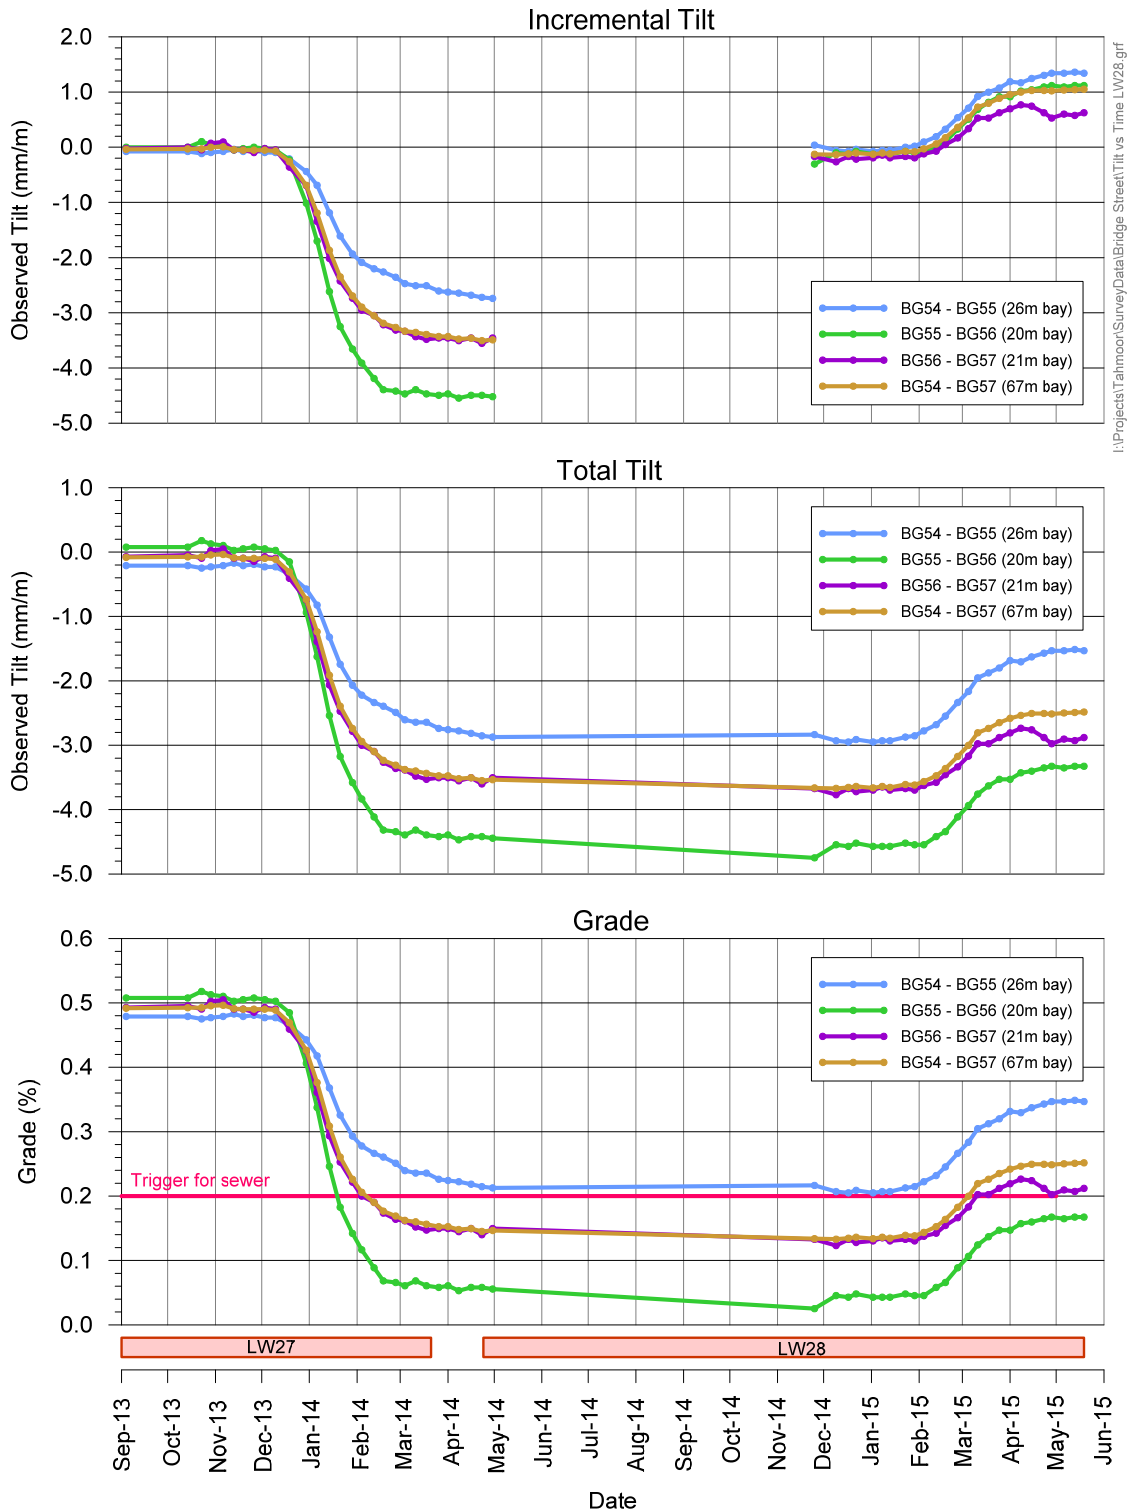
Fig. 2.24 Development of tilt on Bridge Street between pegs BG54 and BG57

The Thirlmere Carrier is the main branch servicing the majority of Thirlmere township. A total of 25 surveys were undertaken along the Thirlmere Carrier during the mining of Longwall 28. One area of focus was changes in grade between Pegs BG54 and BG57, where pipe grades were predicted and observed to reduce during the mining of Longwall 27. As expected, the mining of Longwall 28 increased the predicted grade in this area, as shown in Fig. 2.24. Grades over one short 20 metre bay between Pegs BG55 and BG56 may not recover above 0.2 %. No impacts have been observed to the sewer.

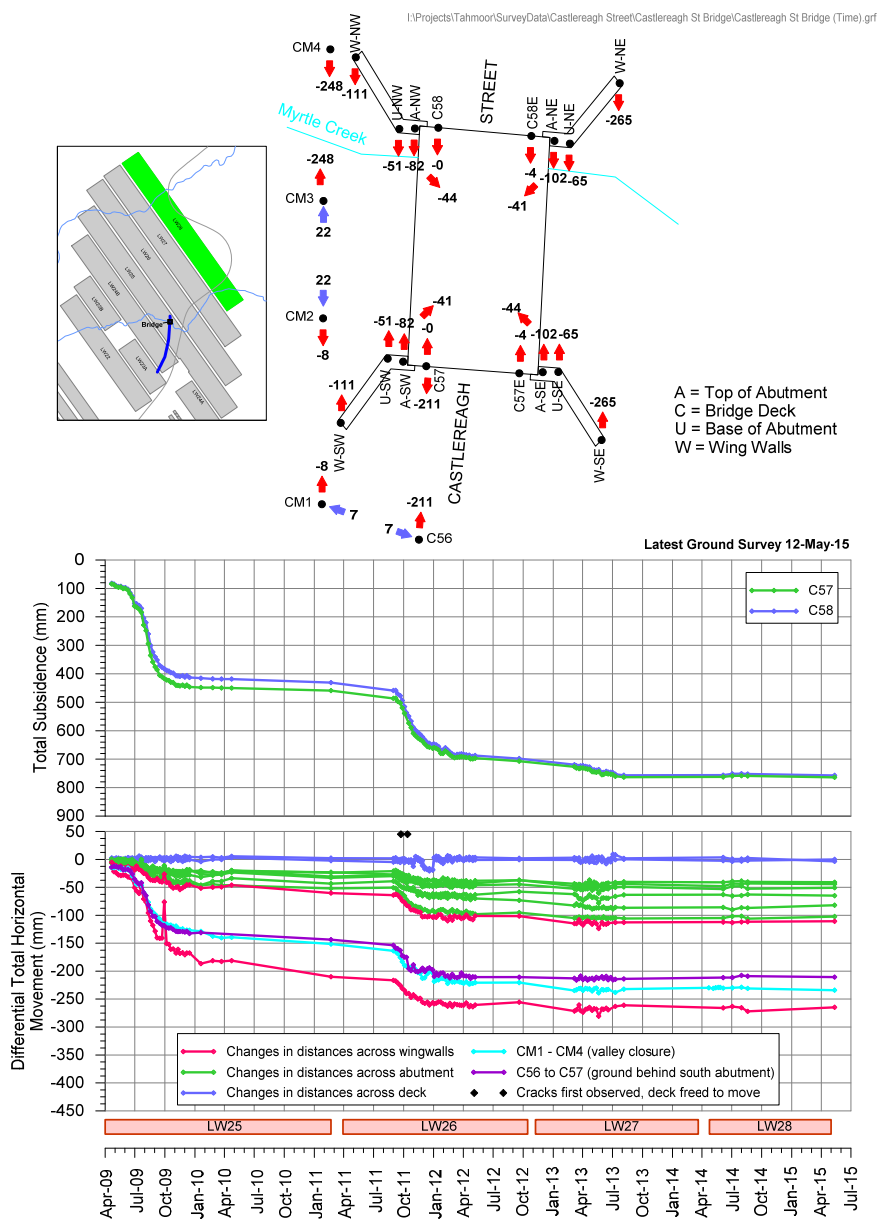
Fig. 2.25 Castlereagh Street Bridge

As discussed in Section 2.3, Castlereagh Street Bridge experienced 3 mm of valley closure during the mining of Longwall 28, which is within survey tolerance.

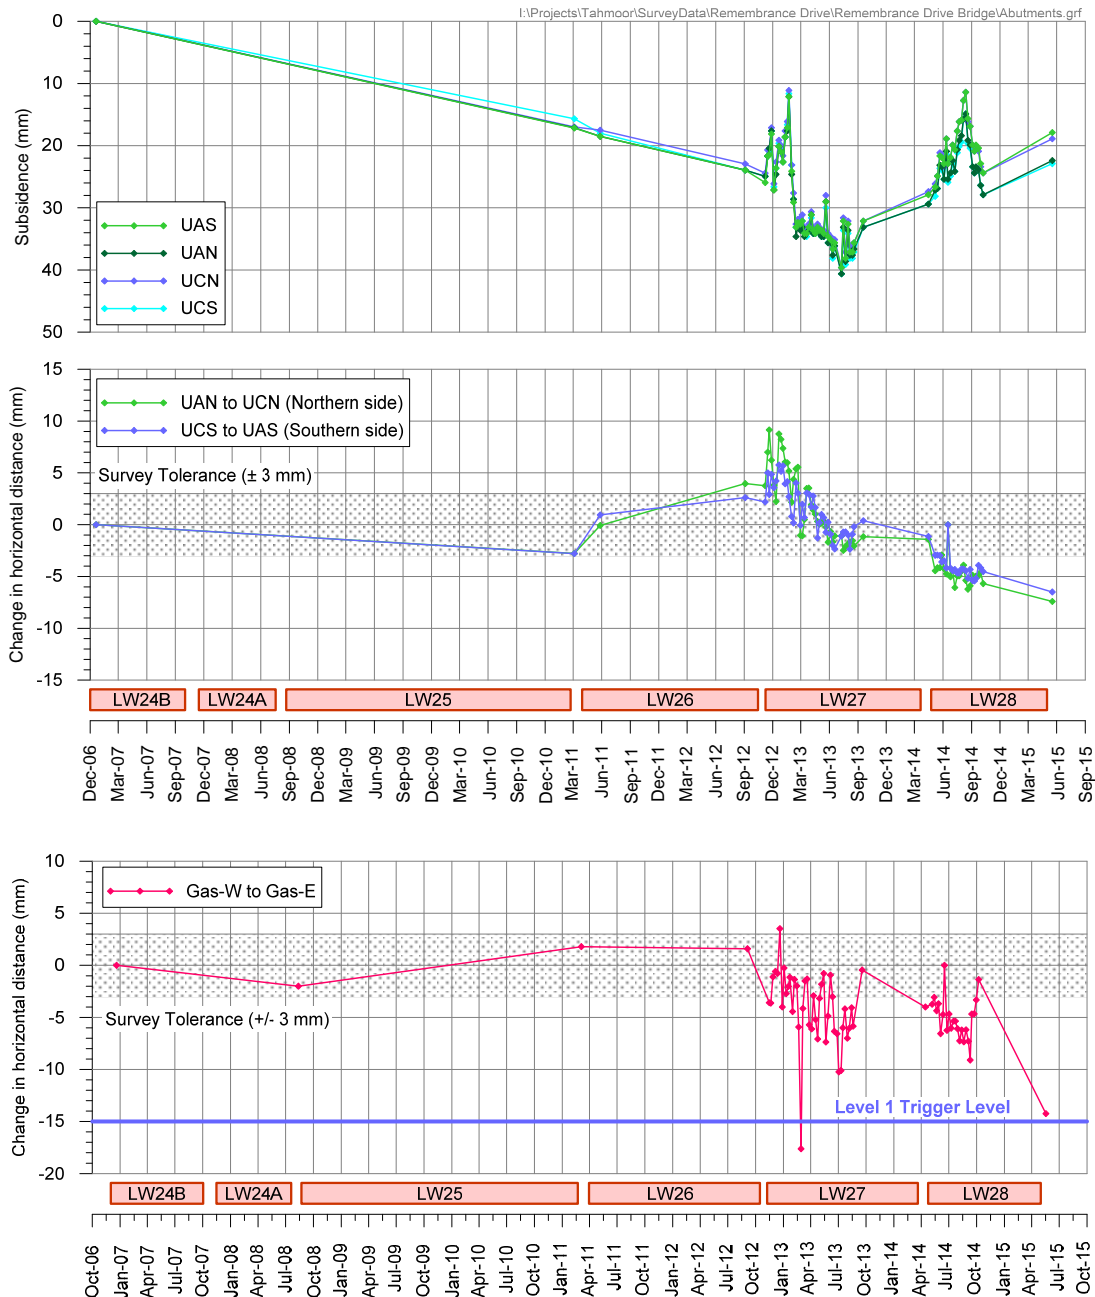
Fig. 2.26 Observed subsidence and changes in horizontal distances across the abutment and gas pipe supports at Remembrance Drive (Myrtle Creek) Road Bridge

Survey marks were installed on the Remembrance Drive Road Bridge prior to the extraction of Longwall 24A. While the Bridge has experienced approximately 40 mm of subsidence, measured changes in horizontal distances between the abutments are small and close to survey tolerance. Minor closure has been measured, as shown in Fig. 2.26. This includes the measured changes in horizontal distances across the gas pipe supports. Vertical subsidence is relatively consistent across all survey marks, indicating that no measureable upsidence has occurred to date.

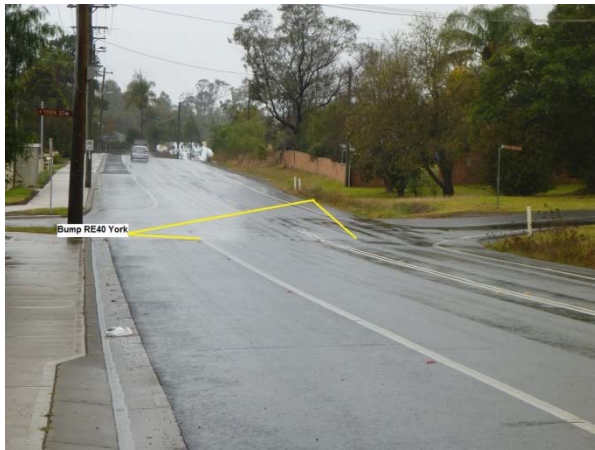
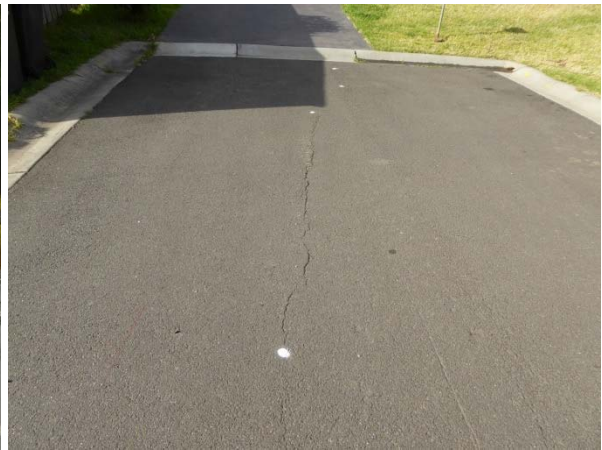
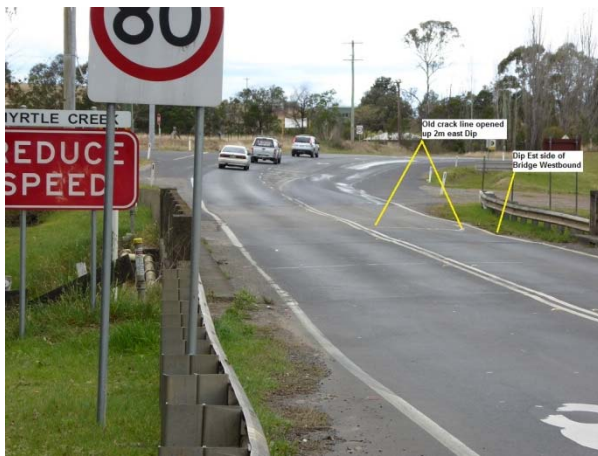
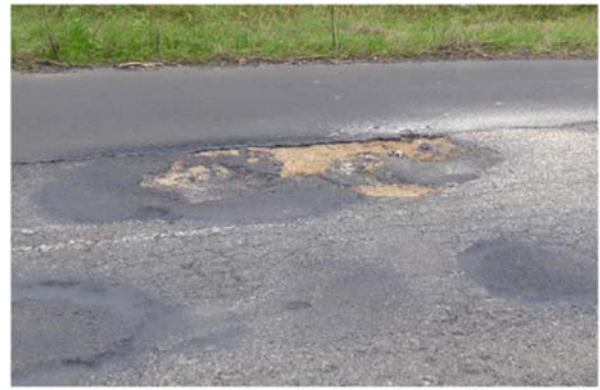
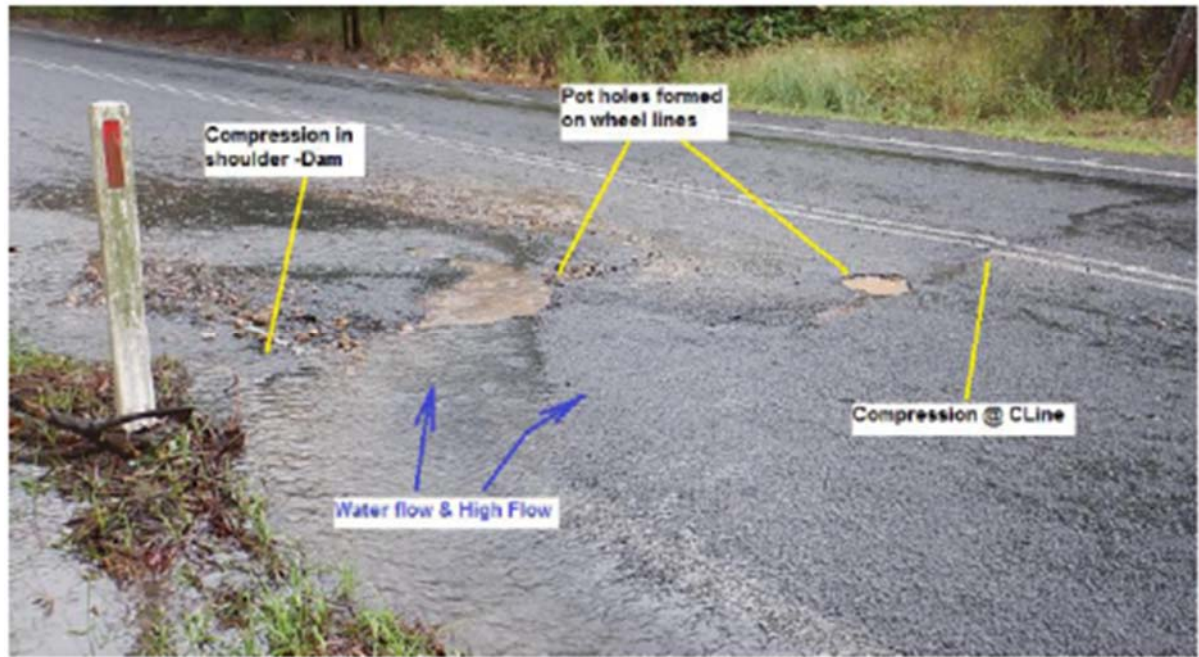
Fig. 4.1 Photographs of Impacts to Road Pavements and Kerbs during Longwall 28

Approximately 25.2 kilometres of asphaltic pavement lie directly above the extracted longwalls and a total of 48 impact sites have been observed. The observed rate of impact equates to an average of one impact for every 525 metres of pavement. The impacts were minor and did not present a public safety risk.

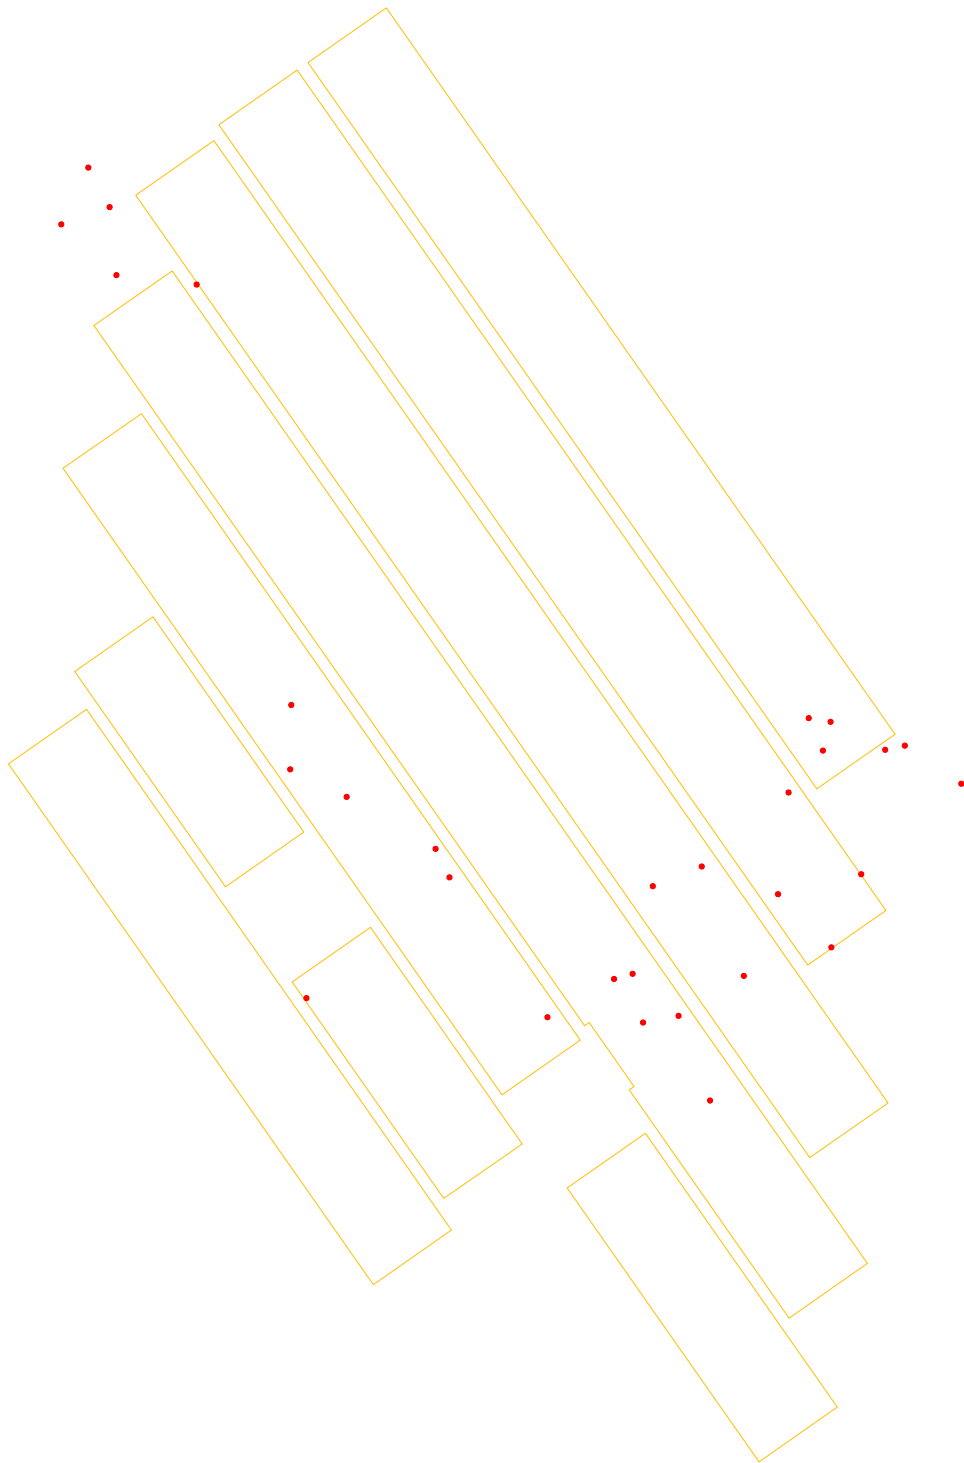
Fig. 4.2 **Locations of Impacts Reported during the Mining of Longwall 28**

This is illustrated by a spatial plot of locations of impacts reported during the mining of Longwall 28 in Fig. 4.2. A total of 24 of 30 claims related to the mining of Longwalls 22 to 27, rather than the active Longwall 28.

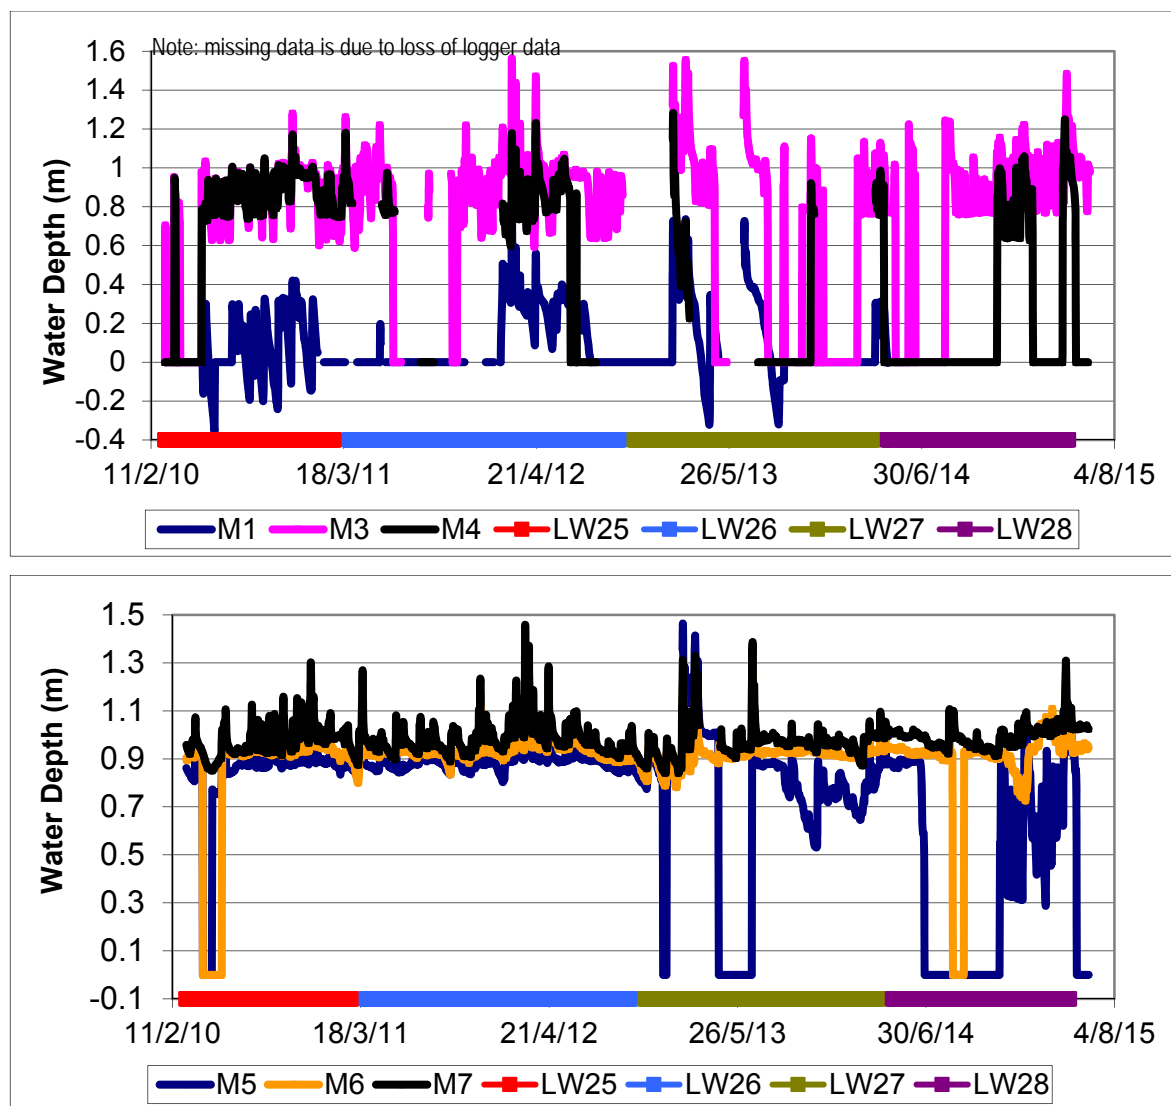
Figure 2 Myrtle Creek Stream Pool Depth

Sites M1, M3, M4, M5 and M6 show evidence of subsidence related pool holding capacity effects, whilst M7 shows no subsidence effects on its pool holding capacity as shown in **Figure 2**.

Observation of weekly monitoring sites 1 to 30, which overlie Longwalls 26 to 28 and to 175m downstream of Longwall 28, indicate that stream flow and pool depths have been significantly affected by subsidence associated with Longwalls 26 to 28 between Sites 13 - 21.

A new seep has been generated at Site 21A, which maintains flow in Site 22, however the water that flows into a large pool at Site 23 is generally insufficient to maintain above low levels and the pool often dries out. Seepage flow is generally observed in a downstream pool at Site 24, with pool levels often maintained although are now more responsive from Sites 25 to 31 as shown in **Drawing 3**.
