GLENCORE:
Tahmoor Colliery - Longwall 28

End of Panel Subsidence Monitoring Report for Tahmoor Longwall 28

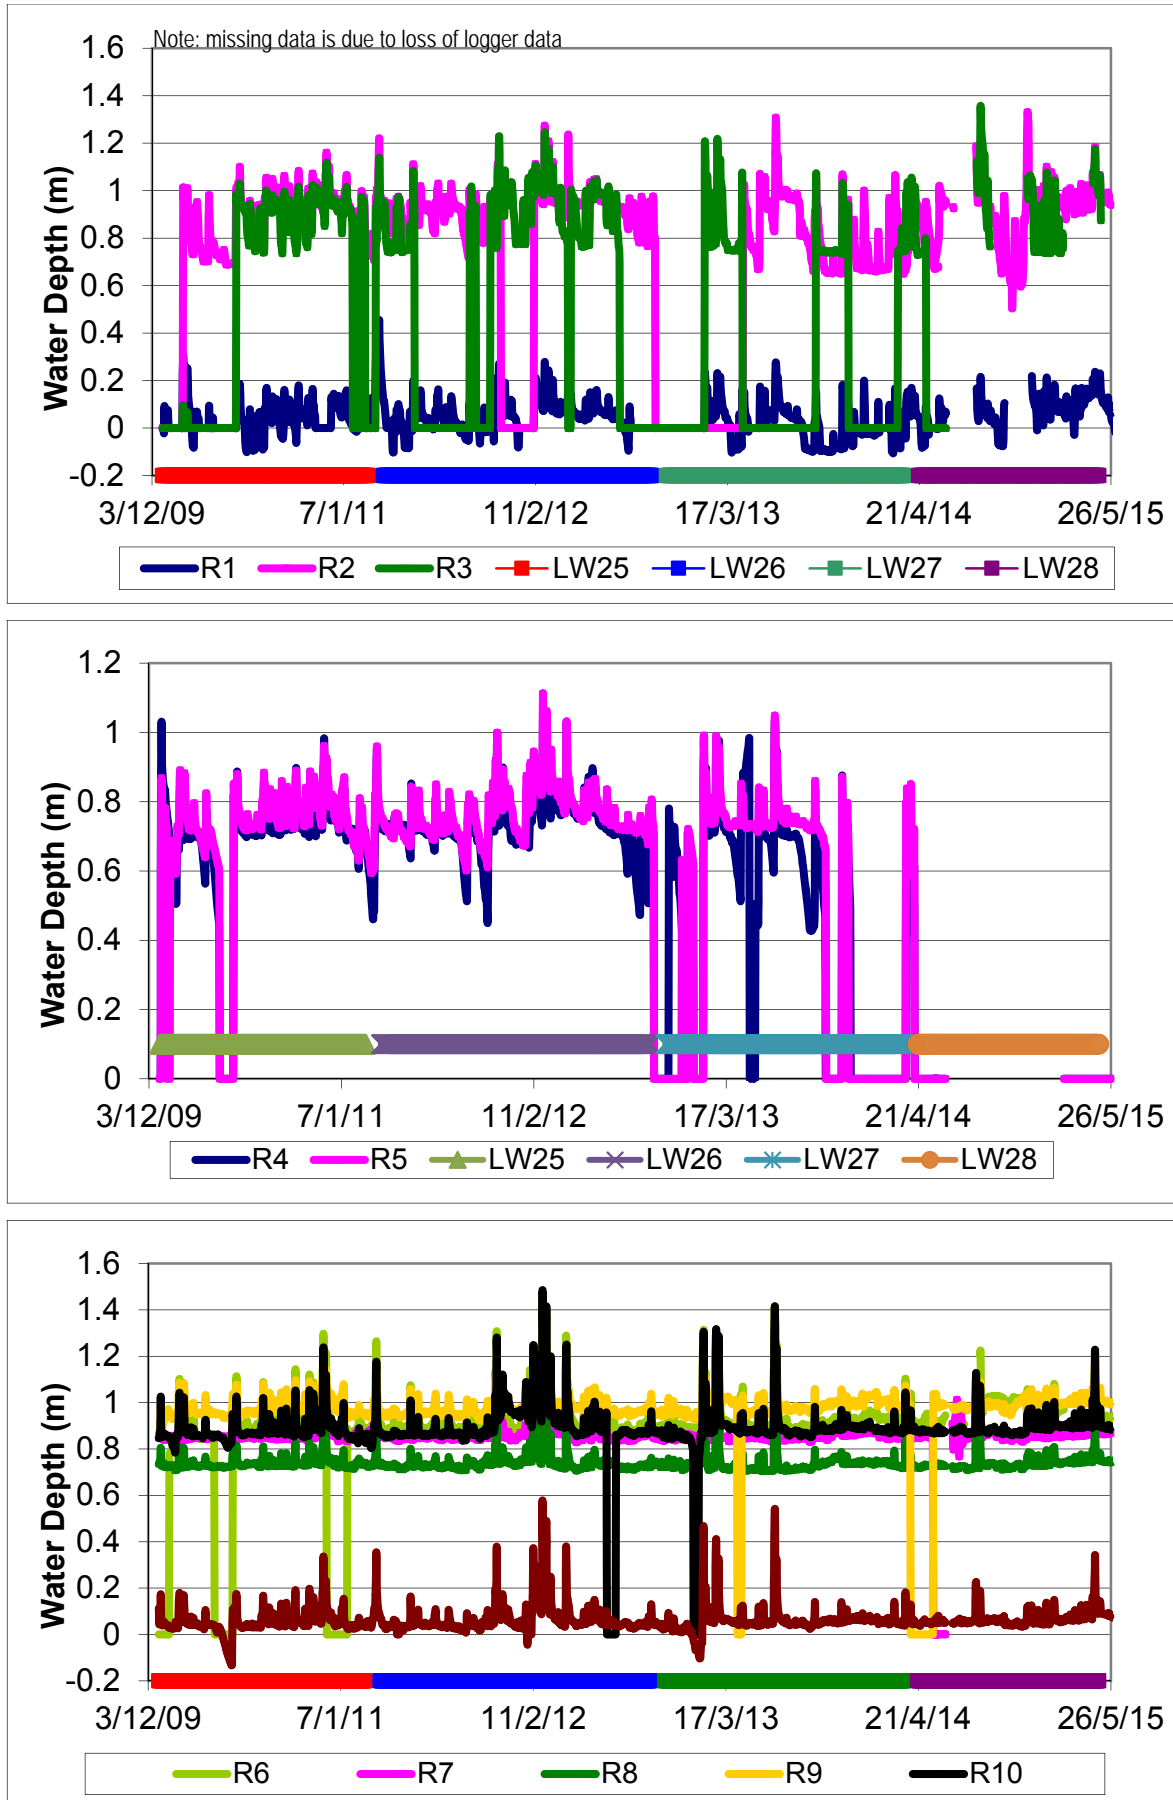
Figure 3 Redbank Creek Stream Pool Depth

Sites R2, 3, 4, 5 and R6, which overlie Longwalls 25 to 29, show evidence of subsidence related pool holding capacity effects, whilst R7 to 11 do not, as shown in **Figure 3**.

Observation of weekly monitoring sites 19 to 37 (over Longwalls 27 to 29) were monitored during extraction of Longwall 28, as well as Sites Rock Race 2 (RR2), rock bar pools RB3 – 6, RR7 as well as RR8, which extend to the tailgate section of Longwall 30, indicate that stream flow and pool depths have been significantly affected by subsidence associated with Longwalls 26 to 28 between Sites 19 – 34, which overlie Longwalls 27 and 28 as shown in **Drawing 5**.

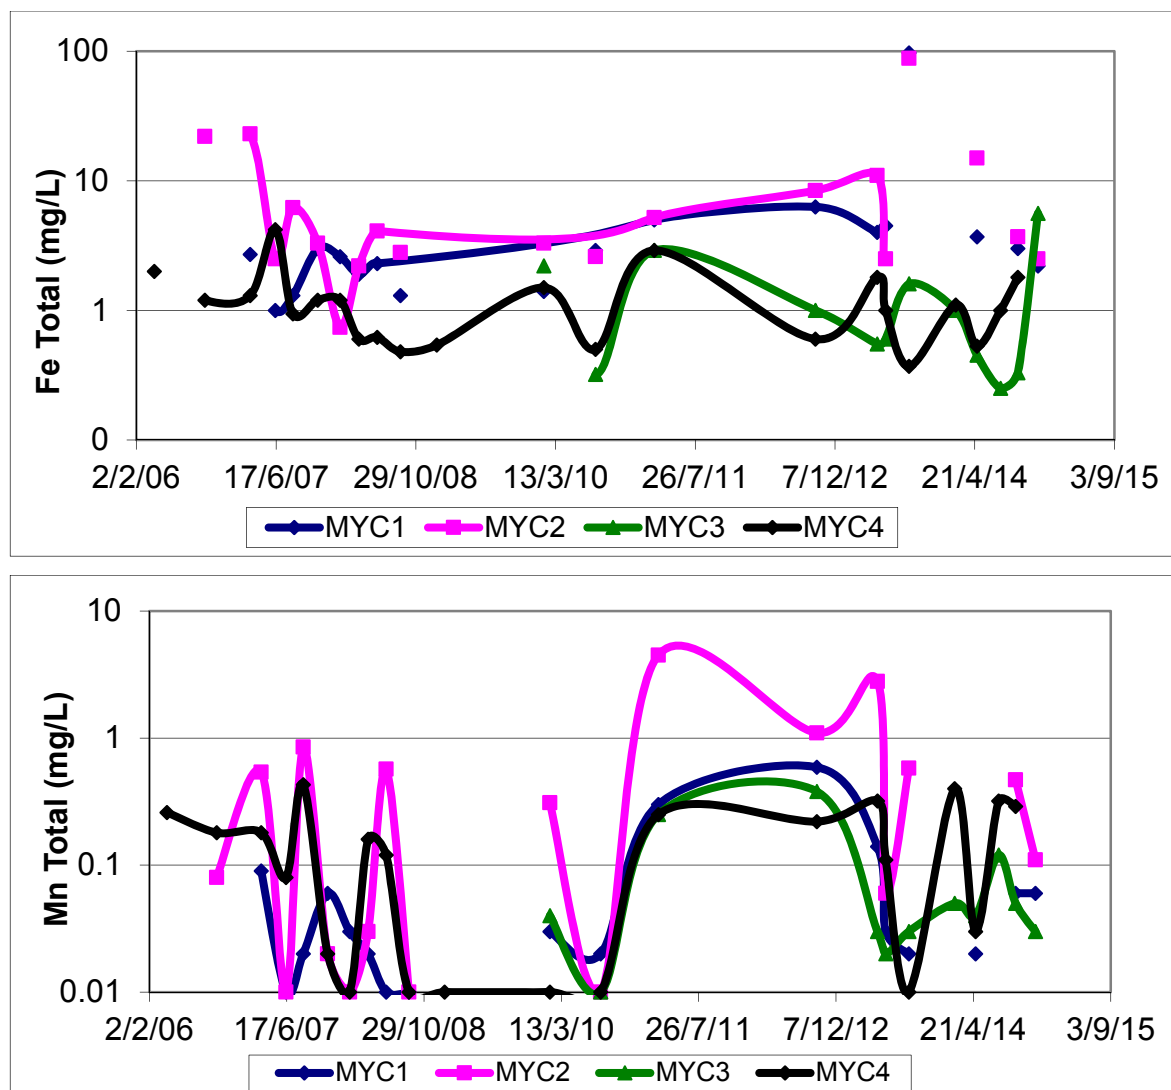
Figure 6 Myrtle Creek Iron and Manganese

Iron and manganese levels are generally not elevated in Myrtle Creek, apart from isolated occasions at MYC1 and MYC2 during extraction of Longwall 27, with no long term trend or increase over subsided areas as shown in **Figure 6**.

A new ferruginous seep was generated downstream of a small (<1.5m high) waterfall at Site 21A during extraction of Longwall 28.

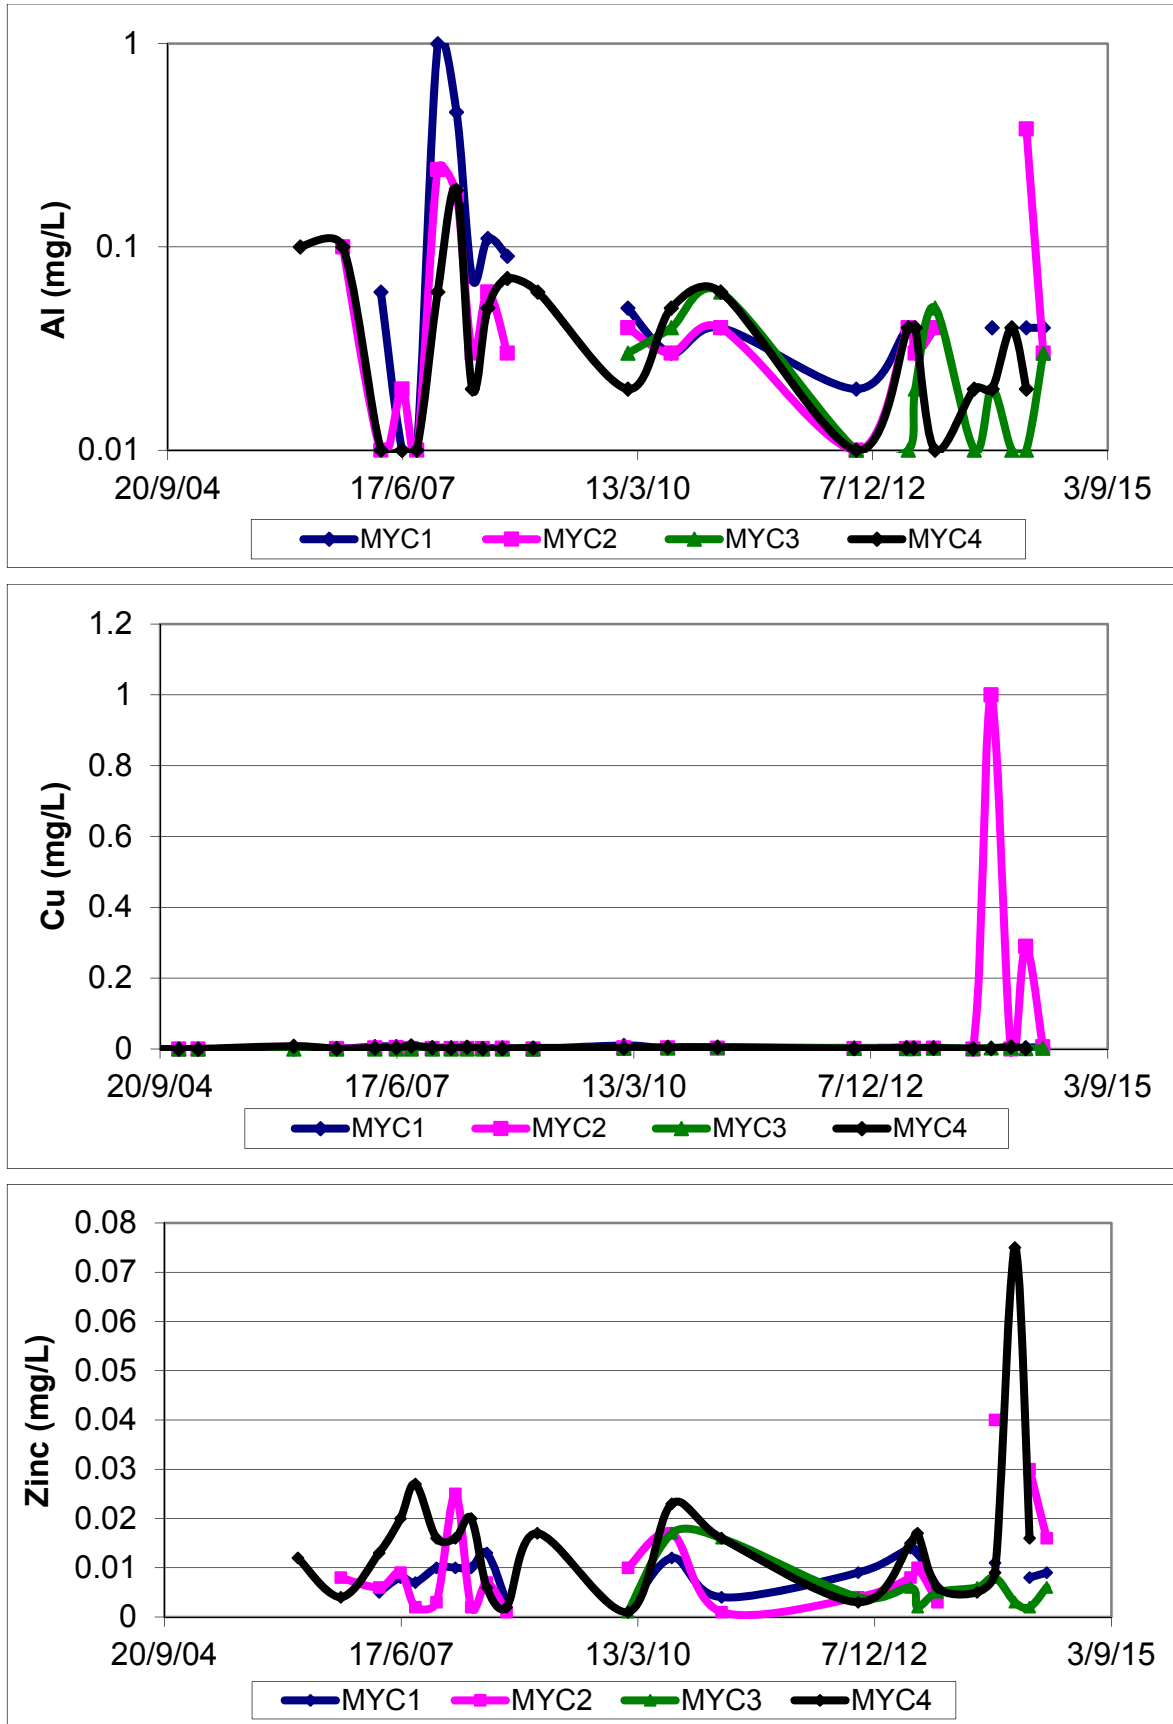
Figure 8 Myrtle Creek Metals

Myrtle Creek can also exceed the ANZECC 2000 trigger levels for filterable aluminium (<1.0mg/L), copper (<0.009mg/L) or zinc (0.027mg/L) at all sites, for variable times at each water quality monitoring site.

A notable increase in copper occurred at MYC2 (over the chain pillar between longwalls 24B and 25) and for zinc at MYC2 and MYC4 (approximately 1.5km downstream of Longwall 28) during the extraction period of Longwall 28 as shown in **Figure 8** and **Appendix B**.

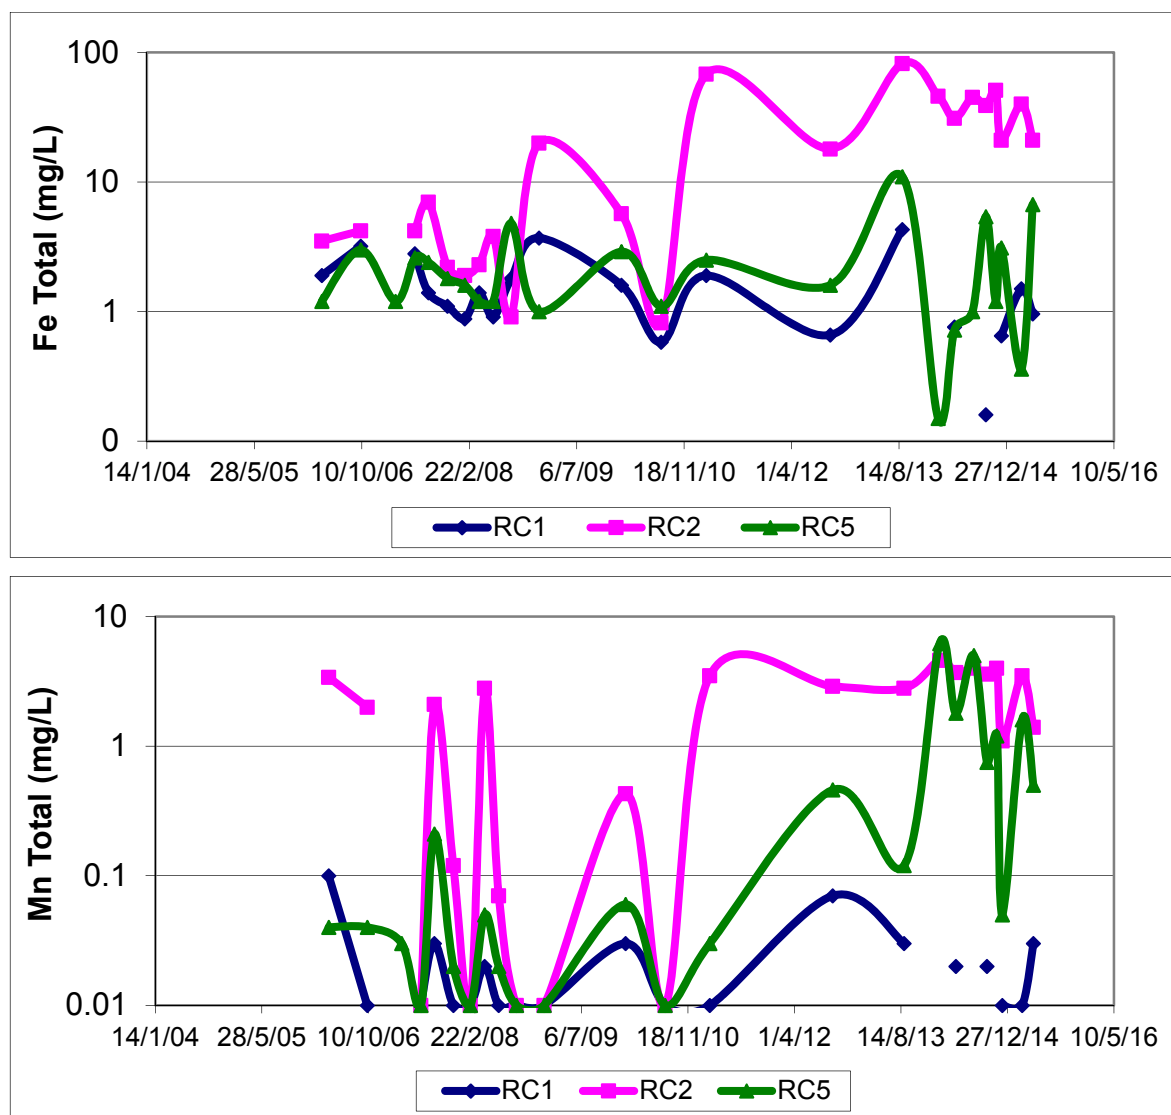
Figure 10 Redbank Creek Iron and Manganese

Redbank Creek generally contains elevated iron and, occasionally, above ANZECC 2000 Protection of 95% of Freshwater Aquatic Species trigger level manganese at RC2 in association with the upstream tributary seepage as shown in **Figure 10** and **Appendix B**.

The stream reach at RC2 (a.k.a. Site 37) has had a definitive ferruginous hydroxide precipitate in the standing pool since monitoring was started in early 2005 which is present due to upwelling and re-oxygenation of chemically reduced waters in the creek between sites 30 to 35, as well as a groundwater seep in a tributary entering Redbank Creek downstream of the railway tunnel at Site 36, as well as sites RC37, RR2, RB3-6, RR7 and RR8.

The iron and manganese levels vary with rainfall in the catchment, with lower concentrations after wetter periods, however a definitive rise in iron has been observed at RC2 and for manganese at RC2 and RC5 since Longwall 27 and Longwall 28 undermined Redbank Creek.

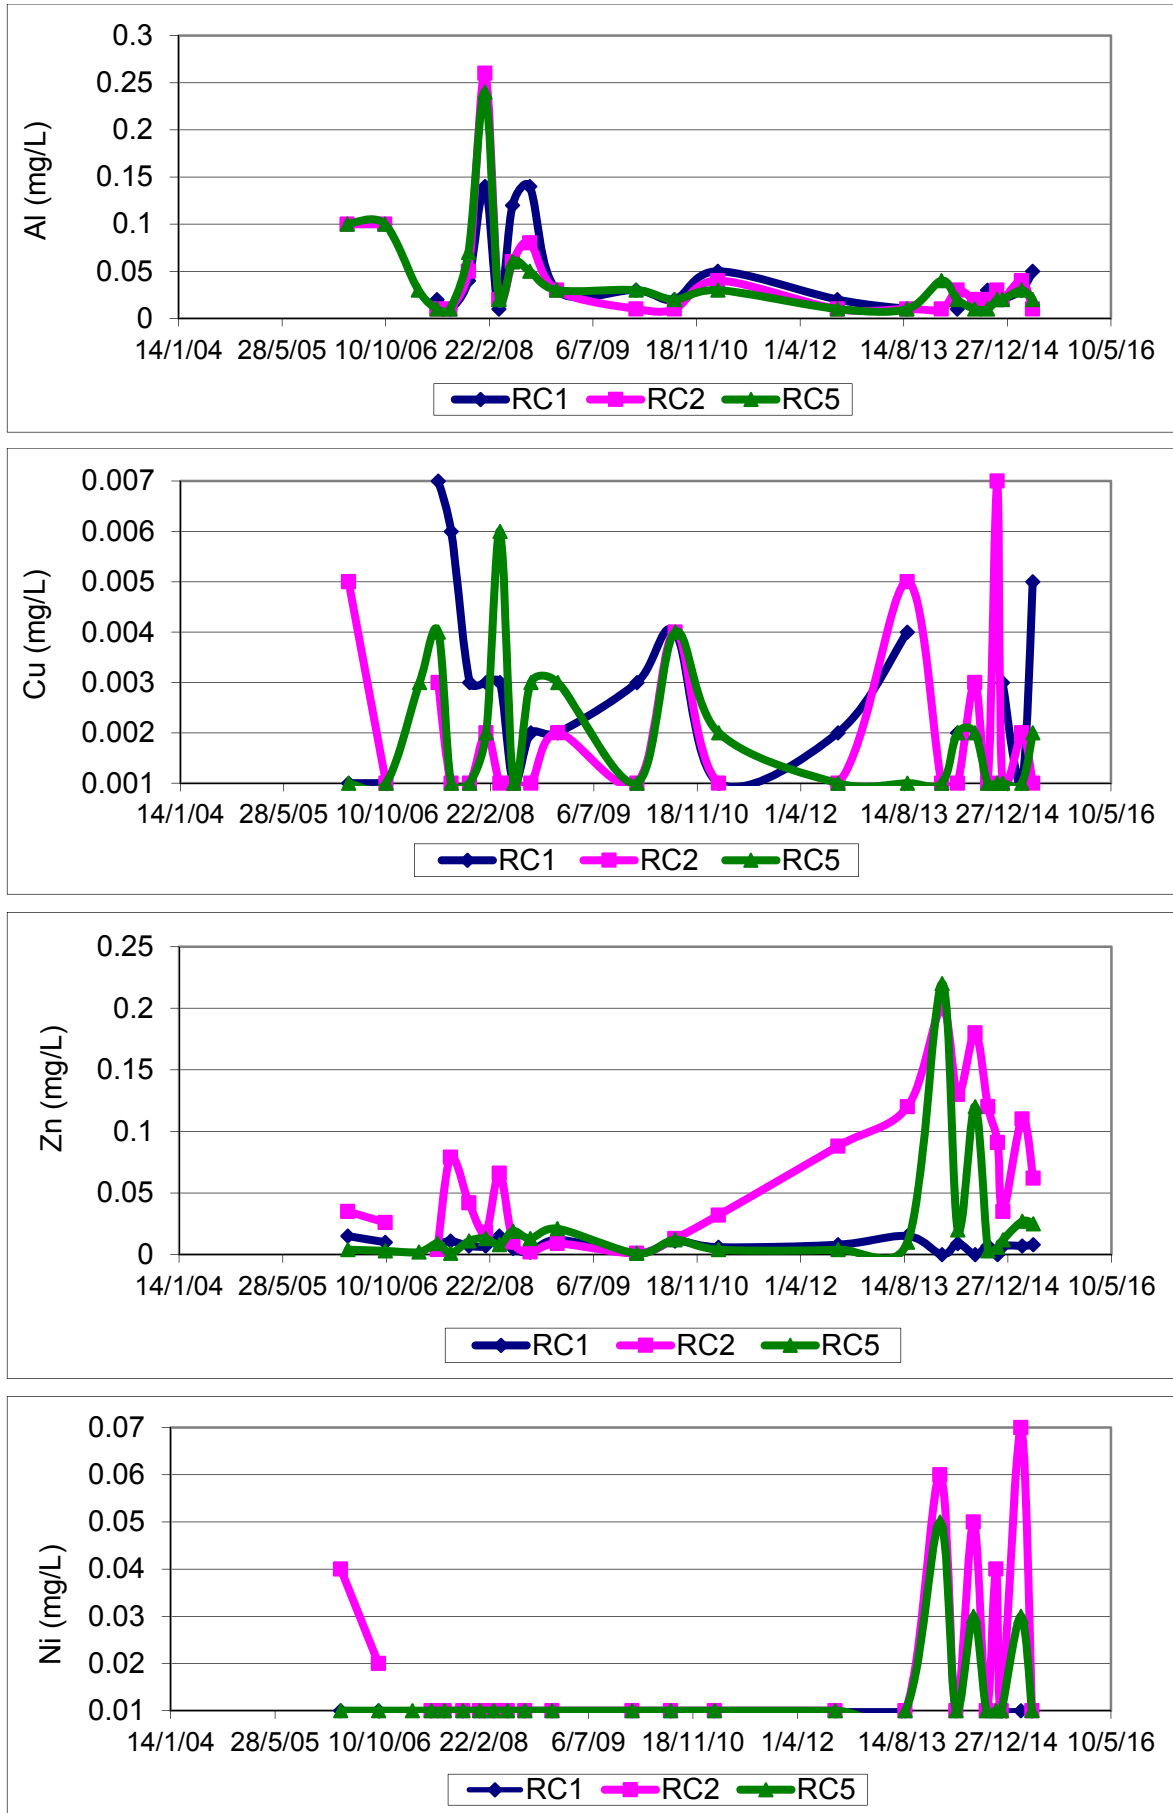
Figure 12 Redbank Creek Metals

Copper can reach up to 0.007mg/L at RC1 and RC2, however no definitive sustained increase downstream of Longwall 28 is observed as shown in **Figure 12** and **Appendix B**.

Zinc can reach up to 0.22mg/L as shown in **Figure 12** and **Appendix B**, with its concentration being observed to rise at RC2 since late 2010, and since August 2013 at RC3 with an erratic, although generalised reduction since February 2014.

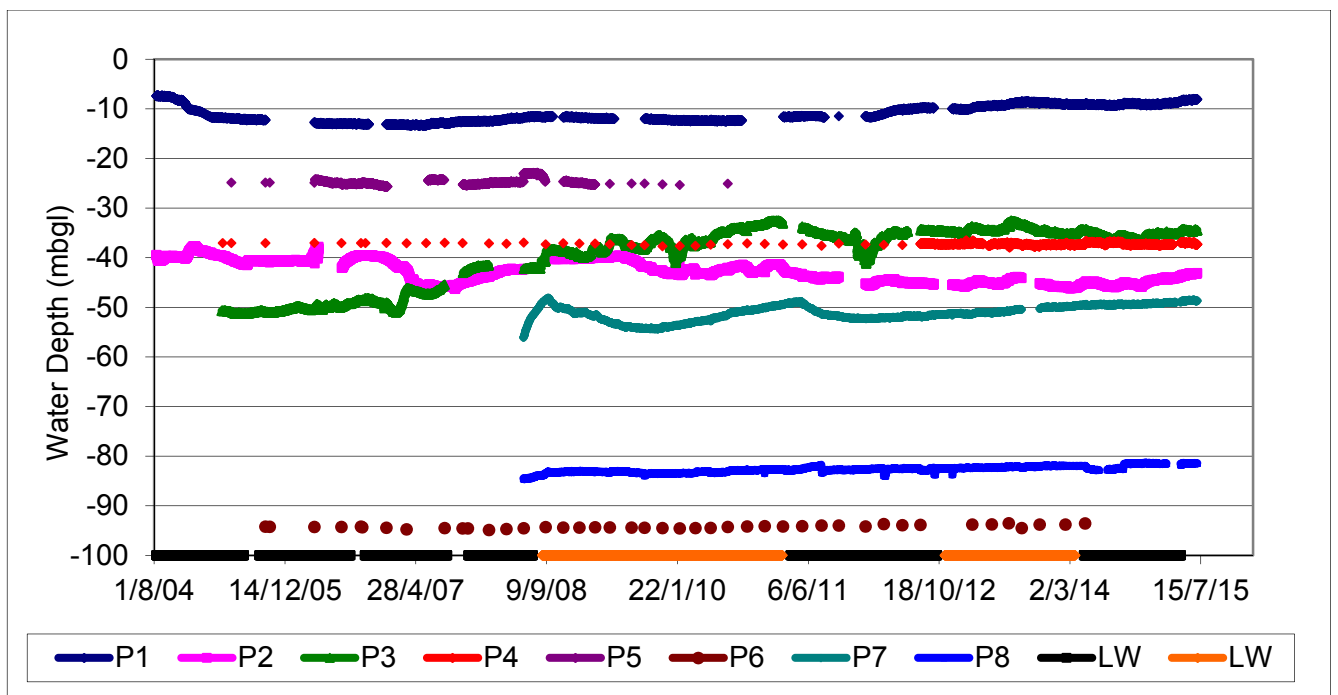
Figure 13 Standing Water Levels and Panel Extraction

No open standpipe piezometer water level reduction in response to Longwall 28 has been observed, and no complaints of adverse effects on private bore water levels or yield have been received by the Colliery.

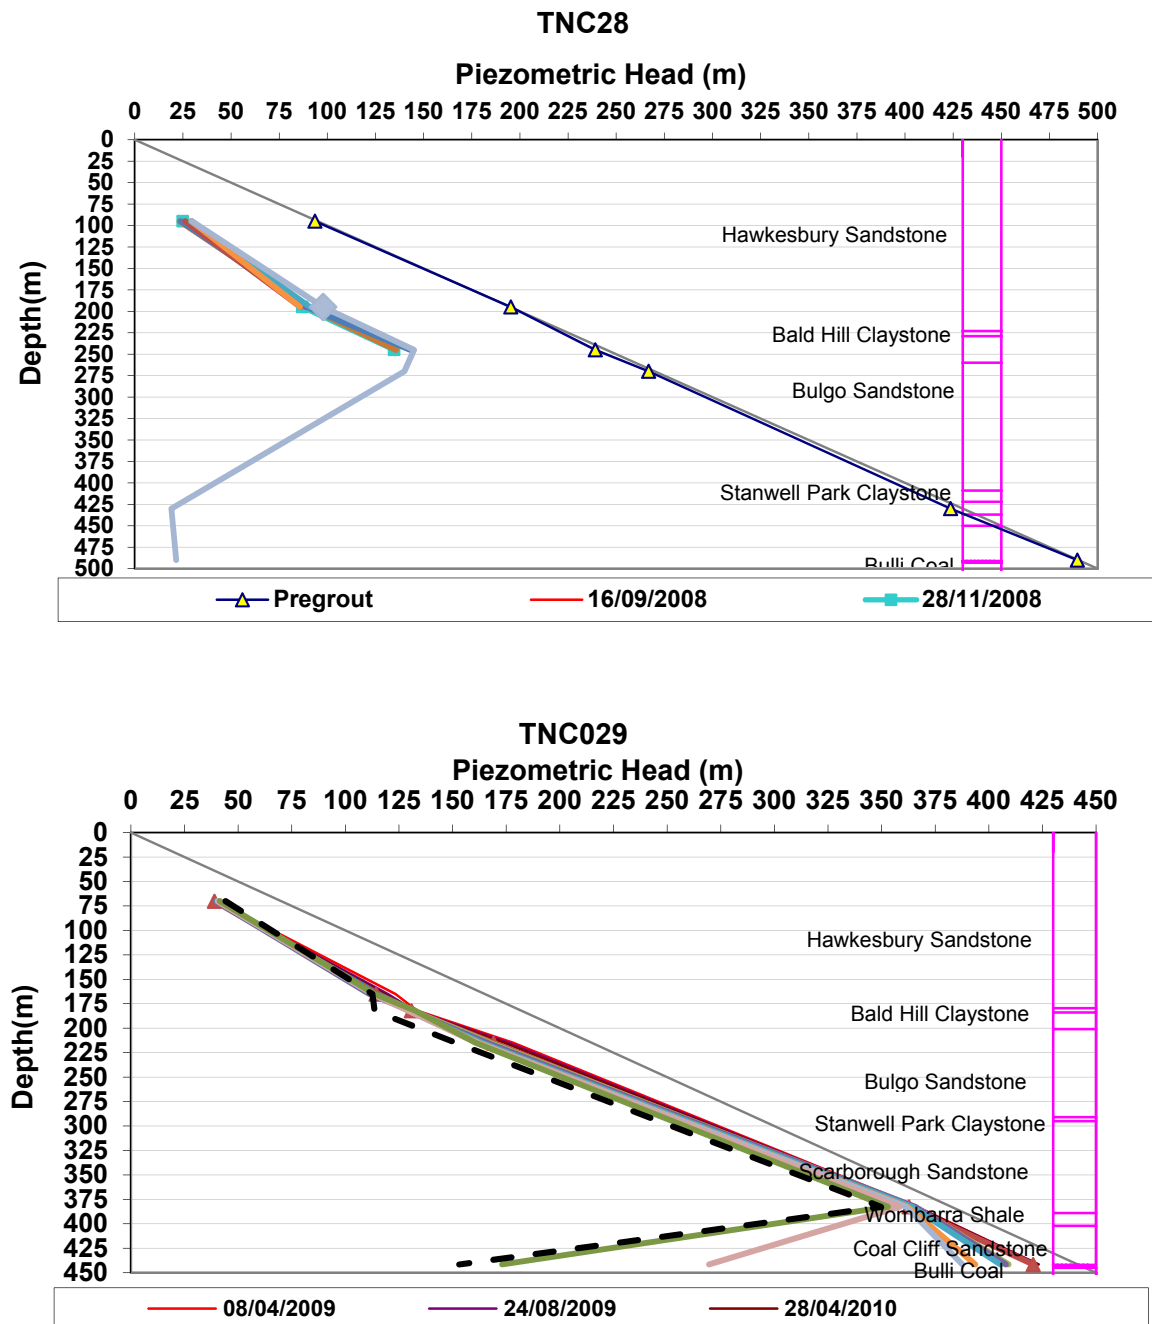
Figure 16 Vibrating Wire Piezometer Head vs Depth

Hydraulic connection has been instigated between the Bald Hill Claystone and Bulgo Sandstone in TNC28 as well as between the base of the Scarborough sandstone and the Wombarra Shale in TNC29 during extraction of Longwalls 22 to 28 as shown in **Figure 16**.

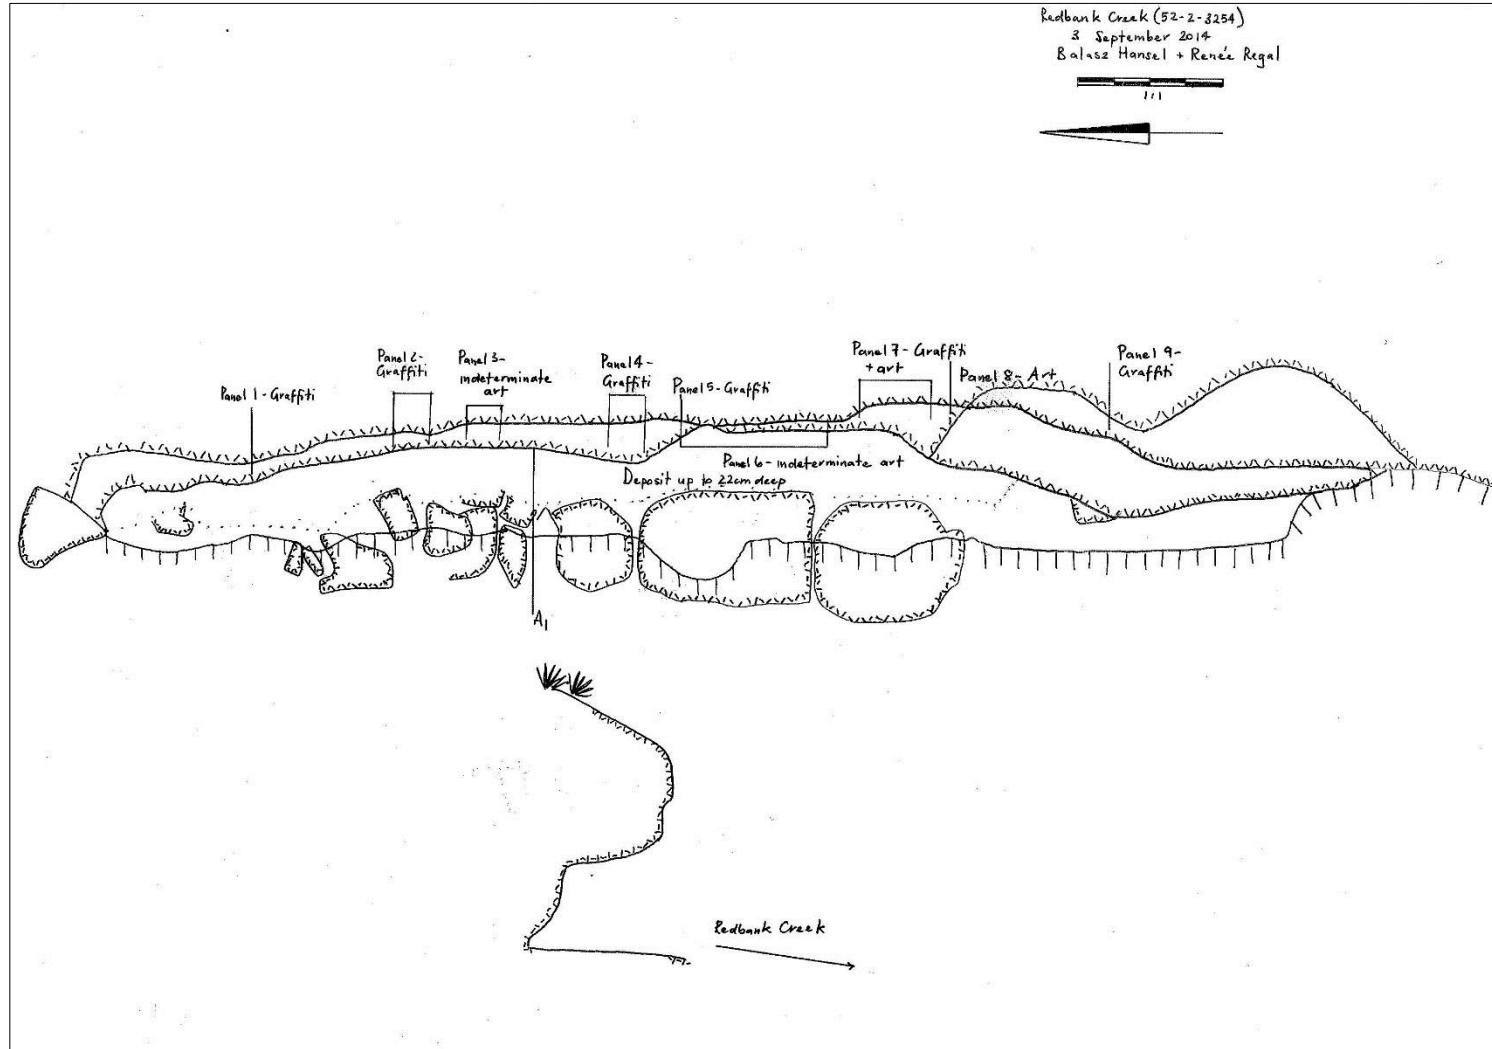
Drawing 1. Revised site plan and section drawing of Redbank Creek-1 (Source: Niche 2014)

Niche (2014) conducted a detailed condition assessment of the site to be used as a baseline for any future assessments of the site's condition prior to any subsidence induced movements. The recording of the site included completing a revised site plan and section drawing (Drawing 1) and additional photographs were taken of the entire site, and features that will act as monitoring points. Attempts were made to find the previously identified stone artefacts within the drip-line, but they could not be located. It was considered that the artefacts had been disturbed through the extensive disturbance to the site by goats. The art was concluded to be in similar condition to its original recording in 1994.

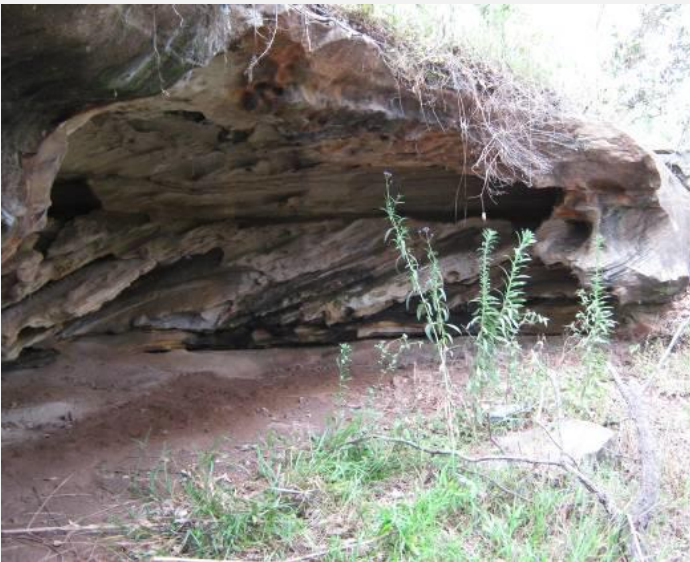
AHIMS Site #	Site Name	Results of Inspection	Photos
52-2-2076	Tahmoor-1	The condition of this site has not changed since the Biosis 2009 condition assessment of the site.

Plate 1: Southern end of Tahmoor-1 (Source: Biosis 2009)

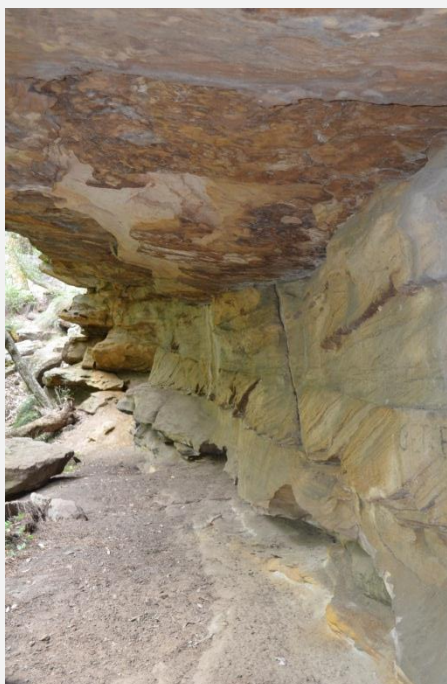
The condition of the site has not changed due to mining related impacts since the Niche 2014 condition assessment of the site. The floor and back wall of the shelter however have suffered some damage as a result of wild goats living in the shelter.

Plate 2: View of Redbank Creek-1, photograph taken facing north (Source: Niche)

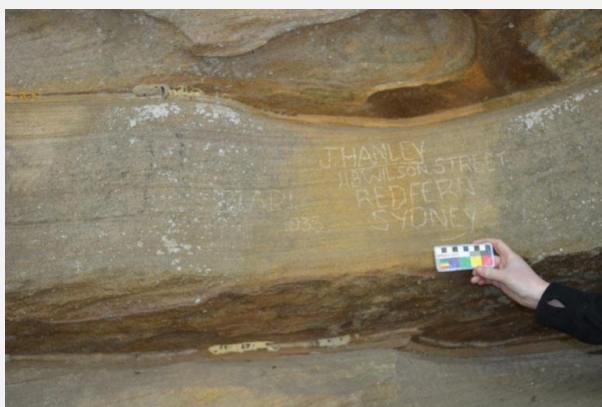
Plate 3: Example of scratched graffiti at the southern end of the shelter (Source: Niche)

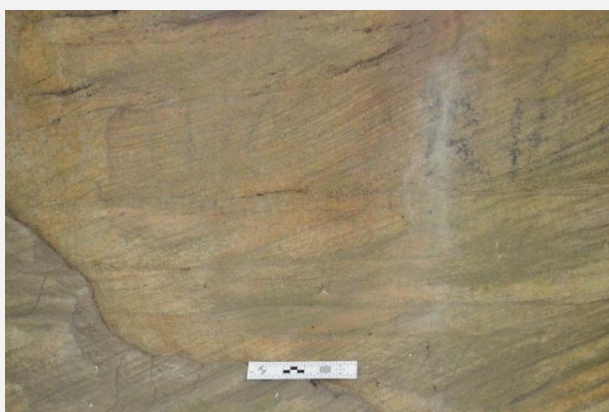
Plate 4: Overview photograph of graffiti on panel 3. See Drawing 1 for location at site (Source: Niche)
