Tahmoor Colliery Longwalls 27 to 30

ENVIRONMENTAL MANAGEMENT PLAN

REVISION D

February 2013

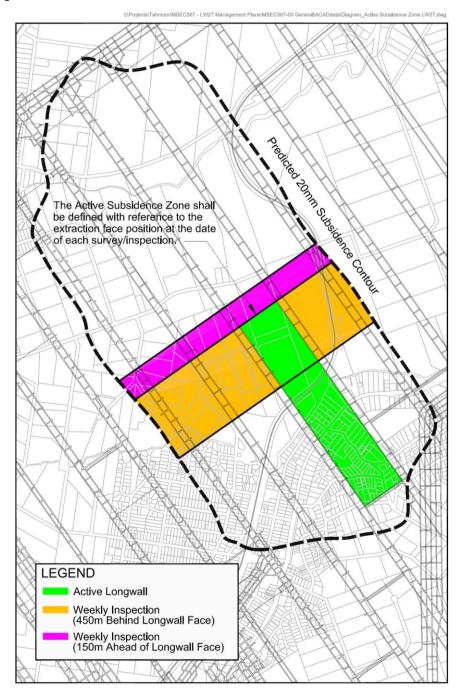
Figure 1.2 Diagrammatic Representation of Active Subsidence Zone

This is termed the "active subsidence zone" for the purposes of this EMP. The active subsidence zone for each longwall is defined by the area bounded by the predicted 20 mm subsidence contour for the active longwall and a distance of 150 metres in front and 450 metres behind the active longwall face, as shown by Figure 1.2.

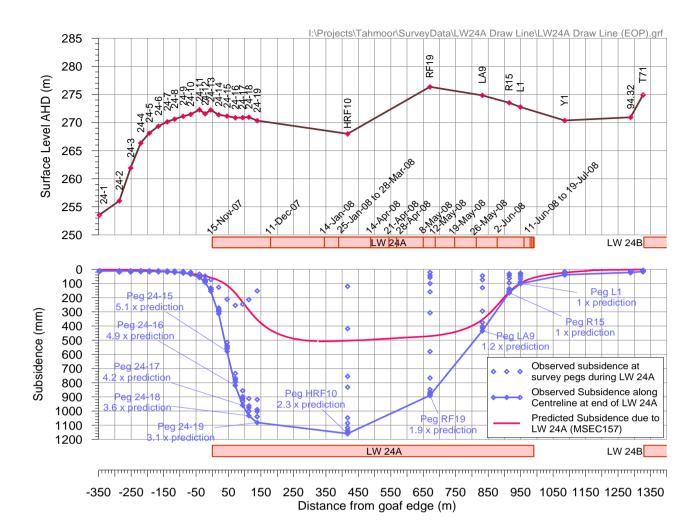
Figure. 2.1 Observed Subsidence along Centreline of Longwall 24A

Observed subsidence was greatest above the southern half of Longwall 24A, that gradually reduced in magnitude towards the northern half of the longwall, and was directly beneath the urban area of Tahmoor. These observations are shown graphically in Figure. 2.1, which shows observed subsidence at survey pegs located along the centreline of Longwall 24A.

It can be seen from Figure. 2.1 that observed subsidence was more than twice the predicted maximum value, reaching to a maximum of 1169 mm at Peg HRF10.

It is possible that actual maximum subsidence developed somewhere between Pegs HRF10 and RF19, though this was not measured. Observed subsidence was similar to prediction near Peg R15 on Remembrance Drive. Survey pegs RF19 and LA9 are located within a transition zone where subsidence gradually reduced from areas of maximum increased subsidence to areas of normal subsidence.

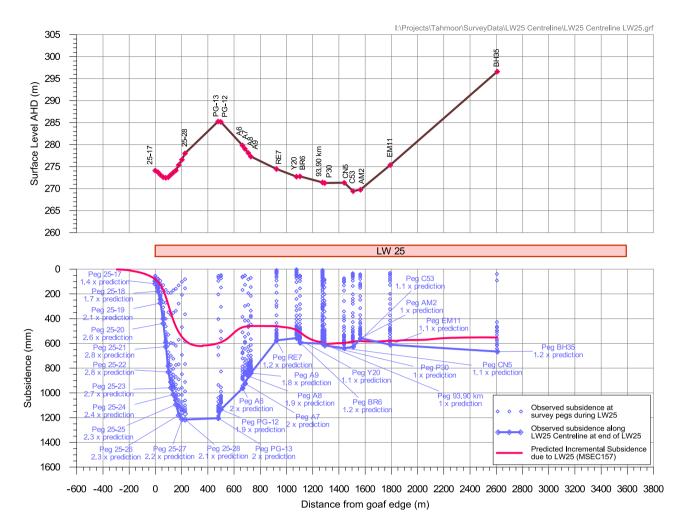
Figure. 2.2 Observed Subsidence along Centreline of Longwall 25

Increased subsidence was observed during the first stages of mining Longwall 25. These observations are shown graphically in Figure. 2.2, which shows observed subsidence at survey pegs located along the centreline of Longwall 25.

It can be seen from Figure. 2.2 that observed subsidence was approximately twice the predicted maximum value, with maximum subsidence of 1216 mm at Peg 25-28.

Observed subsidence is similar to but slightly more than predicted at Peg RE7 and is similar to prediction at Peg Y20 and at all pegs located further along the panel. Survey pegs A6, A7, A8 and A9 are located within a transition zone where subsidence has gradually reduced from areas of maximum increased subsidence to areas of normal subsidence.

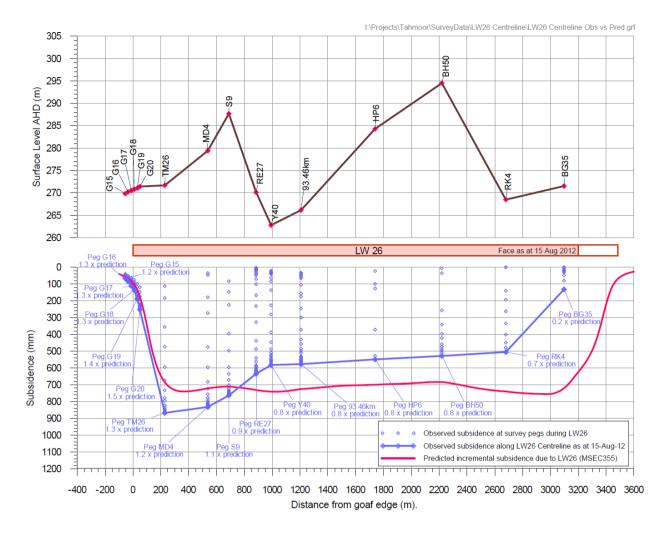
Figure 2.3 Observed Subsidence along Centreline of Longwall 26 as at August 2012

Increased subsidence was observed during the first stages of mining Longwall 26, but at a reduced magnitude compared to the subsidence observed above Longwalls 24A and 25. These observations are shown graphically in Figure 2.3, which shows observed subsidence at survey pegs located along the centreline of Longwall 26. The graph shows the latest survey results for each monitoring line as at August 2012. It is likely that further small increases in subsidence will be observed at these pegs when they are surveyed at the completion of Longwall 26.

It can be seen from Figure 2.3 that observed subsidence was approximately 1.3 times the predicted maximum value, with maximum subsidence of 867 mm at Peg TM26.

Observed subsidence reduced along the panel until Peg Y40 on York Street, where it was less than prediction. Survey pegs S9, and RE27 are located within a transition zone where subsidence has gradually reduced from areas of maximum increased subsidence between Pegs TM26 and MD4 to areas of normal subsidence at Peg Y40 and beyond.

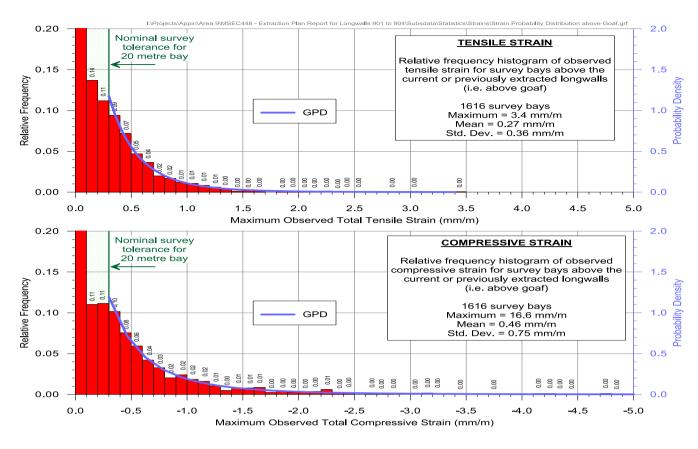
Figure 2.4 Distributions of Measured Maximum Tensile and Compressive Strains at Any Time for Pegs Located Above Goaf in the Southern Coalfield

The relative frequency distribution of maximum observed tensile strains and compressive strains for survey bays located directly above goaf is provided in Figure 2.4.

While not shown in Figure 2.4, it is noted that the maximum observed compressive strain of 16.6 mm/m, which occurred along the T-Line above Appin Longwall 408, was the result of movements along a low angle thrust fault within the Cataract Tunnel. All remaining compressive strains in this dataset (which exclude valley related movements) were less than 5 mm/m.

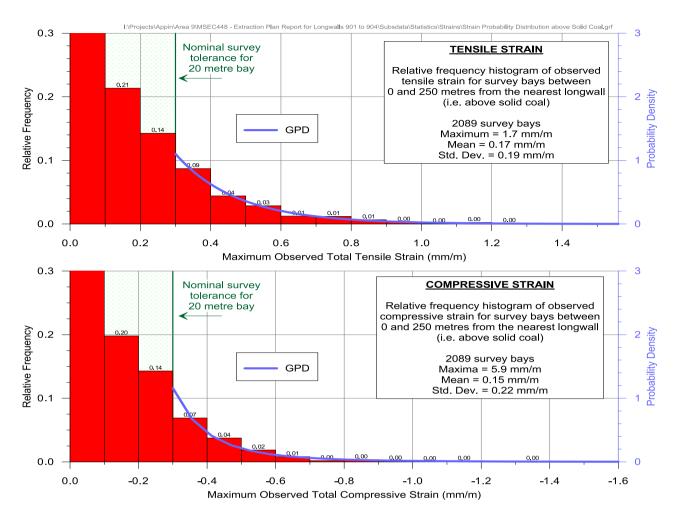
Figure 2.5 Distributions of Measured Maximum Tensile and Compressive Strains at Any Time for Pegs Located Above Solid Coal in the Southern Coalfield

The relative frequency distribution of maximum observed tensile strains and compressive strains above solid coal is provided in Figure 2.5.

While not shown in Figure 2.5, it is noted that the maximum observed compressive strain of 5.9 mm/m, which occurred along the T-Line above Appin Longwall 408, was the result of movements along a low angle thrust fault within the Cataract Tunnel as Longwall 408 approached the monitoring line. A maximum observed compressive strain of 3.1 mm/m was observed across the fault at the completion of Longwall 407. All remaining compressive strains in this dataset (which exclude valley related movements) were less than 5 mm/m.

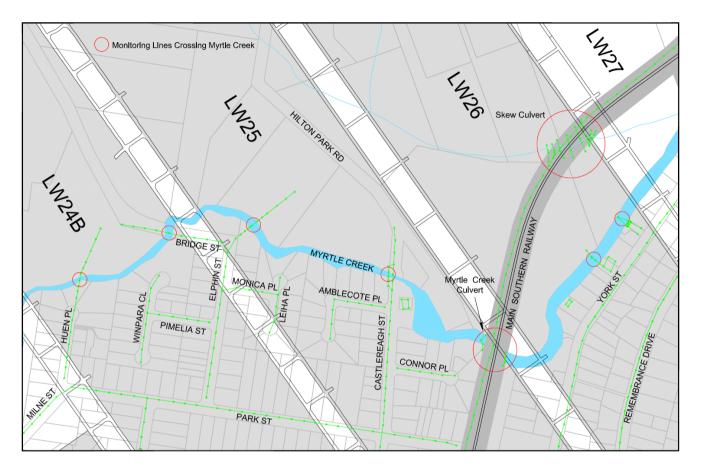
Figure 2.6 Monitoring lines across Myrtle Creek and Skew Culvert

A map of monitoring lines across Myrtle Creek and a small unnamed tributary creek that crosses the Main Southern Railway (at a location called the Skew Culvert) is shown in Figure 2.6.

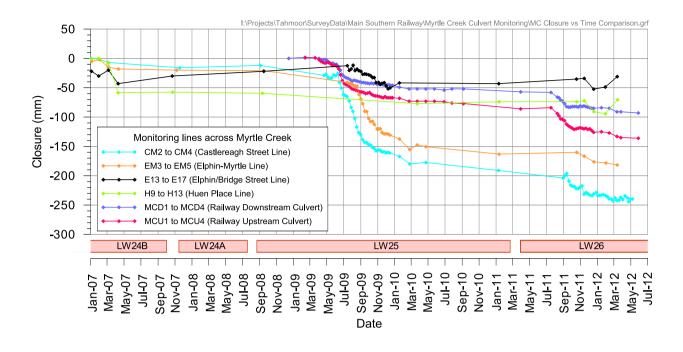
Figure 2.7 Development of closure across Myrtle Creek during the mining of Longwalls 24B to 26

A summary graph showing the development of valley closure across the Myrtle Creek at each monitoring line is shown in Figure 2.7.

It can be seen that observed valley closure has substantially exceeded predictions at the Castlereagh Street crossing, at the crossing of the Elphin-Myrtle monitoring line and to a lesser extent the crossing of the Main Southern Railway during the mining of Longwall 25. It is considered that the reason for the differences in observations may be linked to the change in orientation of Myrtle Creek as the three above-mentioned monitoring lines are located along the same stretch of Myrtle Creek.

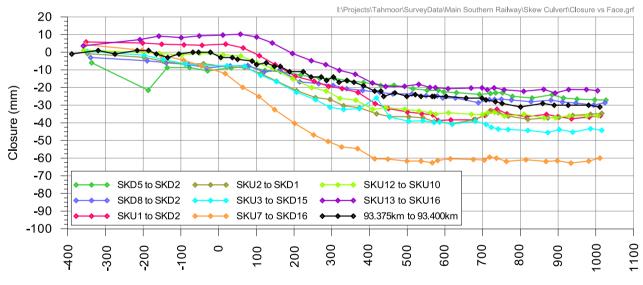
Figure 2.8 Development of closure across Skew Culvert during the mining of Longwall 26 as at 27 March 2012

The development of valley closure across the creek at the Skew Culvert is shown in Figure 2.8.

Distance to longwalls face (m). Postive when undermined.

Observed valley closure across the creek at the Skew Culvert has also slightly exceeded predictions, where the differences between predicted and observed closure are relatively small for most cross sections.

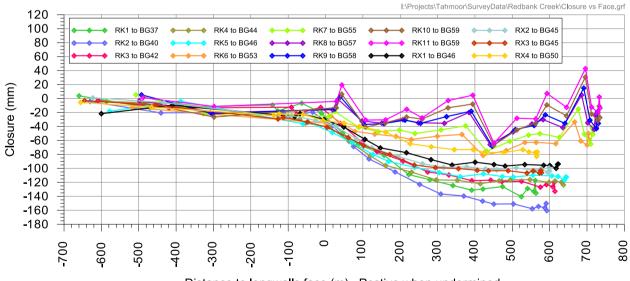
Figure 2.10 Observed development of closure across Redbank Creek

The development of valley closure across Redbank Creek during the mining of Longwall 26 is shown in Figure 2.10. The results indicate that valley closure has developed across Redbank Creek, particularly where the longwall face has passed directly beneath the creek.

Distance to longwalls face (m). Postive when undermined.

Maximum predicted valley closure due to extraction of Longwall 26 was 120 mm. As shown in Figure 2.10, observed valley closure was slightly greater than predicted closure at this stage of mining but much less than the predicted total closure of 500 mm due to the mining of Longwalls 22 to 30.

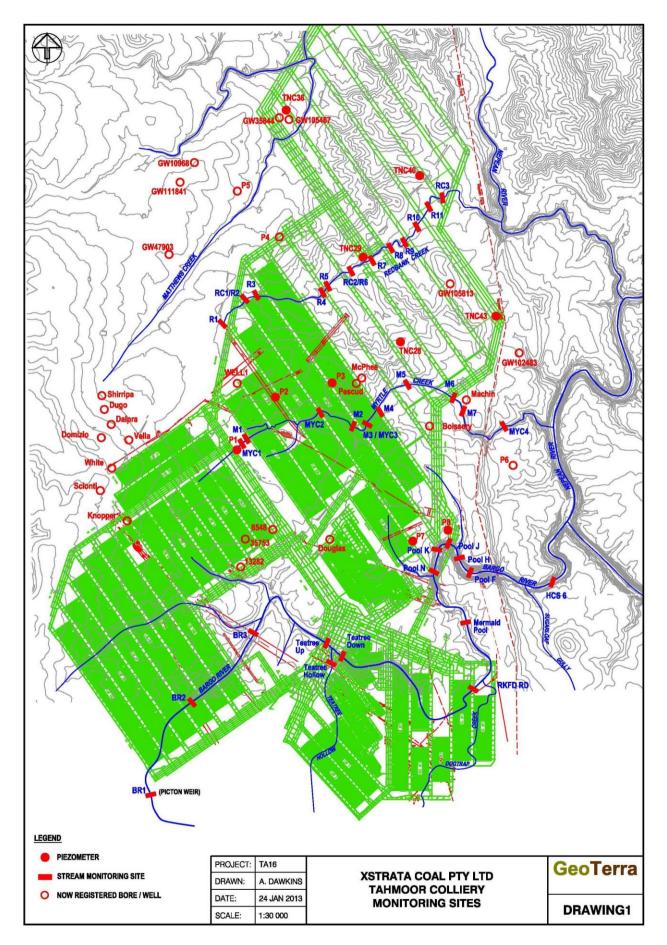
Figure 3.1 Location of Groundwater Bores

Piezometers used for monitoring surface and groundwater within the SMP Area and the locations of these are shown in Figure 3.1. In addition, a number of exploration bores were installed by Tahmoor Colliery in the vicinity of the SMP Area that may also be affected by far-field movements, or change in water quality or supply. These bores are generally sealed from seam to surface after drilling is completed. Their locations are shown in Figure 3.1.

Where access is granted by the landowner, all relevant private bores and piezometers located within a 3km limit of mining in Longwall 27, then subsequently 28, 29 and 30 will be monitored, with locations of the groundwater monitoring suite shown in Figure 3.1.

A disused well is located near Structure W50a, which is located above the pillar between Longwalls 25 and 26 and its location is also shown in Figure 3.1.

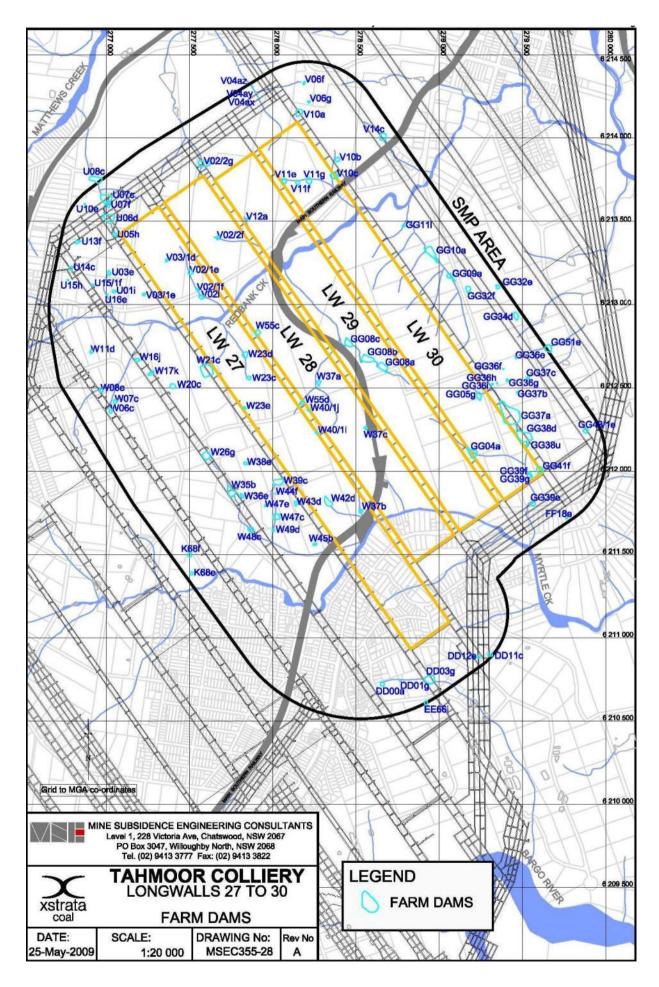
Figure. 4.1 Location of Dams

- Longwall 27 W23c,d,e, 24d, 37b, 40/1i,j, 42d, 55c,d, V02i, V02/1e, f and V031d
- Longwall 28 W37a,c, 40/1i,j, 55c and V02/2f
- Longwall 29 GG04, 08a,b,c
- Longwall 30 GG04a, 05g, and V11a, c, e, f, g
