**Tahmoor Colliery - Longwalls 28 to 30**

Management Plan for Potential Impacts to Built Structures

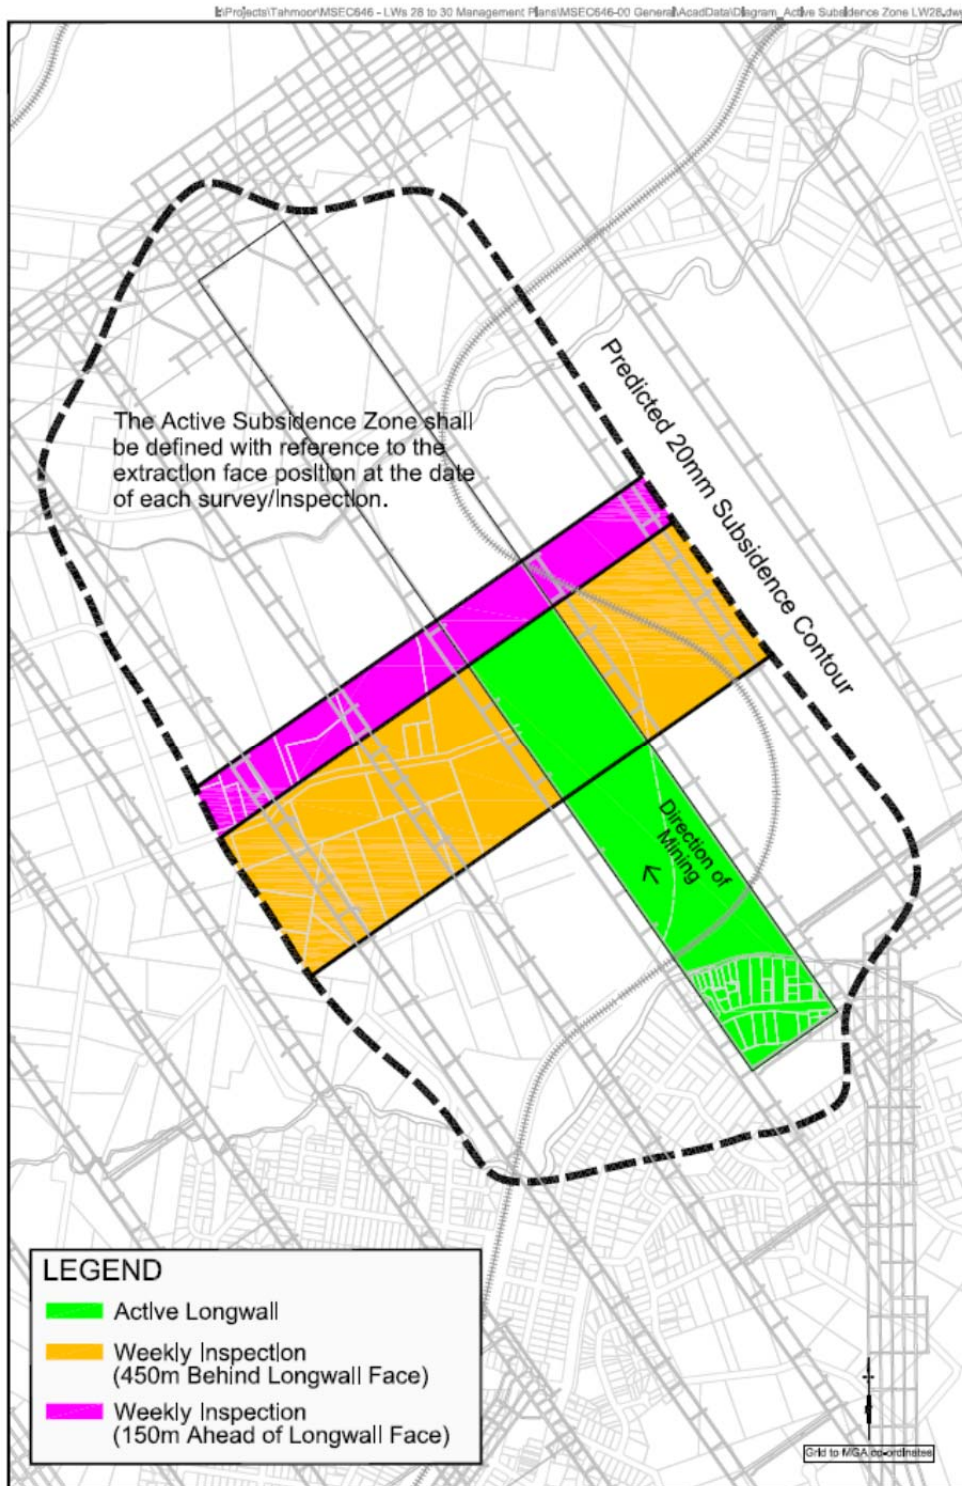
This is termed the “active subsidence zone” for the purposes of this Management Plan, where surface monitoring is generally conducted. The active subsidence zone for each longwall is defined by the area bounded by the predicted 20 mm subsidence contour for the active longwall and a distance of 150 metres in front and 450 metres behind the active longwall face, as shown by Fig. 1.1.

Fig. 1.1 Diagrammatic Representation of Active Subsidence Zone

As a longwall progresses, subsidence begins to develop at a point in front of the longwall face and continues to develop after the longwall passes. The majority of subsidence movement typically occurs within an area 150 metres in front of the longwall face to an area 450 metres behind the longwall face.

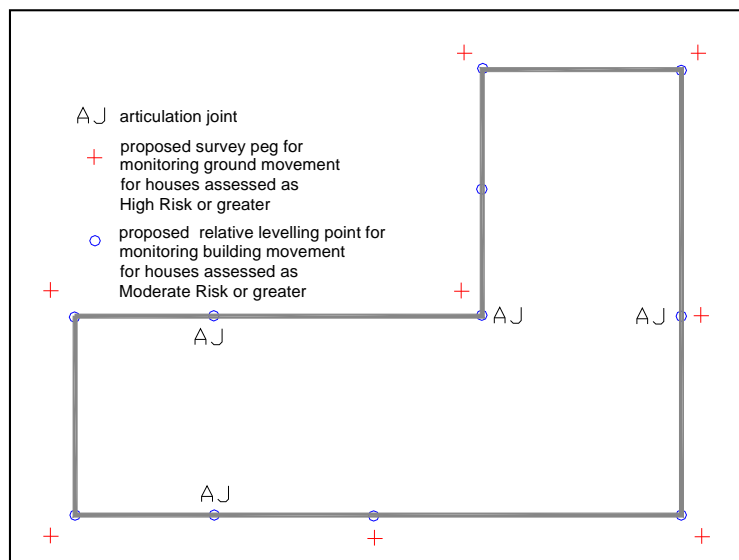
The Colliery will record the reduced levels of each peg, as well as the horizontal distance between each peg around the perimeter of the building. The survey information will provide subsidence, tilt, curvature and strain information on the ground around the building. This general surveying scheme is illustrated in Fig. 5.3. It is recognised that in some cases, it will not be possible to gain access and suitable lines of sight to the entire perimeter of the building, and in some cases, the number of survey pegs may be reduced. However, as a minimum, survey marks will be placed at every corner of the building.

**Fig. 5.3 Schematic layout for ground movement and building level surveys around a typical building**

Ground surveys around structures are used as a baseline monitoring tool. Surveys are undertaken following completion of each longwall unless impacts or high tilts are observed. Tahmoor Colliery will place permanent ground survey pegs around each subject building. The Colliery will endeavour to place pegs at each external and internal corner of the building, and one peg at the centre of each external side of reasonable length (this will depend on the overall size of the building, but is approximately 10 metres).
